IMCA Safety Flash 08/17

April 2017

1 Serious Finger Injury: Procedures During Engine Maintenance

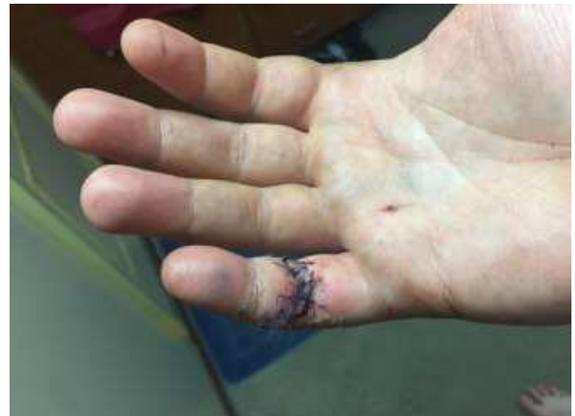
Upon removing one of the pistons, the bottom end bearing cap had been removed and the crankshaft was being turned down to move the crank pin and main bearing shells out of the way of the serrated con rod bottom. The injured person’s right hand was holding the con rod off the crank pin in order not to damage the cylinder liner and crank pin/bottom end bearing shells.

The crank web counter balance was not seen by the injured person as it came around and trapped his little finger between the con rod and crank web counter balance. The crank was immediately turned back and his hand removed from the crank case. He was given first aid treatment on board for a laceration across the width of his right little finger and then immediately sent to local hospital for further treatment.

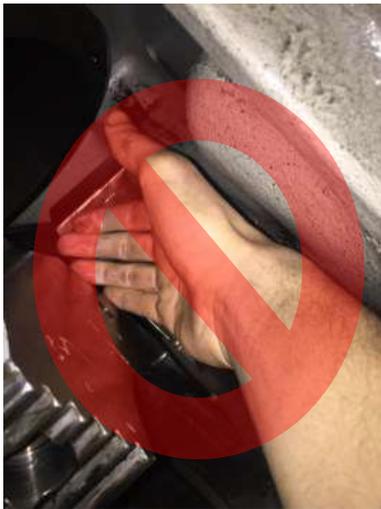
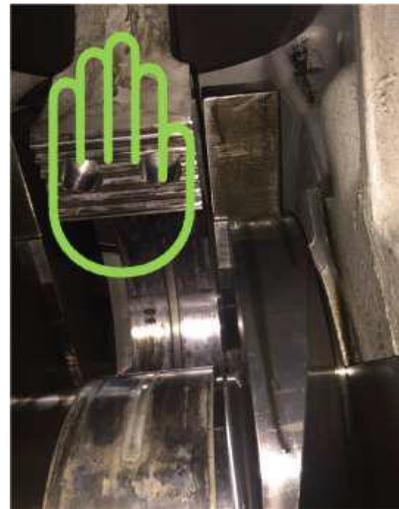
- ♦ **Work Planning** – the work was fully planned, with Risk Assessment and Toolbox Talks conducted, recorded and on-file;
- ♦ **PPE** – the injured person was wearing full required PPE including mechanics gloves; use of these gloves prevented the injury being far worse;
- ♦ **Immediate Actions** – on-board immediate first aid was applied and subsequent external medical treatment was sought;
- ♦ **Follow-up Actions** – the vessel is updating the existing risk assessment to improve safety emphasis on correct hand placement during the task;
- ♦ **Hand Placement** – the injured person had his hand in an unsafe location within the machinery, between the con rod and counter balance; his hand should have been on the con rod itself, with thumb tucked in, to avoid pinch/trapping risks as the counter balance moved.

- ♦ **Question:** *Was a soft stop used around the con rod, to lift it off the shaft?*
 - **Answer:** Not at the time but, since the incident, we have carefully considered different options for supporting the piston and connecting rod whilst turning the crankshaft out, whilst also protecting these components from damage; it is possible to use a substantial wooden lever or a soft stop to avoid placing hands inside.

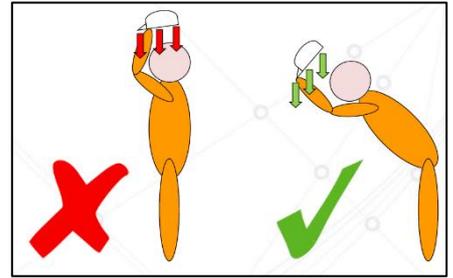
A member has reported an incident in which a seafarer had to receive medical treatment due to a foreign object getting in his eye. The incident occurred when the injured person had been chipping with a chipping gun and other tools. At the end of his shift, approximately 17.20 local time, he stopped the gun and began removing his PPE. While removing his face shield, some rust debris – trapped on top of the face shield's upper lip – fell onto his face and into his left eye. He immediately went to the nearest eye wash station and flushed his eye thoroughly. Assuming that his condition was not serious, he did not report this occurrence to anyone else on-board even though he felt the foreign object was still caught in his eye.

- ◆ He did not report the incident – **report every incident, near miss and observation**, regardless of how minor you think it is!
- ◆ Had he reported immediately to the Medical Officer, further first aid could have been administered on board and a hospital visit could have been avoided;
- ◆ He removed his face shield without being careful – when removing any PPE and equipment be sure to clean off as much debris as possible; this will prevent foreign objects, dust, debris, particles etc. coming into contact with you.

- ◆ Bend forward at the waist – this will ensure any debris falls onto the deck away from you and not into your face and down your coveralls!
- ◆ Ask for help – if necessary, get a shipmate to “spot” you as you go, so they can remove any debris from your PPE and clothing before taking it off.

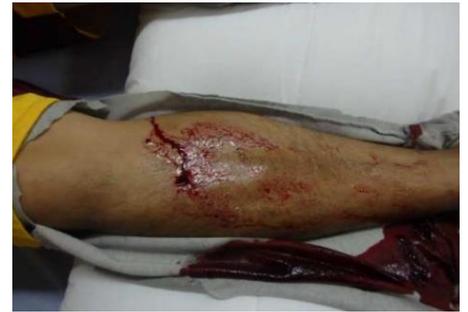
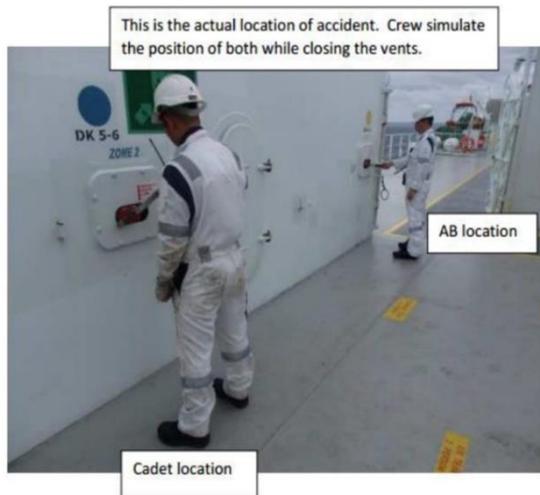
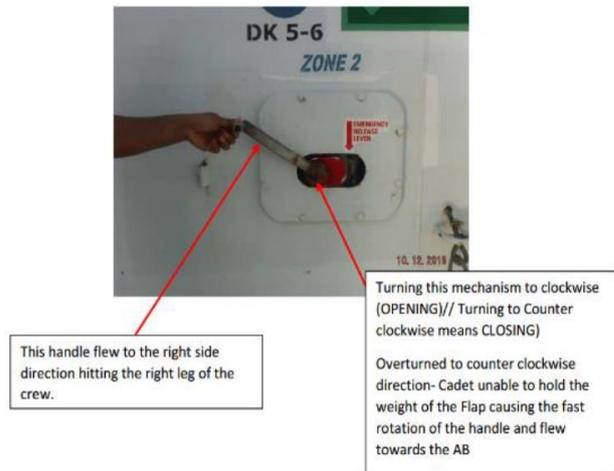
A member has reported an incident in which a crew member suffered a serious leg injury whilst closing ventilation flaps. Two crewmen, one an AB, the other a more inexperienced Cadet, were on the upper deck closing the flaps when a crank handle used to wind the flaps closed became detached and flew through the air. It hit one of the crewmen on his right shin, lacerating his skin and fracturing his leg. He was evacuated by helicopter for treatment ashore.

- ◆ There were a number of **immediate causes**:
 - the emergency release lever was in the wrong position
 - the safety locks were stuck open due to a rusted sheave trapping the wires

- the shallow indentation and wingnut screw used to secure the handle was inadequate;
- ◆ **Causal factors** that were identified:
 - lack of experience and knowledge: The Cadet did not trust his initial judgment that the flap was closed and followed the instruction to keep turning. A more experience crewmember may have been more confident to trust his instinct. He was not aware of proper position of the emergency release and was confused by the instructions painted above

- ◆ **Root causes** identified:
 - risk was not fully assessed or understood and was considered tolerable
 - instructions and warnings were unclear and confusing
 - maintenance of the wires, sheaves, winches locks and handles was not adequate
 - the securing mechanism for the crank handle was poor and left the handle inadequately secured;
- ◆ The **preventative action** taken was to:
 - prepare training in this operation
 - develop a risk assessment including minimum crewing required to do the task safely
 - appropriate maintenance and repair of the wires, sheaves, winches locks and handles
 - Ensure instructions are correct.
