IMCA Safety Flash 13/17

June 2017

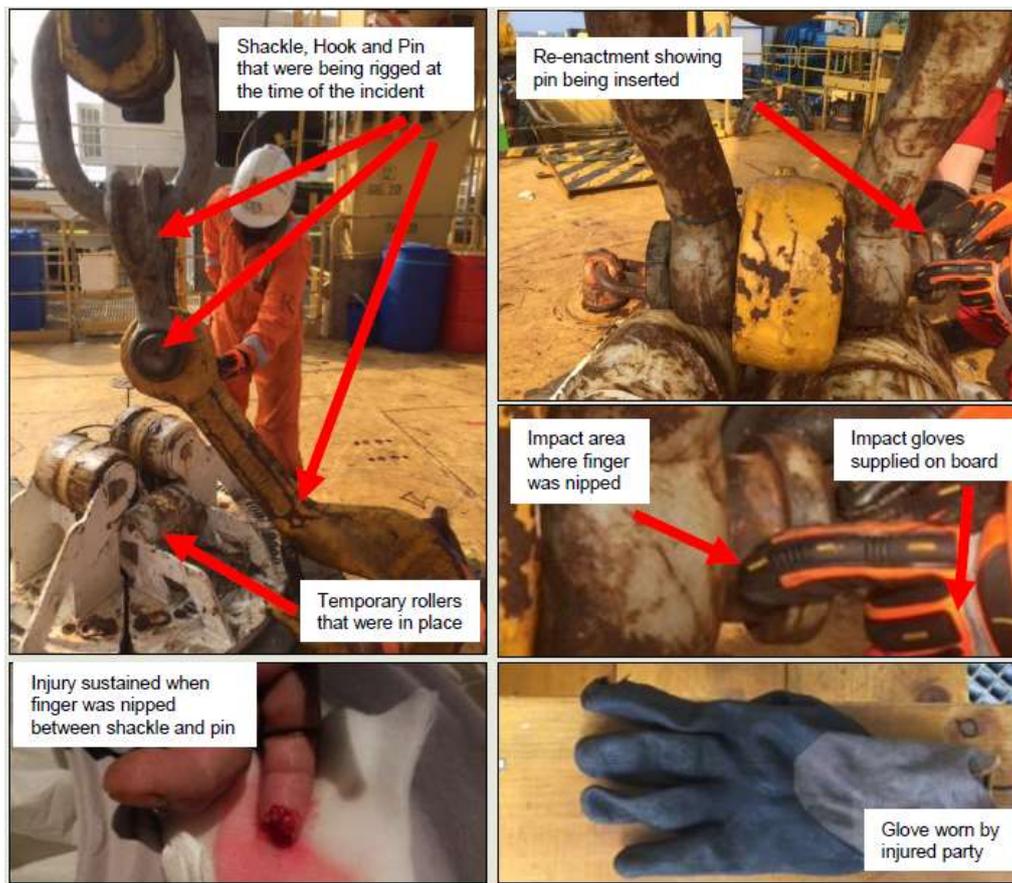
During re-rigging of heavy lifting gear, two riggers were holding the crane hook upright, another three were holding the shackle, and a sixth crewman was holding the shackle pin ready for insertion. As he pushed the shackle pin home, his left index finger was nipped between the head of the shackle and the body of the shackle. This resulted in a serious injury to the index finger of the left hand.

- ◆ Our member identified the following **immediate** causes:
 - not paying attention – lack of awareness of hazards; this was due to the routine nature of the activity
 - inadequate personal protective equipment (PPE) – impact resistant gloves not worn; these could have reduced the severity of the incident;
- ◆ The following **underlying** causes were identified:
 - complacency – due to the repetitive nature of this routine activity
 - prescribed PPE was not worn due in part to poor communication and poor enforcement of the requirements
 - poor design of the shackle pin and the method used for rigging may have contributed to the incident – the size and shape of the pin head left little room for the fingers to hold
 - environment – the work area was restricted and cramped.

- ◆ Easier rigging arrangements involving less manual handling would be investigated, including the possible use of mechanical aids.

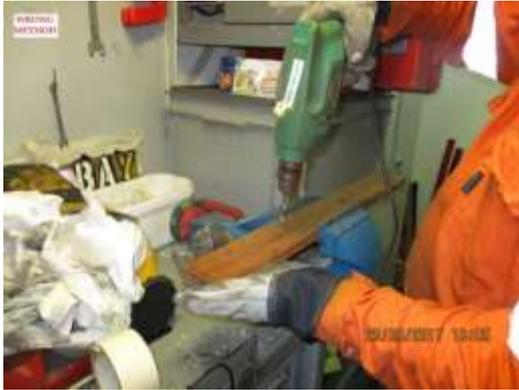
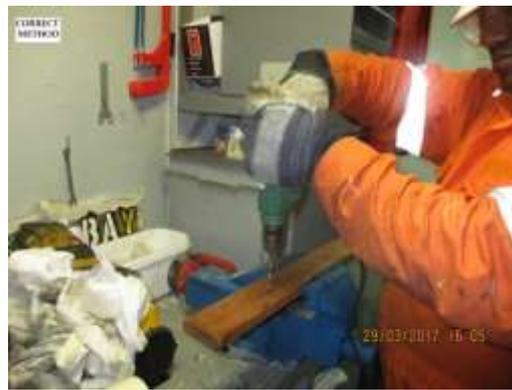
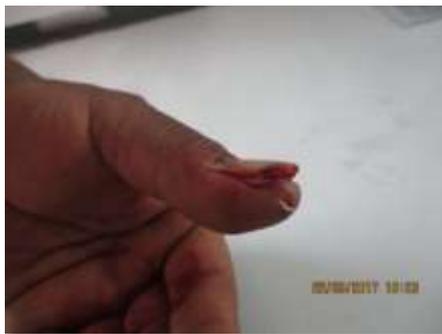
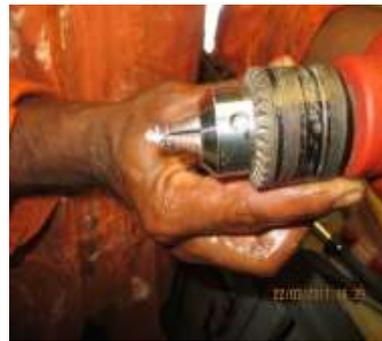
A crewman was in the process of using an electric drill to fix a broom head to a broom stick. The broom stick was held in the vice. The crewman was holding the drill with his right hand, and holding the broom head with his left. The drill bit snapped off which caused the drill to slip and as a result it penetrated the crewman's safety gloves and came in contact with the nail of his left thumb. This slightly dislodged the nail from the thumb. The injury required first aid treatment only.

The **root causes** identified by our member were misperception of risk and improper handling of tools. Appropriate precautions were not taken in proper work techniques. Even though the vice was used, he still held the job with one hand. This could have resulted in a more serious injury.

- ◆ Briefing and training sessions to be conducted for vessel crew regarding safe working practices with hand tools;
- ◆ Greater involvement of vessel crew in identifying hazards and risks for each part of their job.

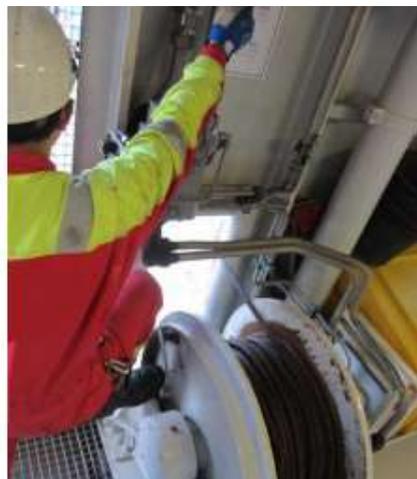
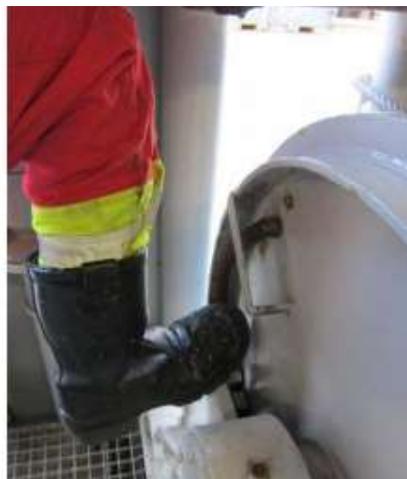
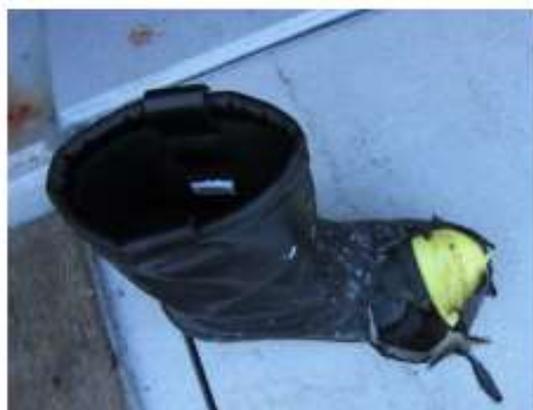
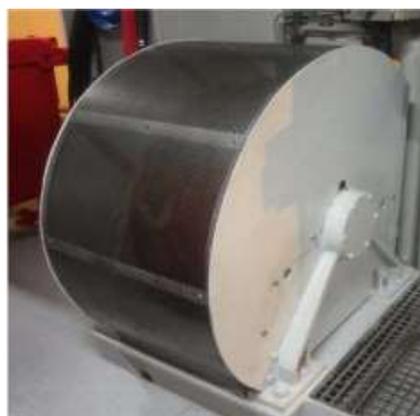
As the winch barrel rotated, the wire securing bar trapped the AB's foot between the winch support plate and the rotating barrel crushing his foot as it rotated.

Following the incident, a protective frame was built around the tugger winch to prevent a similar incident from happening again.

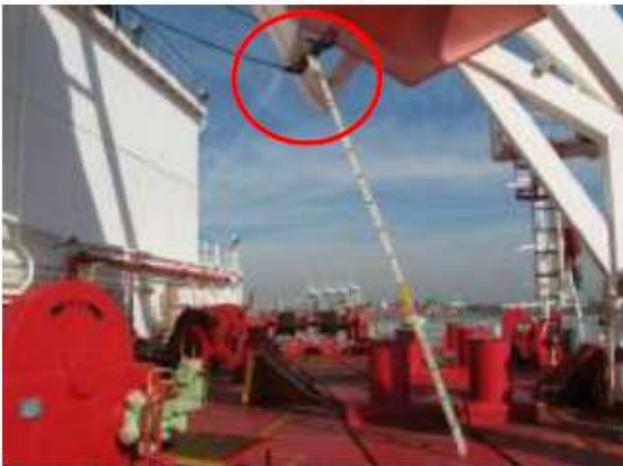
When the AB had climbed part of the way up the ladder, it suddenly slipped on the deck without the bosun being able to keep it steady or stop it from slipping. The AB fell along with the ladder and ended up motionless on the deck next to the ladder. He died three hours later from injuries he sustained.

Ladder as positioned by the AB to reach the forward hook

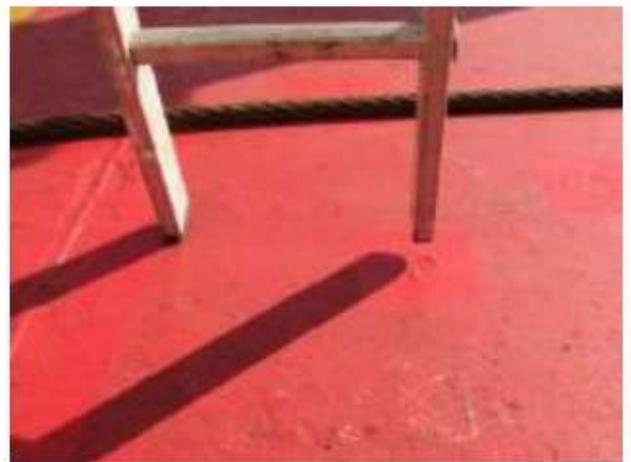
Ladder was unstable, both feet were not in firm contact with the deck
