## IMCA Safety Flash 15/17

June 2017

### Lifting and Rigging

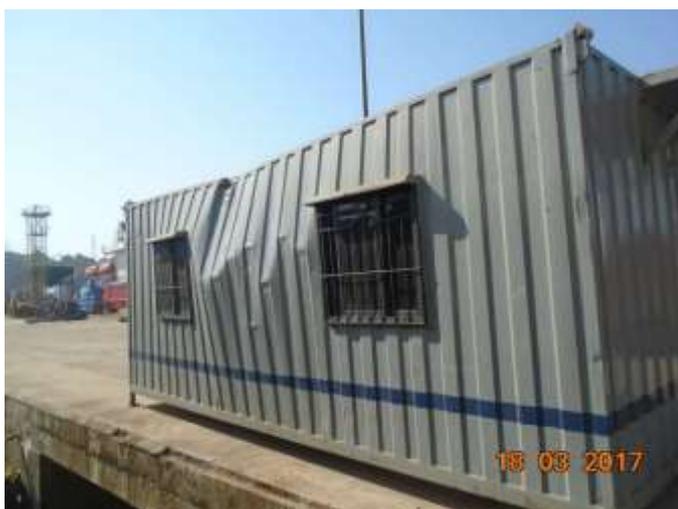
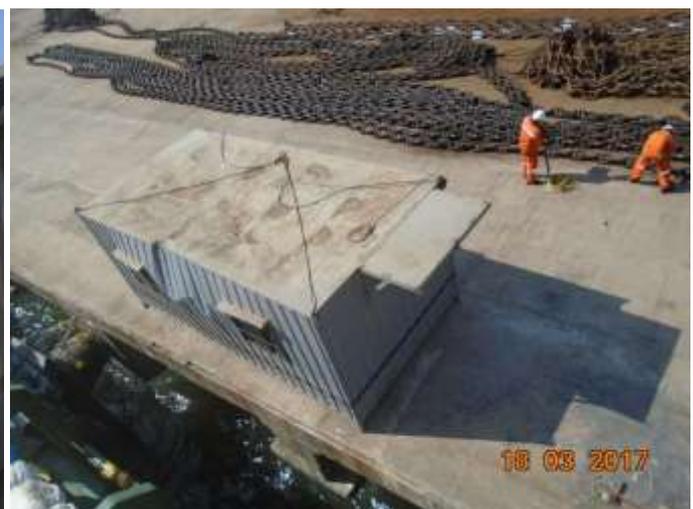
#### 1 Equipment Failure Leading to Crane Collapse

A vessel was tied up in port alongside another vessel (double banked). An attempt was made to lift a 20' freight container cabin from a truck, onto the vessel. The crane of the inboard vessel was used for the operation. A hydraulic line burst and the crane head fell on top of the portacabin. As a result, the freight container fell between the jetty and the inboard vessel, and was badly damaged. No-one was injured.

The immediate cause of the collapse of the crane was the failure of the hydraulic line.

- ♦ Hydraulic lines might burst at any time. It is of the greatest importance to ensure that regular inspection and replacement of such parts is included in the planned maintenance programme;
- ♦ There were significant control of work issues here which were not addressed, in that the crew of the outboard vessel used the crane of the inboard vessel with no assurance as to its condition or fitness for the operation.

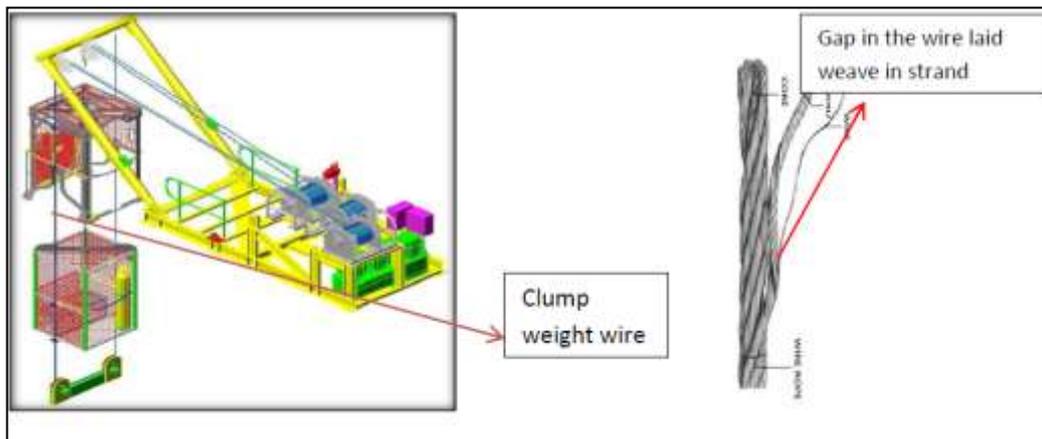
## 2 Near Miss: Fault Spotted in Subsea Lifting Wire

During diving operations at 10 msw, it was noticed that there was a slight gap in the lay of the diver launch and recovery (LARS) clump weight wire. The diver was asked to visually inspect the affected area. It was observed on the divers' helmet camera, and afterwards confirmed by the diver, that no rope strand was broken, only that there was strand protrusion from the rope lay/weave. The following day the rope was re-checked by the dive team & client and a few strands of the clump weight rope were found to be out of the rope lay/weave.

- ♦ Ropes should be monitored frequently to avoid stress due to uneven movements and weather conditions, and an appropriate record kept;
- ♦ Ropes and sockets should be inspected before each dive;
- ♦ Any small defects, damage or abnormality on ropes should be reported immediately;
- ♦ Load testing should be carried out as appropriate after any changes and terminations;
- ♦ Precautions should be in place to avoid stress on ropes during diving caused by weather conditions.
- ♦ **Ropes with core or strand protrusion should be immediately discarded or, provided the remaining length of rope is in a serviceable condition, have the affected section removed.**

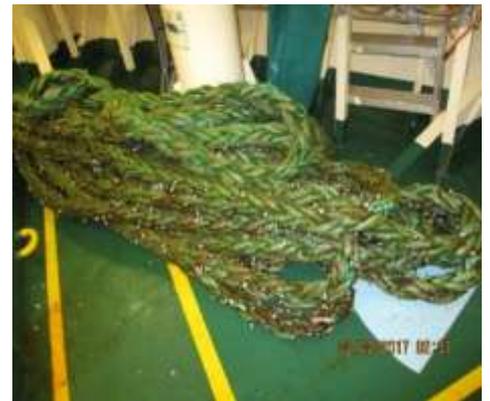
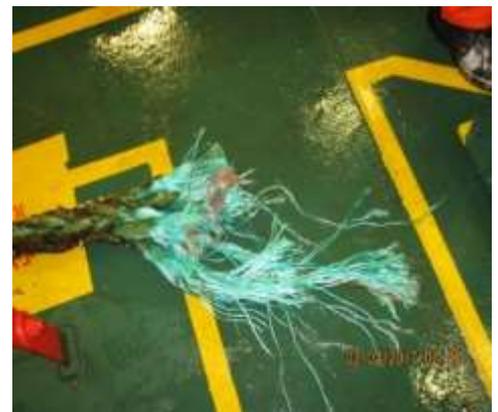
### 3 High Potential Near Miss: Mooring Rope Parted

Mooring buoy rope parted while the vessel was moored. No injuries or damage to the vessel occurred apart from the parted mooring rope. The potential severity of incident was categorized as “high” owing to the potential injuries that could have arisen had someone been in the snap back zone.

Equipment failure following from wear & tear, in turn following from inadequate or insufficient routine inspection. It was evident from inspection after the fact that the condition of the mooring rope was bad.

- ◆ Planned and regular inspection of mooring ropes;
- ◆ If mooring ropes are found in poor condition, they should be taken out of use;
- ◆ All crew associated with mooring operations should be properly informed and fully briefed with regard to:
  - the mooring operation in general;
  - checking for defects with the ropes;
  - proper precautions relating to keeping out of the snap back zone.

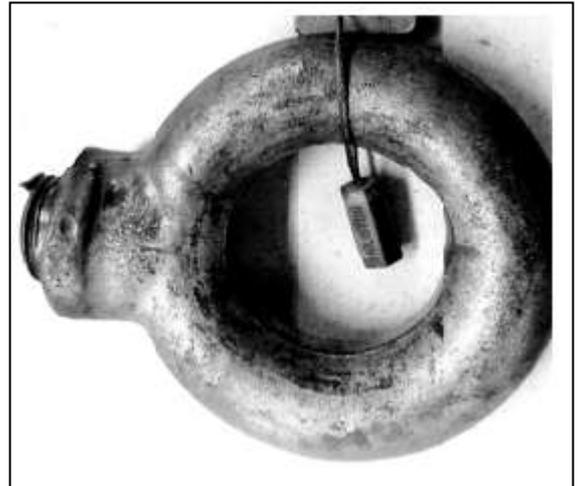
## 4 Collared Eyebolts as Lifting Equipment

NOPSEMA has published [Alert 64](#) relating to the failure of collared eyebolts when used for lifting. A piece of equipment was being lifted during maintenance and repair, when one of the two collared eyebolts used to lift it, sheared. The piece of equipment, which weighed 21.7 tonnes, fell a distance of 1.2-1.8m. There were no injuries.

- ◆ The lifting equipment was configured such that the direction of pull was at an angle to the shaft of the eyebolt, so that a “fleet angle” from the vertical was created. Such an angular load reduced the Working Load Limit of the eyebolt to a significant degree;
- ◆ The collar of the eyebolt was not fully flush with the body of the piece of equipment being lifted, causing a sheering force due to the fleet angle to be applied to the shaft of the eyebolt, instead of the load being spread across the eyebolt and the surface of the equipment being lifted (as per design);
- ◆ A **root cause** identified was **ineffective lift planning**.

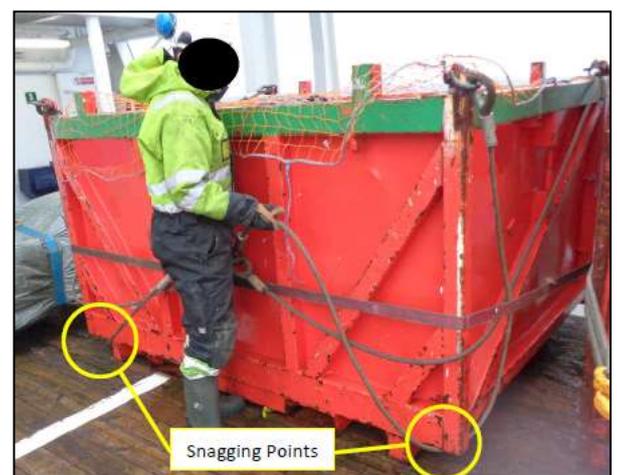
## 5 Near Miss: Snagged Lifting Bridle

The MSF has published [Safety Alert 17-03](#) in which lifting rigging got snagged on an open top mini basket type unit. The incident occurred on a platform supply vessel (PSV) alongside an installation in calm weather. Whilst discharging an open top mini basket type unit, one leg of the basket's lifting bridle snagged on the bottom corner of the unit, almost causing it to tip over.

- ◆ Container manufacturers to consider re-engineering units to eliminate/reduce snagging hazards;
- ◆ The length of the unit lifting bridle will be measured to ascertain if it was too long, leading to this incident;
- ◆ The installation crane operator to be informed about any lifts with a potential to snag;

- ◆ All parties are reminded that good communications between the vessel and the installation crane are essential for safe lifting operations.
