IMCA Safety Flash 05/17

March 2017

Focus: Diving Safety

3 Bailout Cylinder and Pillar Valve Compatibility Failure

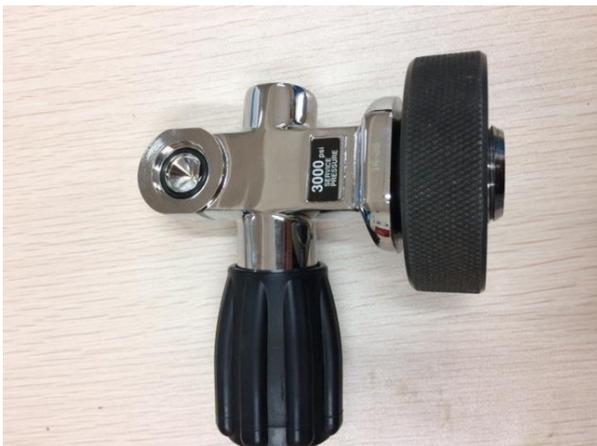
Example of a GO Gauge PASS

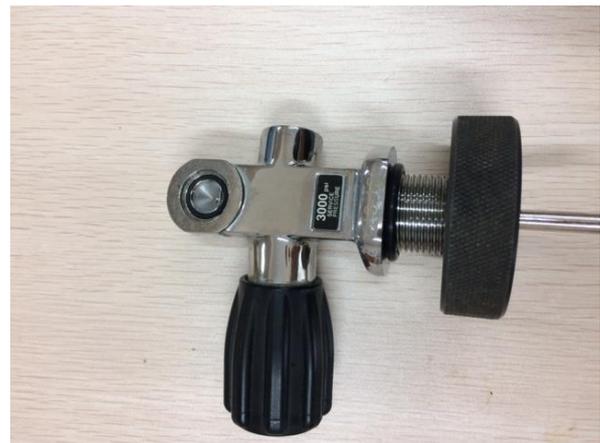
Example of a GO Gauge FAIL

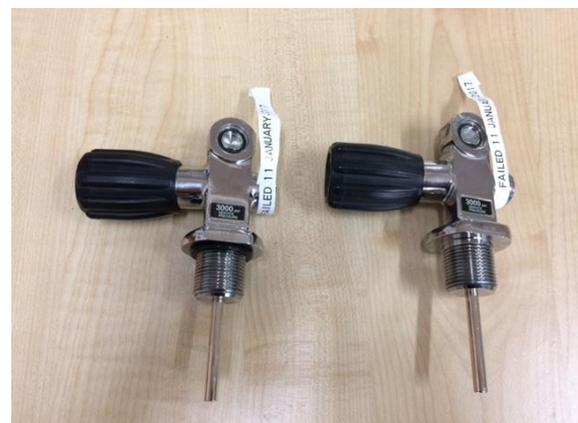
Our member has introduced a quality check of cylinder threads and pillar valves whereby GO/NO-GO thread gauges are used before accepting any new stock. When recently purchasing new cylinders and additional pillar valves the pre-acceptance tests were performed. It was identified that there was a surprisingly high failure rate when testing the new pillar valves. Of six pillar valves purchased, four failed the GO thread gauge test. It is to be noted that similar failure rate has also been the case with subsequent purchases of pillar valves.

Example of New Pillar Valves that FAILED

- ◆ It is recommended that organisations using Bailout Cylinders:
 - establish a planned maintenance system procedure whereby on all 6 monthly internal visual inspections the cylinder and pillar valve threads are checked using the GO/NO-GO thread gauges
 - ensure that cylinders and pillar valves are checked when purchased and before putting into service to ensure correct fitting using calibrated GO/NO-GO thread gauge and by a trained technician
 - implement a method of marking the pillar valves so that a register can be created to record or link a particular pillar valve to a particular cylinder by serial number.

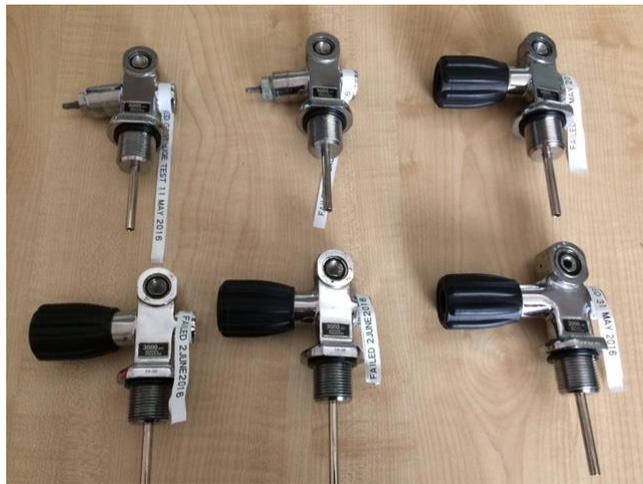
A member has reported a near miss incident in which there were failures of pillar valves. The incident occurred during visual inspection of bailout cylinders, when it was identified that six out of the twelve pillar valves tested, with GO/NO-GO thread gauges, failed the GO thread gauge test.

Of the six cylinders that passed the original test, four cylinders were rechecked at the next six-monthly planned maintenance check, and two of the pillar valves failed the GO gauge thread test. A possible cause of the later failure may have been wear & tear, continual emptying & recharging to 200 bar (at 200 bar there is almost 1 tonne of force on the pillar valve).

Six In-Service Pillar Valves that FAILED
