## IMCA Safety Flash 11/17

May 2017

### Theme: Dropped Objects

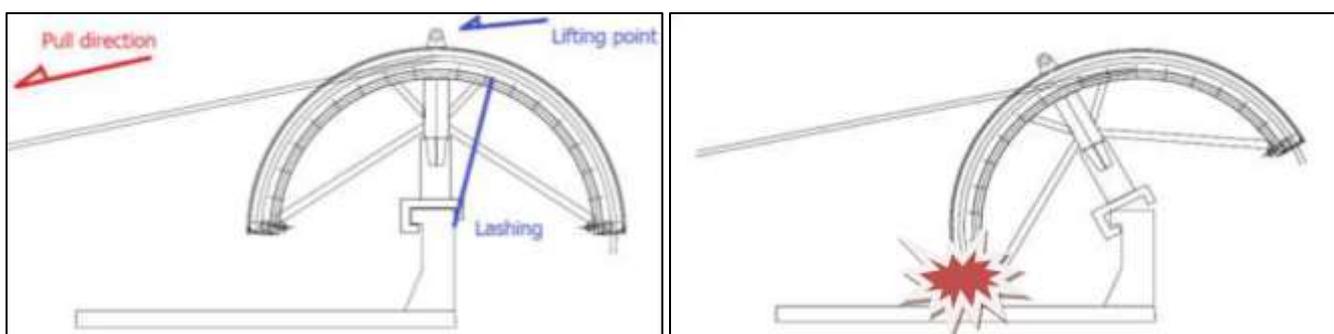
As a result of being unsecured, movement in the cable caused the quadrant to topple and fall to the deck, striking a crewman in the leg. The incident caused minor grazing to the leg and soreness. First aid was administered and the crewman returned to work for the next watch. The incident could easily have resulted in more serious or permanent injuries. Our member treated as a high potential near miss.

- ◆ The pedestal mounting will be fitted with tipped bolts to secure it directly to the bulwark in future;
- ◆ Management will designate a specific person in charge for deck operations.

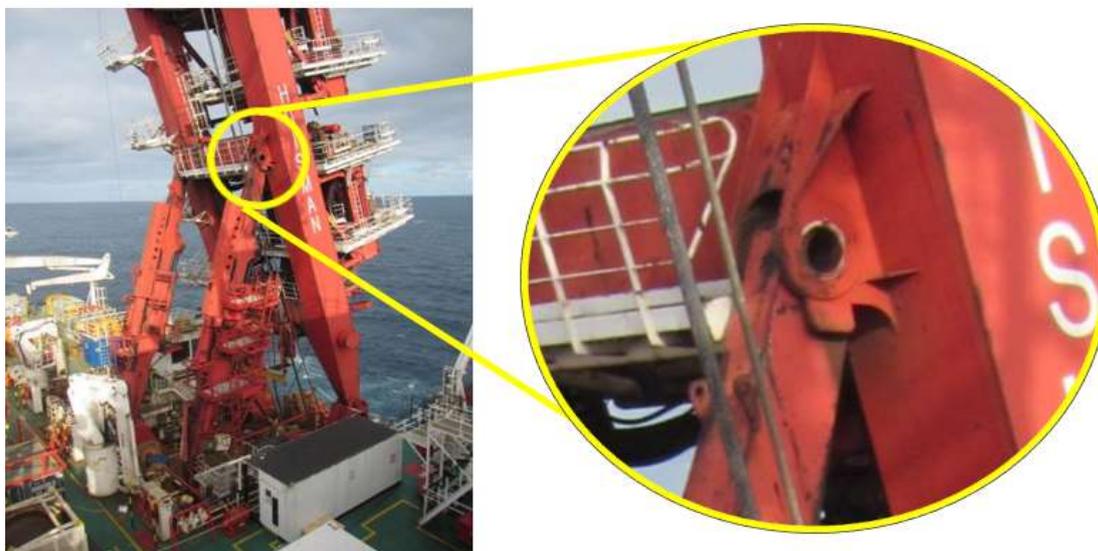
The securing pin from a Tilttable Lay System (TLS) adjuster leg, weighing 600 kg, fell 16m to deck. The incident occurred when the keeper plate bolts slackened off. No-one was in the immediate area below the adjuster leg at the time of the event and no-one was injured.

*Right: Close-up of the adjuster leg housing (with bolts, keeper plate and pin missing)*

- ◆ Investigations found that the planned maintenance and inspection regime was inadequate and unclear;
- ◆ During transits the tower was at times kept in operational position which could have allowed excess movement of the pin due to reduced load and increased dynamic movement;
- ◆ The design made it difficult to lubricate the pin adequately which may have caused excess friction.

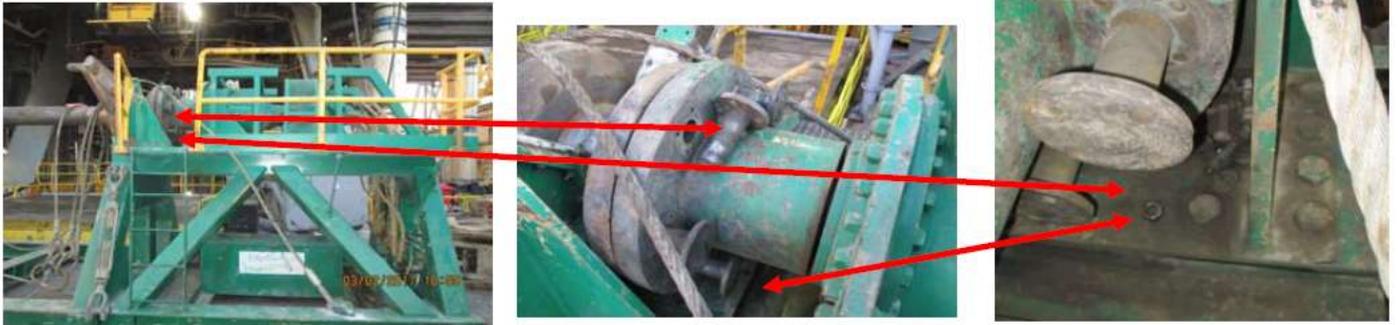
A vessel loaded a spooling unit and other cargo onto a platform. After lifting operations were completed, the platform reported that multiple potential dropped objects (total 19 items) had been identified on the spooling unit. These were mainly loose and unsecured items on the spooler working platform, on its upper level. The following were found, amongst other things: spooler locking pins weighing 7 kg each, securing nuts and bolts, unsecured spooler in cradle, unsecured gratings and unattached grating securing chain.

- ◆ Large and complex objects – such as this spooling unit – should be subject to thorough inspection for potential dropped objects at every stage of the transportation process;
- ◆ Do not under-estimate the hazards of loose objects falling from loads from trailers on the road or during loading operations;
- ◆ Crew should be alert at all times to the danger of potential dropped objects and should never be under the load.

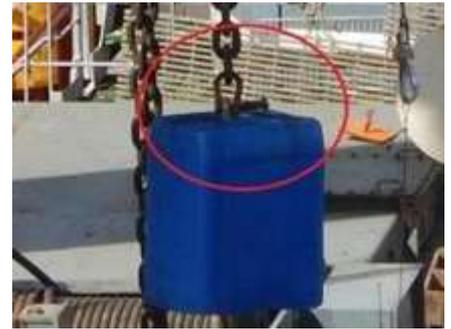
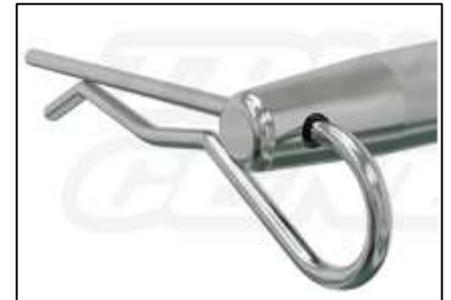
- ◆ Inspection of the securing arrangements revealed that the wrong securing clips had been used and these had fallen out, enabling the shackle pins to work loose. A split pin or wire seizing should have been used to secure the shackle pin;
- ◆ The equipment was covered by weather protection boxes which prevented easy inspection of the securing arrangement;
- ◆ This incorrect securing arrangement was identified previously but **lessons were not shared** across the fleet or with the contractors who installed this equipment.

“R” clip type that was incorrectly used for this application but is commonly used in diving operations.

- ◆ Conduct a hazard hunt to confirm that any overhead equipment is secured correctly to prevent it coming loose;
- ◆ Visual check of rigging and securing of any man riding or fall arrest equipment for similar issues;
- ◆ Ensure appropriate regular inspection regimes are in place, particularly for locations where visual inspection is difficult – consideration should be given to equipment already positioned at height or concealed from view;
- ◆ Users of fall protection devices may not be able to visually inspect the connections because of location or if weather protection devices are used. In these cases, additional or other suitable inspection arrangements should be in place;
- ◆ Care should be taken to confirm the adequacy of the securing arrangements applied when third parties are engaged to install, maintain or inspect such equipment.
