IMCA Safety Flash 14/17

June 2017

The following incidents have no common theme, though as far as possible, broadly similar issues are grouped together. This safety flash includes four incidents relating to lifting and rigging equipment, chains and towing equipment; an incident relating to the failure of a large casting and the discovery of a huge leak in the fresh water system on a vessel.

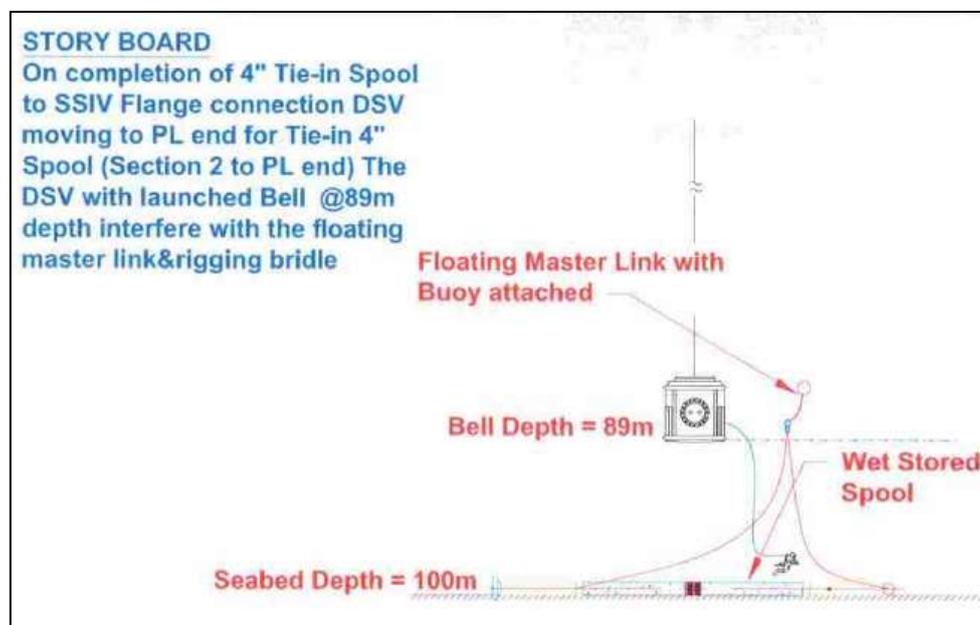
During a bell run at 90msw a task was completed and the diving support vessel (DSV) needed to relocate to a pipeline end. The move was started with the diver on the bell clump. He called an 'all stop' when he saw the wire rope and four-part lifting bridle approaching the bell.

- ◆ There was no information available as to the depth of the buoys;

- ◆ There was added risk of umbilical entanglement when the divers passed unknowingly through the wire lifting slings;
- ◆ An ROV was deployed to the worksite and found buoys at 13m above seabed. The bell was being held at 90 msw (10m above seabed).

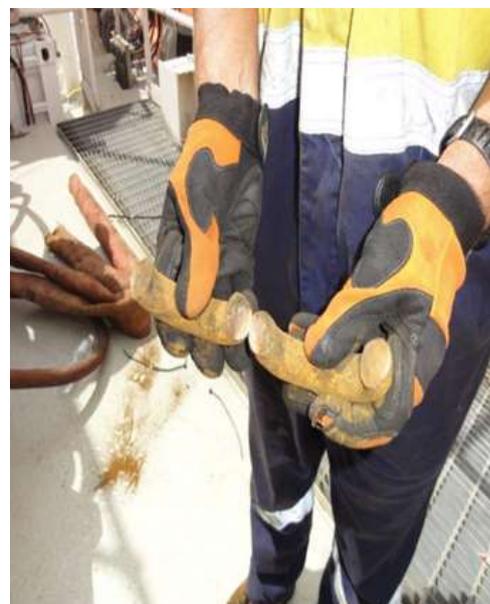
A self-propelled hyperbaric lifeboat (SPHL) was being lifted to the main deck for an hyperbaric reception facility (HRF) mating trial. During this activity, the aft lifting chain on the SPHL broke whilst transferring the weight of the SPHL from the davits to the crane. The SPHL was approximately 50mm clear of the cradle when the aft chain snapped. At the time of the incident the crane reported an 8 tonne load. The dry weight of the SPHL was 13 tonnes. No persons were in the SPHL or in the immediate vicinity at the time of the incident. There were no injuries.

- ◆ The rigging had been sent ashore for annual testing and failed on-board the vessel, shortly after it had been inspected by a 3rd party;
- ◆ The rigging was not tested as per 3rd party inspection procedures;
- ◆ The rigging was being stored outside in open environment – this will have contributed to the condition of the chain;
- ◆ A canvas sock around the rigging made it more difficult to inspect and see corrosion;
- ◆ A chain link failed at 2 positions and appears to not be deformed – indicating existing crack propagation.

- ◆ Storage of the recovery rigging on top of SPHL exposed chain to the external environment – this contributed to the chain becoming corroded;

- ◆ Inspector checked lower links of the chain only and did not inspect the section hidden by the protective cover. The Inspector assumed that he had inspected sufficient percentage of the chain from which to infer the condition of the entire length. Chain under protective cover had significant corrosion.

- ◆ All chain slings older than 12 months to be destroyed;
- ◆ SPHL recovery rigging to be stored below decks and fitted only when SPHL is required;
- ◆ Audit to be conducted of 3rd party to ensure compliance with inspection procedures. Improved liaison and communication with 3rd party auditor.

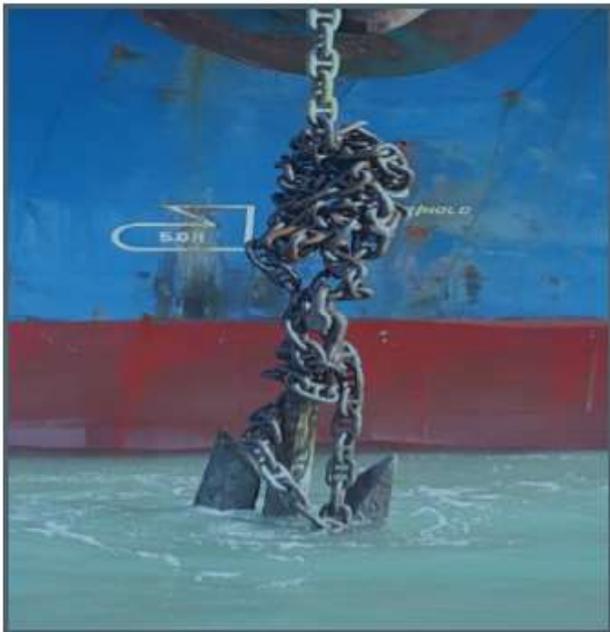
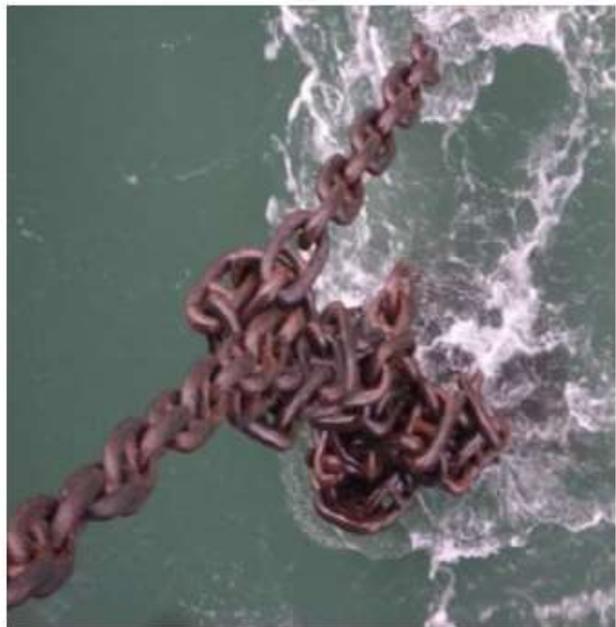
A vessel had used both anchors whilst waiting for 3 days off the coast. Both chains were fouled and could not be cleared by the vessel. External assistance was provided but owing to the weather and sea conditions, the anchors could not be cleared, and both chains had to be cut. Attempts at retrieval of the anchors from the seabed were unsuccessful. The vessel lost both her anchors with one length of cable on the port and two lengths of cable on the starboard side anchor.

Both anchors had to be cut free and arrangements made for the vessel to go alongside for repairs. The vessel was off hire for 12 days.

- ◆ The Master, based on his previous experience, had the vessel use both anchors to reduce the swinging speed and angle of yaw of the vessel;
- ◆ There was inadequate discussion between the bridge team and anchoring team before anchoring;

- ◆ There was not an effective anchor watch maintained.

- ◆ More effective communication and meeting between bridge and anchoring teams before anchoring;
- ◆ More thorough planning and risk assessment before arrival into the anchorage or when deciding to remain at anchor.

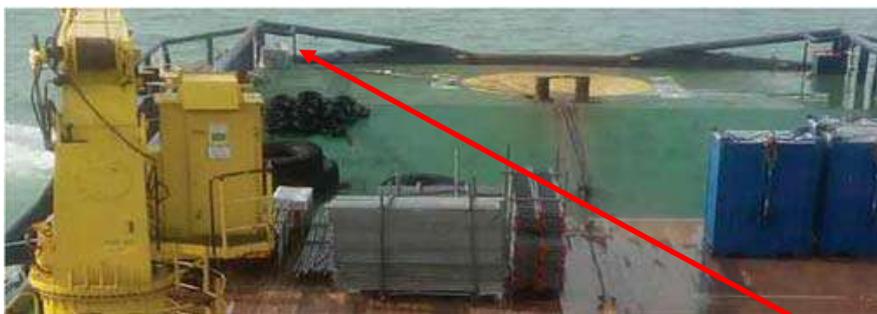
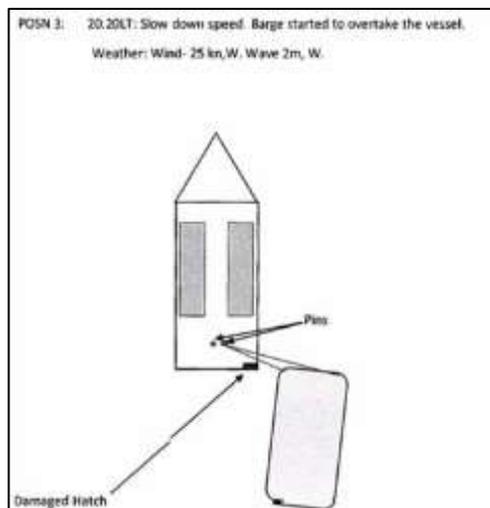
An anchor handling tug supply (AHTS) vessel, whilst towing a barge, encountered heavy seas (wind on the beam, 25 knots, waves, 2m) and began to roll heavily. In order to avoid damage to the barge, the Master decided to slack off the towing wire by 10m. As soon as the vessel and barge came to calmer water, speed was picked up to 6-8 knots. Then, for other reasons the Master had to reduce the speed of the vessel again. The momentum of the barge was such that it continued to move in such a way that the towing line caught the open hatch of the emergency exit from the Engine Room, which had been kept open at sea.

- ◆ All watertight openings were not physically inspected before sailing to ensure they were secured for sea, despite requirements in company operations manual that this should be done;
- ◆ Crew had decided to keep the Engine Room hatch open due to insufficient Engine Room ventilation leading to a high air temperatures, in turn leading to alarms being triggered;
- ◆ The problem with the ventilation system in the Engine Room had been experienced for a long period of time, but had not been reported to the relevant parties nor any investigation conducted;
- ◆ The original stern fenders of the vessel had been temporarily replaced by smaller fenders, which made it difficult to keep the towed barge tight to a stern of the vessel while towing.

- ◆ Any defect or abnormal condition onboard should be reported immediately to relevant parties;
 - the problem with engine room ventilation system would be investigated. A new hatch to be fabricated and installed as soon as possible;
 - further training provided on board emphasizing importance of timely defect reporting;
- ◆ Original fenders would be reinstalled at stern for safer towing operations;
- ◆ Further coaching and training provided on board to ensure proper physical inspection of all watertight openings before sailing.

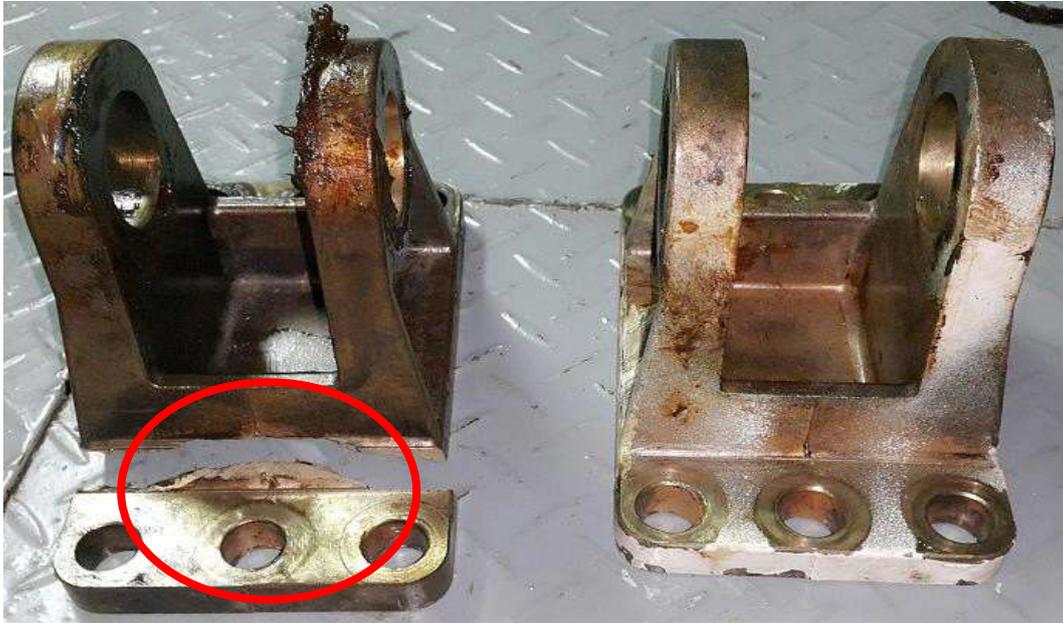
Damage was reported to the steering gear hydraulic ram foundation brackets connecting the ram to the structure of the vessel. The foundation bracket casting failed.

- ◆ The failed brackets were of a cast bronze design and by nature of the material were unable to withstand shock loads;
- ◆ It can be seen in the above photograph that the casting had a design flaw whereby there is no radius where the main body meets the flat mounting plate. The clearly shown sharp corner results in a stress raiser where the crack has occurred;
- ◆ Subsequent inspections across the fleet revealed several vessels with damaged brackets.

- ◆ Thorough inspection of steering gear ram foundation brackets for cracks is recommended;
- ◆ Appropriate modification of vessel planned maintenance system to include this visual inspection;
- ◆ Our member noted that later vessels have brackets fabricated using welded steel plate.
