IMCA Safety Flash 16/17

June 2017

Hand Injuries, Burns

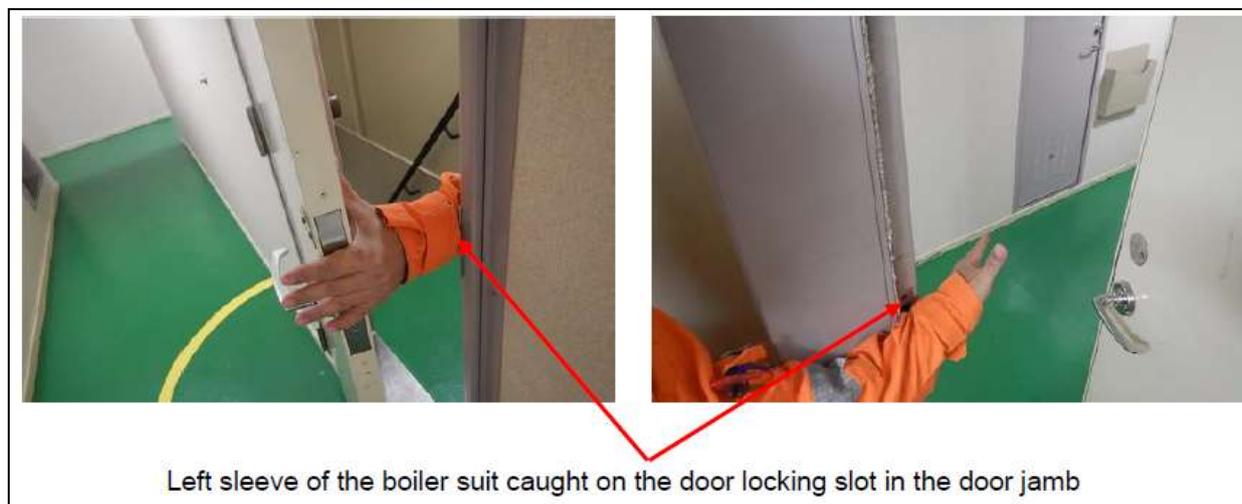
1 LTI: Hand Injury Resulting from Clothing Catching on Door

Crew were standing down from mooring stations after a vessel left port. One crewman was passing through a heavy door, when the left sleeve of his overalls got caught on the door locking slot in the door jamb. Before he could free the sleeve, the closing door shut hard on his hand, causing injury to the ball of his thumb. First aid was rendered on board immediately. He was referred to the doctor ashore for further treatment and was advised to sign off for further treatment thereafter.

- ◆ **Immediate causes** identified were;
 - carelessness and lack of situational awareness – he did not safely pass the door frame resulting in overall sleeve being snagged by the door jamb
 - the cuff or sleeve of his overall was loose
 - the door closing mechanism was not properly adjusted;
- ◆ **Causal factors:**
 - management – inadequate work standards; the weekly inspection did not adequately identify the potential hazards of door closing mechanism and unsafe door jamb;
- ◆ The **root cause** identified was that risks were considered tolerable – crew were using the door on a daily basis without observing and reporting the existence of the potential hazards, and wearing overalls with sleeves loose.

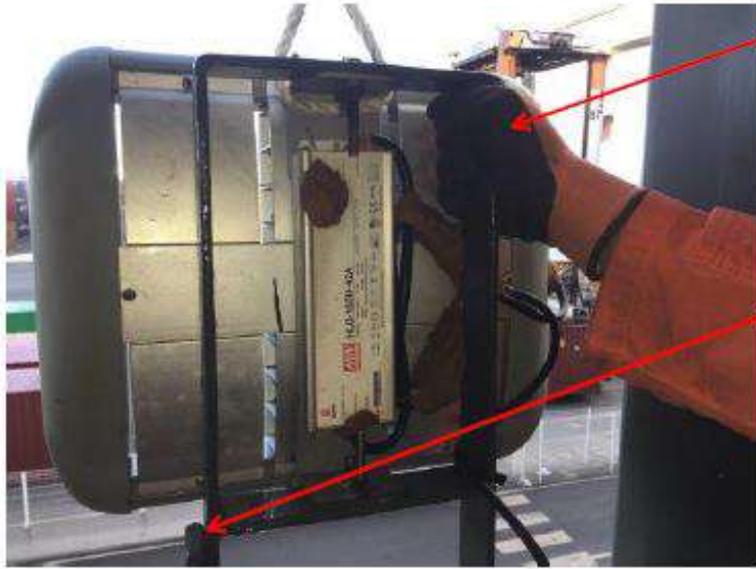
- ◆ The **immediate cause** was found to be that the injured person was not in the right position. He misjudged the situation and used an improper technique to adjust the floodlight. He tried to catch the bracket arm from falling, thinking it would damage the lamp;
- ◆ The following **causal factors** were identified:
 - no-one foresaw the need for precautions in adjusting the flood light
 - the crewman had limited knowledge the potential risk involved;
- ◆ The **root causes** were found to be:
 - risk was considered tolerable – this was a routine recurring task
 - safety systems were inadequate – there was no properly designed handle to hold the light bracket in place while removing the securing pin.

He was holding here with right arm, with gloves, same type as shown, Winter hard protecting gloves

Left hand held here, after removing the pin, the light allowed to swing down, because of severe ambient cold, right hand slipped and lost the hold.

By reflex, used left hand to hold the light from hard hitting down

Left arm finger nail got crushed coming between lamp bracket and ship structure

- ◆ Review of specific ship and task risk assessments to include potential risks involved in this operation;
- ◆ More effective toolbox talks to be conducted for the crew involved;
- ◆ More care to be taken when conducting routine work, especially when less experienced crew are involved.

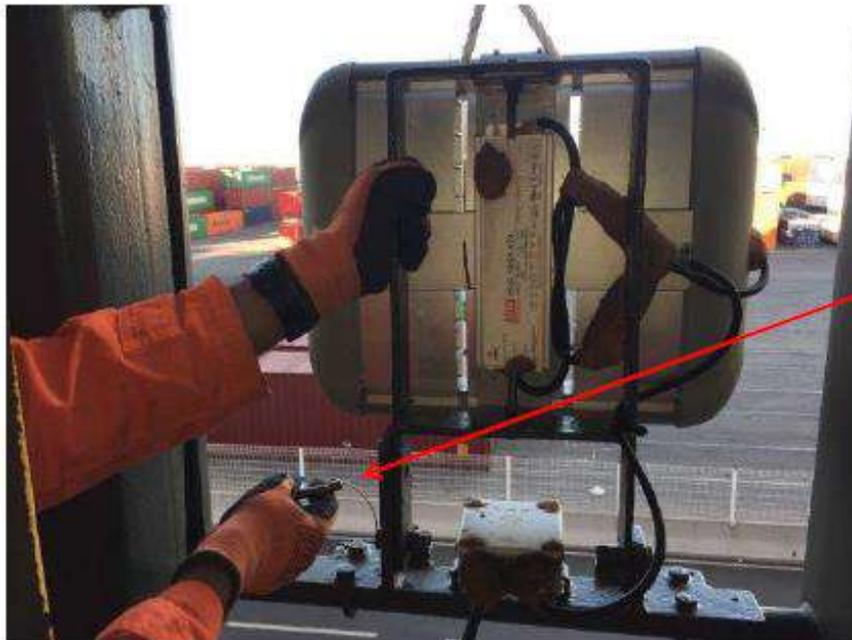
The Pin securing the light with bracket

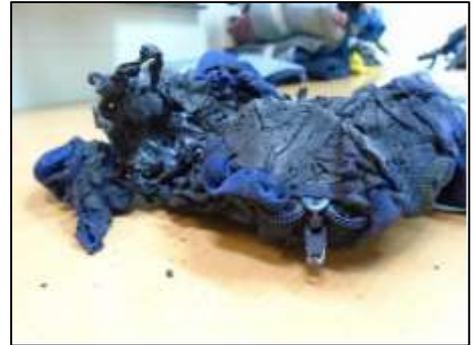
UK Step Change in Safety has published an alert in which a member of the crew suffered a burnt hand whilst working in the laundry. The person put a hand into a dryer (prior to running the cooling cycle) to check if the garments were dry. In doing so, that hand touched a “base layer” type garment that had melted inside the machine. The result was a burn that escalated to an LTI.

Base layer type garments are usually either a mix of or entirely made from polypropylene. This fabric has qualities which allow moisture to wick away and heat to be retained. Because of its melting factor, air drying is recommended instead of machine drying.

Some work activities should be done in sequence to ensure safety (e.g. running the dryer cooling cycle before entering). In such cases, it is necessary not only to know what the control measures are, but also to carry the work out in a particular order. Users of offshore laundry facilities should make sure that clothing is appropriate for machine washing and drying. Certain fabrics can melt under high heat, increasing the risk of injury to laundry workers and the possibility of fire.

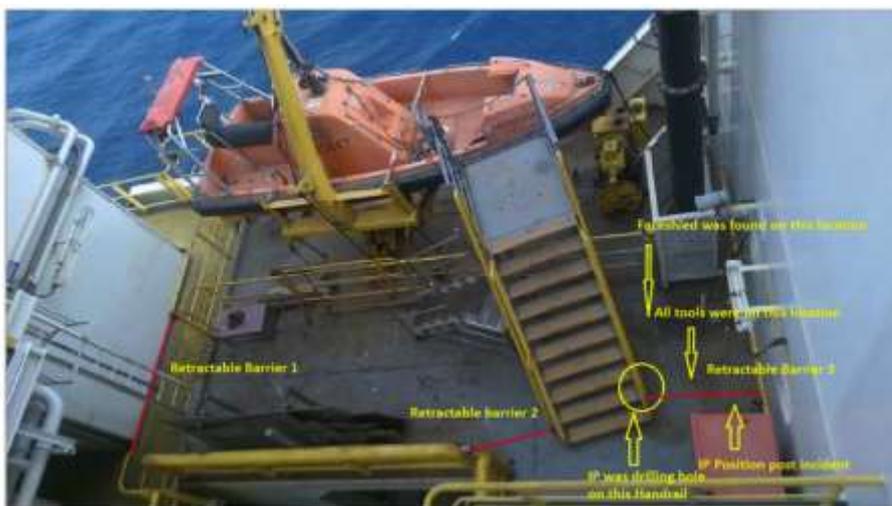
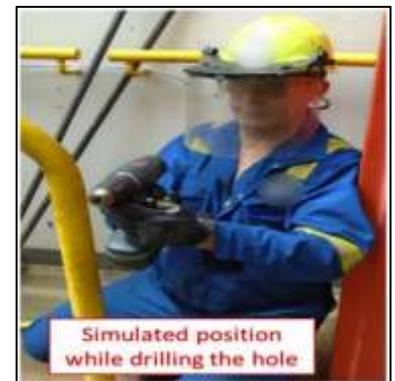
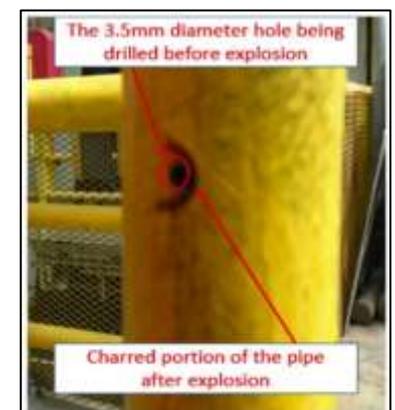
4 LTI: Crewman Burnt in Fire Following Release of Flammable Gas from Hand Rail

A mechanic was drilling a 3.5mm hole into the access stair handrail of a rescue craft, in order to install a safety barrier clip. When the drill bit penetrated the wall of the handrail pipe, there was a release of an unknown flammable gas that caused a fire and subsequent injury. He suffered burns which required recovery time in hospital and lost days from work.

- ◆ The design of the handrail, using/creating hollow and enclosed structures, led to the conditions for accumulation of hazardous gas. There were no design features to allow for venting. The construction of the

handrail (of low grade steel) contributed to the accumulation of a combination of hazardous gases in the hollow and enclosed structure;

- ◆ The drilling introduced a heat source for ignition of the hazardous gases when released;
- ◆ The mechanic was in the path/route of the hazardous gas release (line of fire), and was not wearing his personal protective equipment (PPE) with all fastenings secured, as was required.

The Investigation team believes that the injured person was carrying a paper copy of the risk assessment for the job in – but sticking out of – his right side front pocket at the time of the incident. It is believed that when it burned, an intensified heat spot was created which contributed to the degree of severity of the burns suffered.

- ◆ Handrail design should consider features/measures to limit or avoid the potential for accumulation of gases inside hollow and enclosed structures. Examples include using angle irons for hand rails, non-metallic tubulars, weep or vent holes in tubulars, etc.;
- ◆ Establish procedures to safely tap into a hollow and enclosed structure which potentially has hazardous gas inside;
- ◆ PPE to be worn as designed, with all fastenings secured.

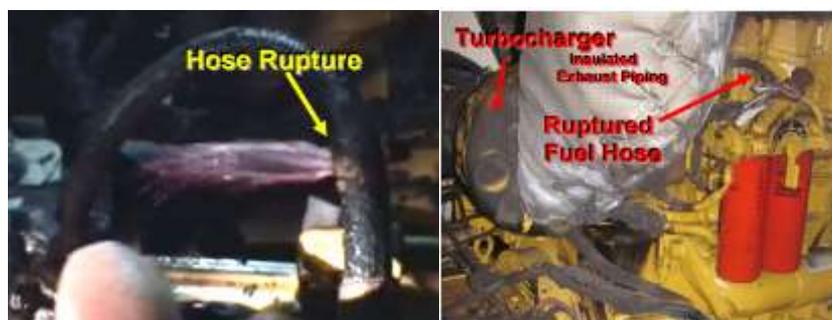
5 Fuel Spray Fire - Déjà Vu: Prepare and Prevent it from Happening to You!

The crew member on watch entered the engine room and identified a high-pressure fuel leak spraying over and upon the port engine’s turbocharger. He also reported a large quantity of diesel fuel in the bilge.

The Master then went down into the engine room and witnessed the ignition of the fire. Using a hand held portable fire extinguisher he quickly attempted to extinguish the fire without success. The Master activated the general alarm, secured the hatches, had crew members secure the ventilation dampers and closed the remote fuel shut-off valves to the engine room. The fire then quickly self-extinguished. No-one was harmed, but this engine room fire led to significant damage, operational down-time of the vessel and lost company revenues.

The source of the fuel leak was identified to be a rupture on a flexible fuel hose connected to the fuel filter assembly. The USCG recommendations can be summarised thus:

- ◆ Avoid an “out of sight, out of mind mentality” and regularly inspect unmanned machinery spaces;
- ◆ Inspect fuel and lubricating systems closely from source tanks to system end points;
- ◆ Examine all heat sources particularly with respect to engine exhausts;
- ◆ Minimize the use of non-metallic flexible hoses in systems carrying flammable liquids particularly around engine areas where failures leading to leakage or spray may find hot spots capable of igniting the fluids;
