## IMCA Safety Flash 03/17

February 2017

#### 1 Near Miss: Unidentified Differential Pressure Led to Divers' Umbilical Getting Trapped

## 2 Quality Assurance of Diving System Audits

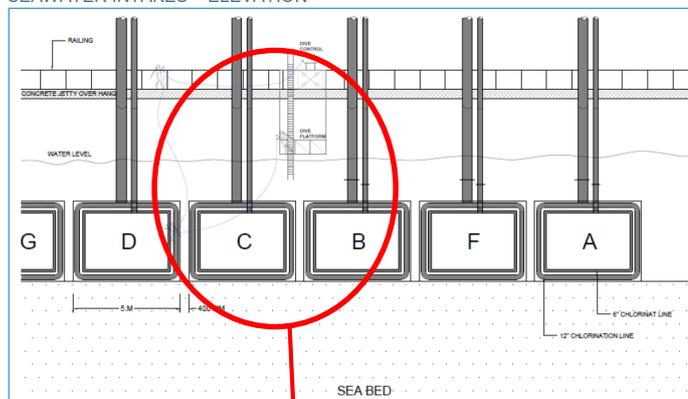
SEAWATER INTAKES – ELEVATION

A member has reported an inshore diving near miss incident in which a divers umbilical became trapped and subsequently damaged – no divers were injured. The incident occurred when two divers were working on some underwater clamps associated with two chlorination dosing lines on either side of the entrance to a gravity fed seawater intake located in a culvert.

Each of a number of culverts at the location contained a seawater intake fitted with an automated grating and trash cleaning system recessed 5m from the main opening. The diving operation necessitated moving repeatedly back and forth across the 5m wide intake opening between the clamps. This allowed some slack to be unintentionally introduced into the divers deployed umbilical. After an extended period of incident free operations, one of the divers' umbilicals became entrapped with the automated trash cleaning system, resulting in the diver being pulled towards the intake. The 2nd diver cut the umbilical to facilitate escape and both divers ascended to the surface in a controlled manner without injury.

- ◆ The presence of an automated trash removal system was not communicated by the asset owners to the project team;
- ◆ As a consequence of this omission there was no system in place to ensure the automated trash removal system was effectively isolated;
- ◆ There was a "lock out/tag out" system in place for the seawater intake valves;
- ◆ The project risk assessment was not effectively reviewed on site to identify appropriate controls for site-specific hazards;
- ◆ The position of the dive tender was not relocated as the dive progressed across the face of the multiple intakes, meaning that excess umbilical was deployed in the water, increasing the potential for snagging.

IMCA notes that this was actually a **differential pressure incident** where the divers' line was drawn into the gravity fed seawater intake by the suction generated. This is an excellent example of the very serious (and often potentially fatal) risks faced by divers in differential pressure situations. In this case, the important point is that the pressure differential was *not identified*. Differential pressure situations are subtle and difficult to spot, widespread, and potentially deadly to divers. Vigilance is key to the prevention of such incidents.

- ◆ Improvements were made to the project start up process to ensure that critical information related to automated systems is properly passed on;
- ◆ Physical barriers to be placed across the intakes;
- ◆ Lock out/tag out confirmation of the automated systems to be verified before resuming diving activities. This is captured in the Pre-dive checklist;
- ◆ Project manager to verify and confirm that the activity risk assessment has been reviewed on site by the team before resuming operations;
- ◆ Dive tender to be repositioned throughout the diving operations to ensure that the optimum amount of deployed umbilical is in the water column to minimise the likelihood of snagging.
