IMCA Safety Flash 18/17

July 2017

1 High Potential Incident: Fast Rescue Craft Capsized

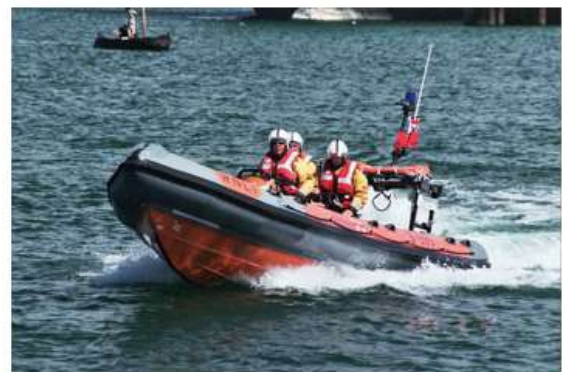
A fast rescue craft (FRC) being used in a near-shore shallow water seismic survey in tropical waters, capsized causing four people to fall into the sea. There were no injuries, but most of the work equipment was either damaged or lost. Two of the personnel were not wearing lifejackets.

The operation had been taking place in good weather; however, minutes before the incident the weather conditions deteriorated rapidly with the wind quickly changing direction. The coxswain recommended running for shelter, but was overruled by offshore vessel management.

Towed equipment became snagged on the seabed causing it to act as an anchor, turning the small boat stern towards the weather. The crew were not able to free the equipment, and the small boat, which was operating at its maximum load capacity, took on water over the stern and capsized.

- ◆ Reiterate to all personnel that the company will always support a **'Stop the Job'**, putting safety over production;
- ◆ Review small boat procedures and associated risk assessments to ensure all reasonable emergency situations have been considered;
- ◆ Ensure that small boats are suitable for the task and capable of working in all expected environmental conditions. Never operate to the absolute limit of the vessel.

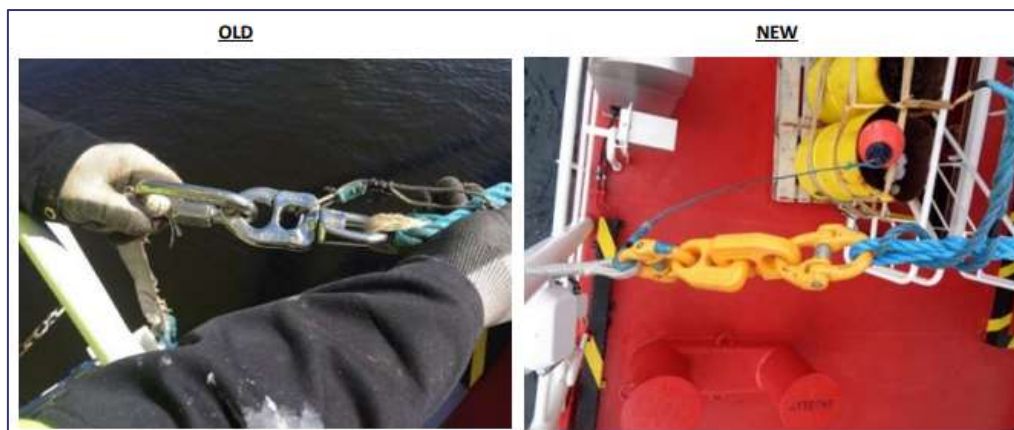
During recovery of the FRC, the forward painter quick release parted just as the FRC was lifted out of the water. The FRC then swung to starboard causing the stern to come into contact with the mother vessel. The jet guard struck the side of the vessel and the jet itself struck the side of the vessel. The FRC bucket was cracked, as was the jet inside the bucket and the jet guard was found slightly bent. The FRC was recovered with no injuries to the crew-members.

- ◆ The forward painter quick release mechanism used had no time limit for use nor inspection criteria, and had been in operation for two years;
- ◆ A previous near miss had been recorded where the clip had parted resulting in a visual inspection of the 'outside' of the quick release where the spring mechanism cannot be viewed.

The springs inside the quick release clip will deteriorate with weather exposure and high usage and cannot be viewed from the outside. There were no records of inspections within the planned maintenance system.

- ◆ The quick release mechanism was replaced immediately with a G-link type, eliminating the spring mechanism;
- ◆ Planned maintenance system – 6 monthly visual inspection implemented;
- ◆ Risk assessment reviewed;
- ◆ All crew reminded to be conscious of dangers at all times – complacency is not an option!

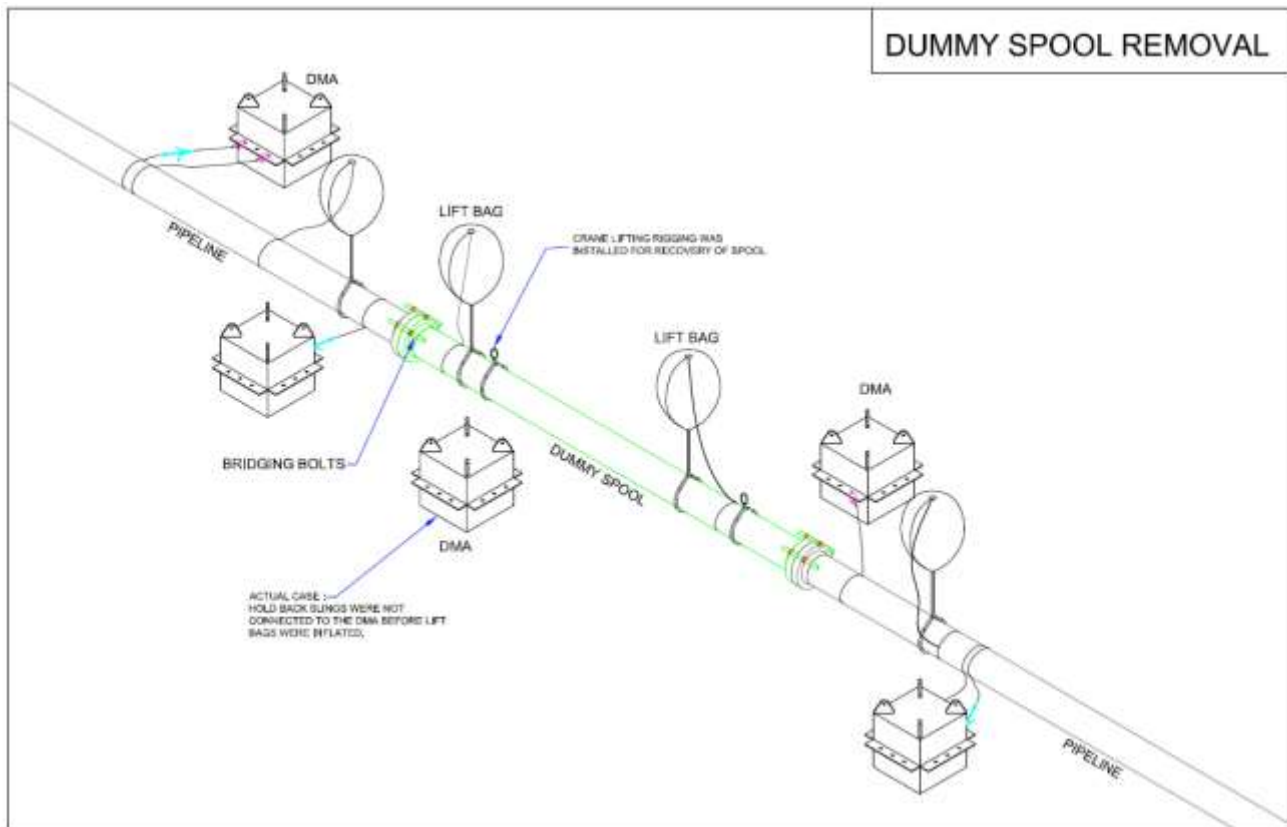
Divers were carrying out a dummy spool removal activity on the seabed at a depth of 110 fsw. As the last bolt was being removed the spool section broke free and rapidly ascended to the surface. When the bags arrived at the surface they lost some of their volume, resulting in partial deflation, and the load fell back to the seabed, away from the dive site. The load was later safely recovered to the deck of the barge.

Investigation suggested that the **immediate cause** was the absence of hold-back lines from the spool section to suitable fixed anchoring points.

The lift bags had been inflated without appropriate 'hold-back rigging' in place and that there had been a failure to follow company procedures, handover instructions and guidance detailed in [IMCA D 016 – Open parachute type underwater air lift bags](#).

- ◆ Ensure the dive plan is read, understood and followed;
- ◆ Ensure mitigations identified in risk assessments are applied stringently;
- ◆ Ensure the diving task is conducted following company working procedures;
- ◆ Ensure the diving task and company procedures follow IMCA recommendations on any diving operation;
- ◆ Ensure dive supervisors fully understand their ownership and accountability for the activities with which they are tasked.

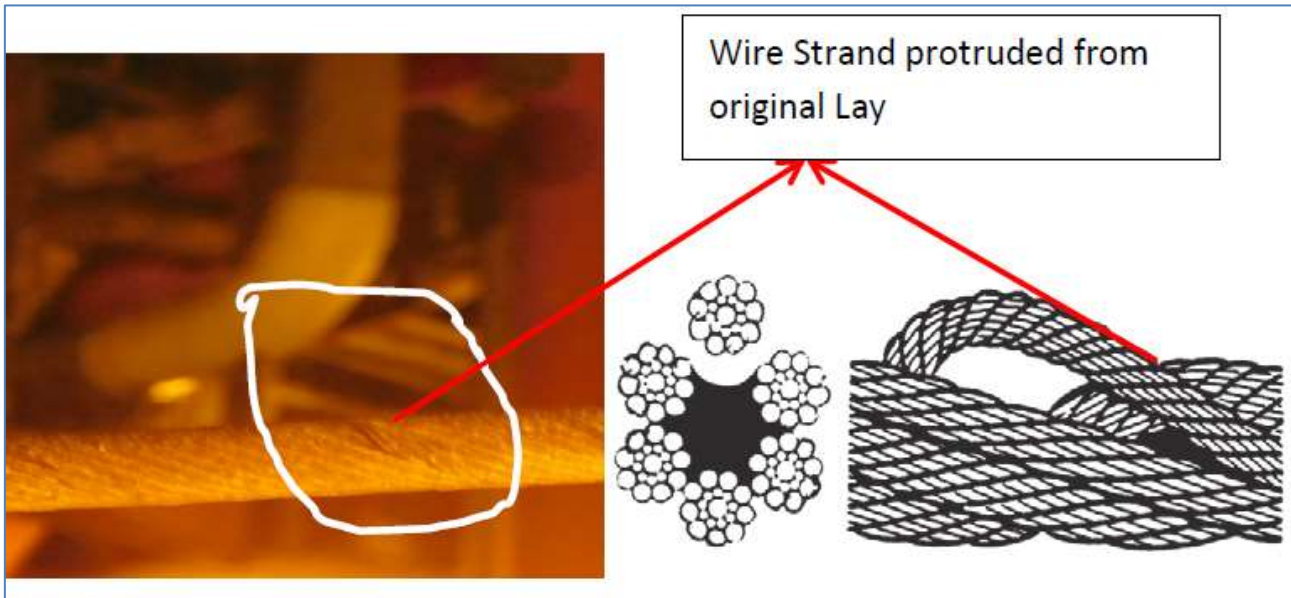
During deployment of the bell and clump weight from a vessel for subsea inspection of a riser line, it was observed that a single wire strand protruded from original lay ('high stranding'). The bell was recovered, the clump weight wire visually inspected and it was determined that a 60m cut back of damaged rope take place. The damaged section was removed and the rope re-terminated.

Third party mandatory load test and certification of the item was carried out and certified as fit for purpose and diving operations resumed.

- ◆ The clump weight should not remain subsea during periods of increased tidal current above the limit recommended for diving operations;
- ◆ There should be thorough visual inspection of all the ropes and sockets during recovery and deployment of clump weight;
- ◆ Ensure frequent monitoring for the ropes and sockets, and any findings recorded;
- ◆ Any small defects, damage or abnormality on ropes should be brought to the attention of the Competent Person;
- ◆ Precautions should be in place to avoid stress on ropes caused by adverse weather conditions.

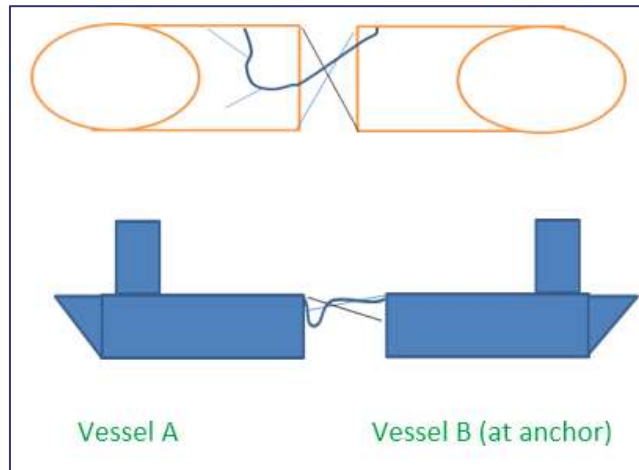
The mooring rope from Vessel A parted due to jerking and continuous yawing. Crew on Vessel B were told to close the deck fuel valve and disconnect the hose for retrieval. The hose was disconnected and crew on Vessel A started retrieval using the port tugger winch. While they were retrieving the hose, it got entangled with the remaining single mooring rope and the vessel structure, and the hose parted on deck. No spillage was noticed as hose was empty.

- ◆ There were 1.5m seas and wind of approx. 14 knots. Both vessels were yawing – the mooring ropes was getting intermittent jerks which resulted in one of them parting. The uncontrolled heaving of the bulk cargo hose resulted in it parting;
- ◆ Both vessels could have decided to call off or postpone the operation until the fuel pump was operational and/or weather would improve.

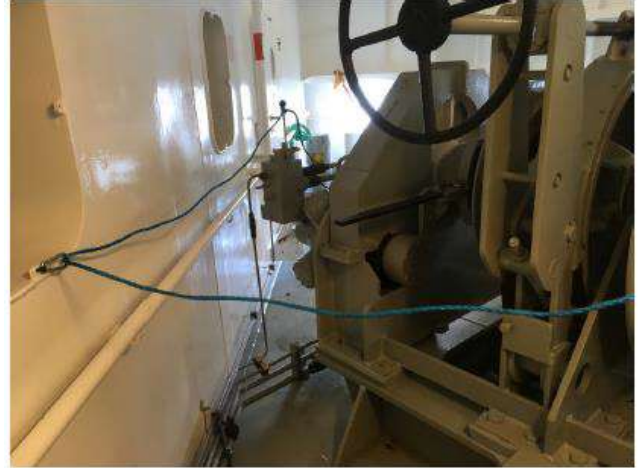
During a routine marine inspection of a vessel it was observed that rope lines had been attached to the mooring winch control levers to facilitate 'remote' operation of the winches.

This is an inappropriate and unsafe practice. There are a number of very good reasons why, including:

- ◆ Accidentally pulling on the wrong line and performing an unintended action;
- ◆ Crew member getting entangled in the lines and inadvertently operating the winch;
- ◆ Lack of proper control of winches.

- ◆ Adequate personnel under the supervision of a certified officer should be available for:
 - handling of equipment and gear
 - communications
 - directing the winchman.
