## IMCA Safety Flash 20/17

August 2017

### Summary

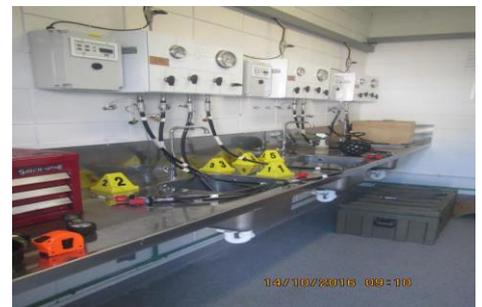
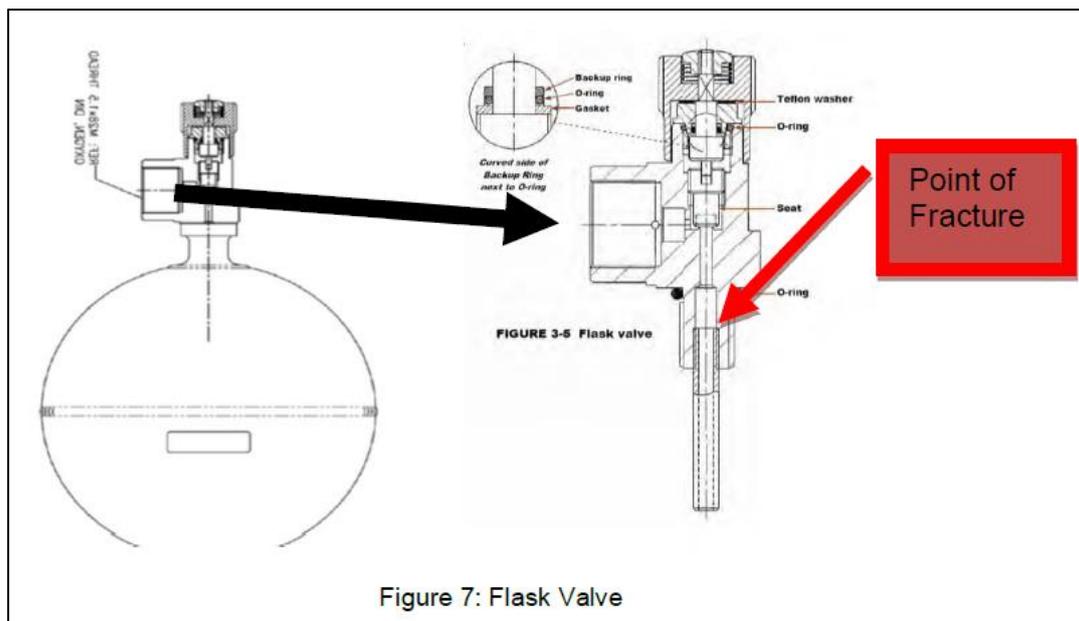
Though the filling components had been correctly connected, one of the bottle valves has failed and was violently expelled from the high pressure (HP) cylinder. As a result of the failure, the charging whip and valve remnant had forcefully impacted a nearby wall. Had these parts hit the crewman the consequences could have been very much more serious.

- ◆ The valve failure was mechanical in nature; a metallurgical failure of the integrity of the valve assembly, rather than being due to the process of filling the flask. Analysis determined that a combination of corrosion induced cracking and fatigue in the dipper tube thread roots lay at the heart of the failure;

- ◆ All similar valves of a similar age have been removed from service and replaced with new;
- ◆ Appropriate record-keeping measures were put in place for controlling the age of valves in use;
- ◆ A new method of securing filling arrester whips to cylinder necks was devised to prevent the potential thrashing around of loose whips under pressure;
- ◆ A review was made of procedures for valve oxygen cleanliness to ensure they meet the minimum internationally recommended standards;

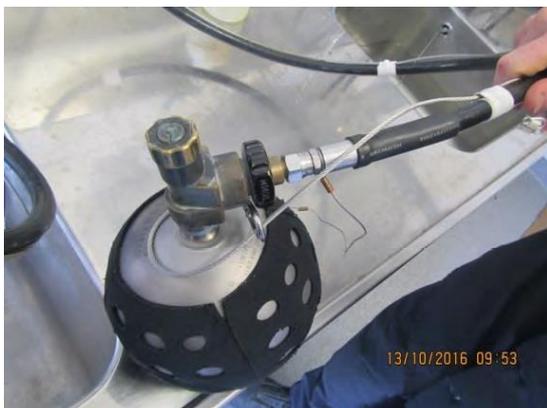
*Normal Flask Filling*

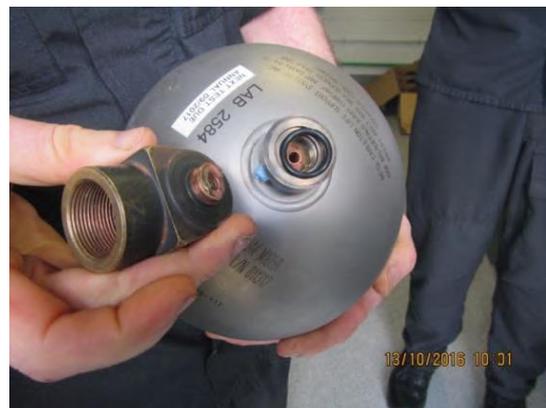
*Post-incident outcome*

- ◆ The exact cause of the corrosion could not be identified; however, the presence of dezincification and small particles of Verdigris in the cracks suggested that insufficient rinsing, after the 24-monthly application of mildly acidic BIOX cleaning compound, was the most probable cause;

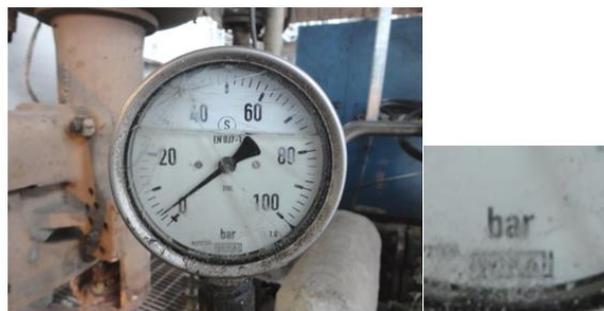
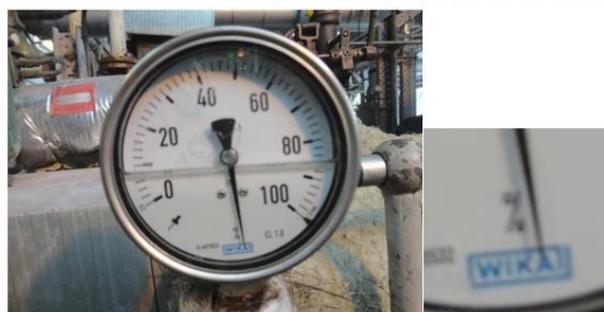
The International Association of Oil & Gas Producers (IOGP) has published [Safety Alert 284](#) relating to a small steam leak from a pressure gauge on the high pressure steam supply to a turbine. An incorrect gauge was installed. The pressure gauge was rated to one Bar(g) and the safety seal failed when it was exposed to 55 Bar(g) steam during re-commissioning. The pressure gauge in question was brand new and had been fitted during the recent maintenance period.

- ◆ The pressure gauge was inspected and found to be a **“0-100%”** gauge, where a **“0-100 Bar”** pressure gauge should have been installed;
- ◆ The 0-100% gauge had been ordered in error for a prior boiler shutdown and had been subsequently stored in the utilities equipment room, rather than returned to the warehouse for disposal;
- ◆ Technicians had established a culture of storing some small items in equipment rooms to allow easy access for small maintenance tasks;
- ◆ On the day of installation, the 0-100% gauge was mistaken for a 0-100 Bar pressure gauge (due to the near identical appearance) and was taken from the utilities equipment room and installed on the steam turbine high pressure steam supply line.

- ◆ Check all stores stock to ensure that all pressure gauges are stored in the correct place and in the correct boxes;
- ◆ Ensure that all unused equipment is returned to the place of issue at the end of each day. This ensures that only the correct equipment for a specific work order can be withdrawn;
- ◆ Ensure that all pressure gauges are function checked and fit for purpose before installation;
- ◆ Review stores stock items and material numbers to establish those that are no longer used or required. Block all numbers that are not required so as to prevent re-ordering by accident;
- ◆ For legacy assets, review and rationalize all local pressure gauges across each facility with a view to removing those that are no longer used or required.

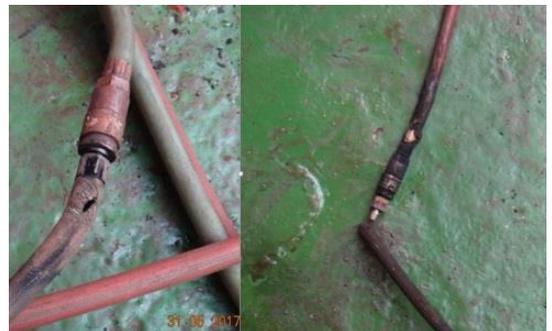
A small fire was discovered in oxygen/acetylene hoses. Workers heard an “air blowing sound” and left their work location to investigate. Smoke and flames were noticed and a closer look revealed oxygen and acetylene hoses on fire. The fire alarm was raised; one person immediately grabbed and kinked the hoses to close the supply of gas. This ceased the fire before another person came with an extinguisher, which at that point was no longer needed. The valves on the gas cylinders (located some distance away) were closed, and the hoses depressurized and disconnected. There were no injuries, just some slight material damage.

- ◆ No personnel were working in the area;
- ◆ No hot work activities were ongoing in the area;
- ◆ Gas hoses were found contaminated with a few hydraulic oil stains;
- ◆ Gas hoses were in a narrow-edged area.

- ◆ Sharp edges and a surface that could have damaged the hose;
- ◆ Oil residues that could have contaminated the hose;

- ◆ Narrow, almost confined space conditions, with potential lack of ventilation that could have contributed to the build-up of the oxygen level.

1. turn off the oxygen supply;
2. extinguish cigarettes and open flames;
3. make sure the room is well ventilated;
4. identify and repair the source of the leak.
