## IMCA Safety Flash 23/17

September 2017

### 1 Property Damage: Platform Supply Vessel Collided with Legs of Jack-Up Rig

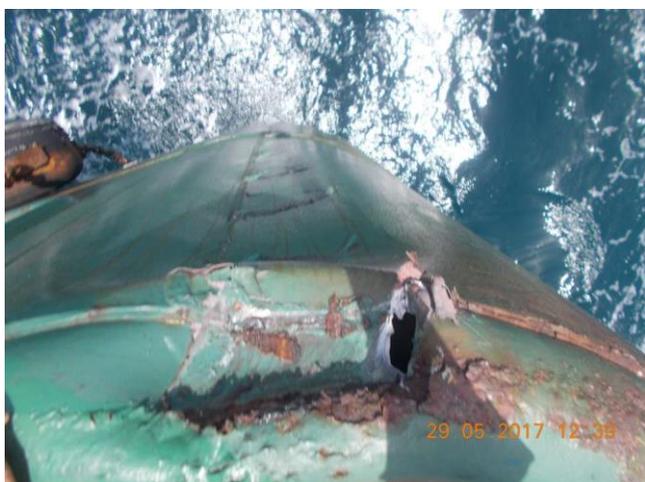
A Platform Supply Vessel (PSV) collided with the legs of a jack-up drilling rig, causing some damage to the PSV. The incident occurred after transfer of water to the rig. The PSV had been ready to disconnect the hose, but the rig informed the PSV that there would be a delay. The PSV was to the windward (weather) side of the rig and the weather was “rough”, with the wind approximately 22 knots.

A little under an hour after completing transfer of cargo, but whilst the hose was still connected, the PSV starboard engine and thrusters tripped. As a result the PSV started to move astern and to Starboard. DP control was immediately transferred to manual mode. The hose was dropped in the water. Whilst pulling away to safety, the PSV made contact with the forward leg of the drilling rig.

*Dent in PSV as a result of collision*

- ◆ Better management and assessment of risk during simultaneous operations – if required, the vessel should come off and get out of the safety zone;

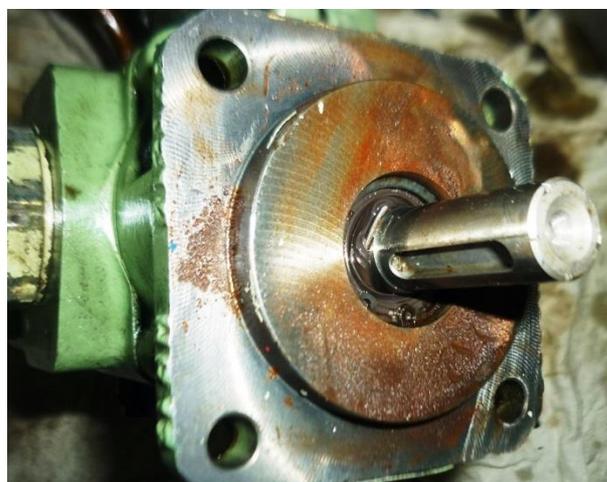
*Damaged fuel oil pump*

- ◆ Procedures were not followed: Vessel working on the weather side as the jack-up rig was not geared up to receive water on the lee side;
- ◆ Equipment: Mechanical seal of fuel oil pump was damaged suddenly indicating material failure.

- ◆ Whilst material failure of items can be unpredictable, planned maintenance schedules and manufacturer's instructions should be followed for critical equipment.

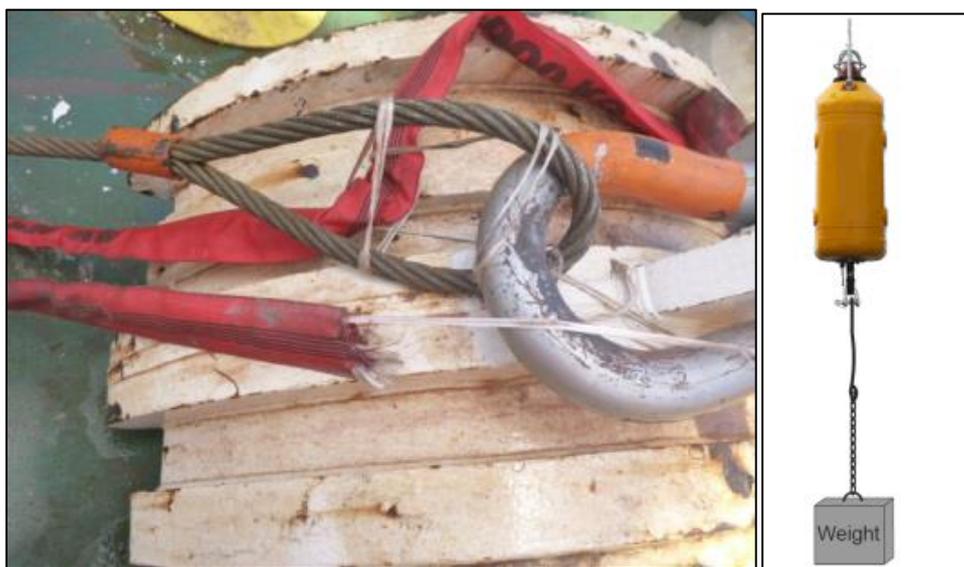
During two recent lifting operations, loads fell from height to the deck. In one case the rigging crew were close to where the load landed – the incident could easily have had fatal results. No one was hurt in either incident.

- ◆ Investigation into both incidents showed that unapproved changes had been made to the rigging. This was highlighted as a major contributing factor to the loads being dropped.
- ◆ It was found that the Management of Change (MOC) process had not been followed and that the crews had a lack of awareness regarding the application of the MOC process and when it should be applied.
- ◆ The company's MOC process was not followed; the changes were made without engineering reviews and subsequent risk assessments.
- ◆ If the MOC process had been applied, then the subsequent checks could have prevented both incidents.

- ◆ Conduct a review to ensure that there are no unauthorised modifications to rigging or equipment (welding on ROV hooks for example);
- ◆ Equipment found to have been modified without engineering review or where the MOC process has not been followed, should be quarantined and not used until the MOC process and a risk assessment can be completed and approved;
- ◆ Particular care should be taken to ensure that modifications do not introduce further new hazards to the operations;
- ◆ Ensure that the MOC process is fully understood and applied across all worksites.

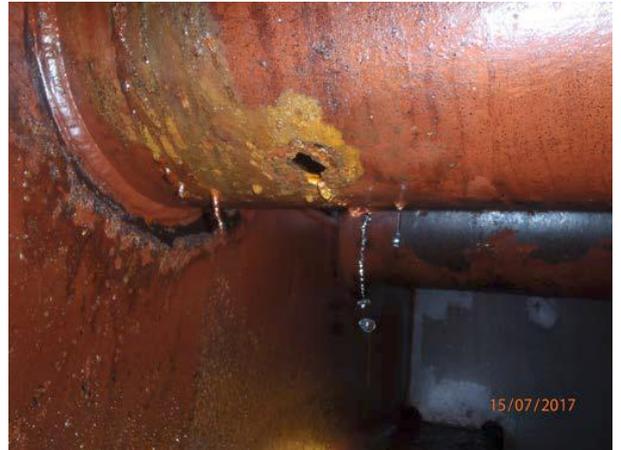
Water ingress into a fuel tank was discovered to be from leaking pipework. Water ingress was reported into a fuel tank from two seawater lines running through the tank. Engineers investigating a high-level alarm on the fuel tank initially thought it was due to vessel movement. But upon inspection of the pipework, a leak was found on a sea water pipe approximately 150mm outboard from the Pump Room bulkhead.

There was a hole of around 13mm diameter in the pipe, which had caused seawater leakage into the tank and thus, a rise in level. Fuel was transferred from this tank to the port side settling tank and shortly after starting the transfer, the port side fuel separator tripped out. The 3rd engineer went to clean the strainer and quickly realised that a large amount of water was present in the system. A check on the settling tank drain confirmed that there was water present.

The cause was failure of pipework installed on the vessel at build stage.

- ◆ Clarification of fuel tanks on vessels if pipework lengths run through tanks;
- ◆ Inspection of pipework in tanks for integrity through visual and ultrasonic thickness baseline measurements.
