IMCA Safety Flash 26/17

October 2017

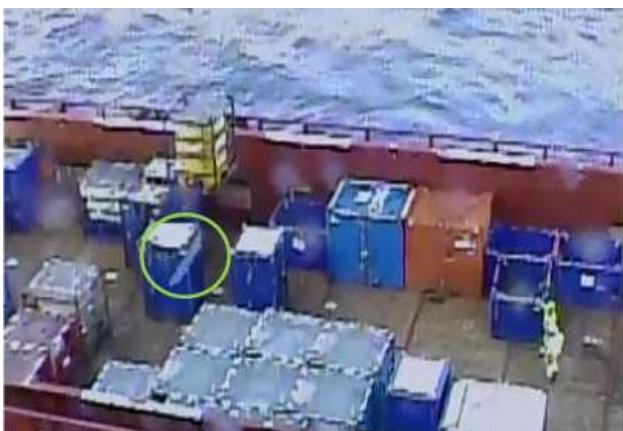
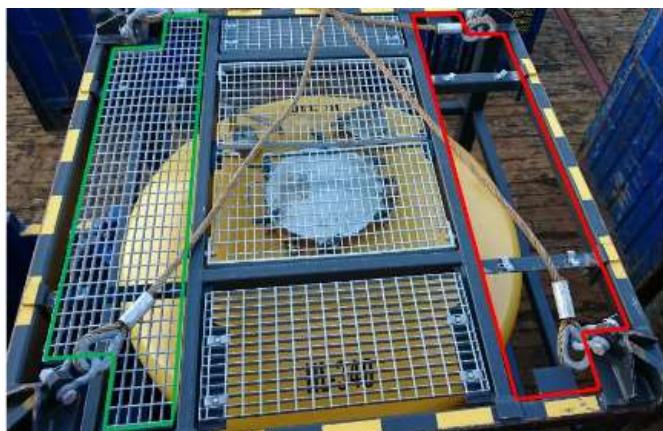
The tank frame has grating sections on the top of the unit to allow crew to get to the hatch on the top. The centre sections of grating hinge to allow the hatch to be opened. The outer sections of the grating are intended to be fixed in place with four bolts and butterfly clips.

On subsequent investigation in port it was found that only one clip was correctly fitted on one side grating and all four clips appeared slack on the side from which the grating fell. One of the clips was also bent.

- ♦ Instructions were given to the tank vendor to ensure checks are made to the securing arrangements on all their cargo units;
- ♦ The MSF has issued this safety alert to warn all other suppliers, vendors, logistics service providers, road transport companies, vessel and installation crews of **the dangers of unsecured loose objects on cargo units** and the potential for dropped objects. Loading and discharging cargo in an offshore environment is very dynamic often with significant vessel and crane hook motion which may sometimes lead to the cargo unit colliding with other containers or structures, leading to potentially dislodging loose items;
- ♦ This incident aptly demonstrates the importance of vessel and installation crews staying well clear of suspended crane lifts at all times where there is a potential for falling objects.

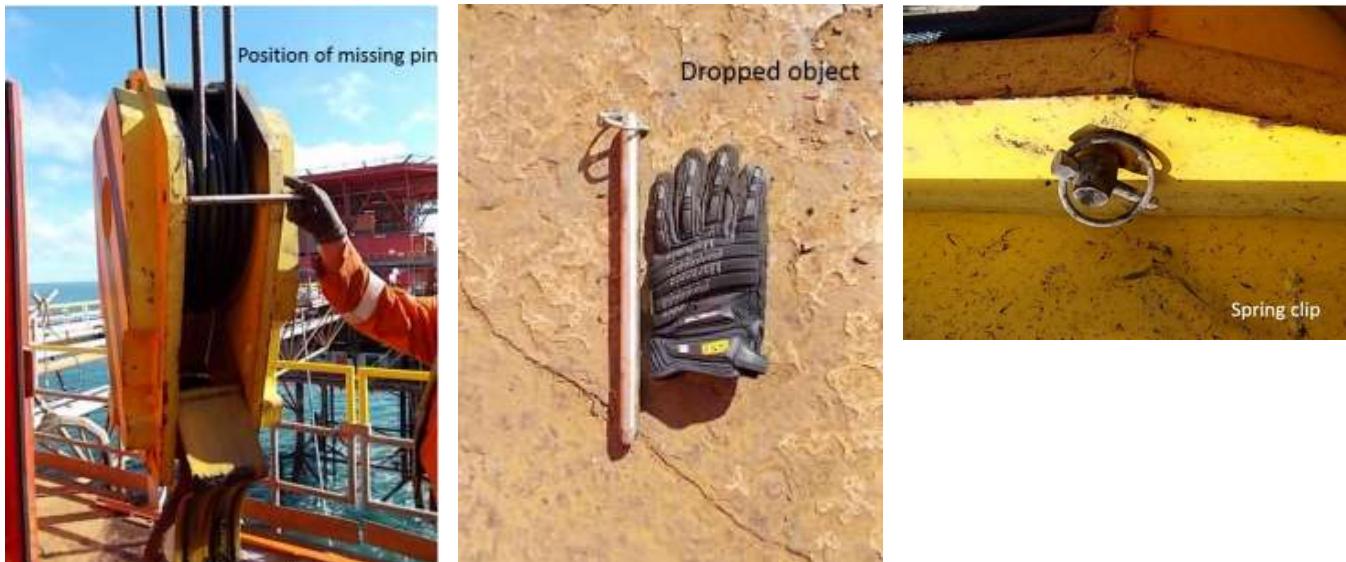
During the lift, a member of the deck crew heard a loud noise. On investigation, he found that the securing pin from a main block sheave guard had come loose, and had fallen to deck. Crane operations were immediately halted and the crane main block was brought to deck level for inspection. The fallen part weighed 0.8kg and fell 25m; it landed 2m from a member of the deck crew. This is could have been a potential fatality on the DROPs calculator.

The sheave guide was secured by a spring clip. The crane block was supplied with this spring clip configuration. It cannot be determined if the clip had failed or was not installed correctly.

The spring clip on the sheave guide was removed and replaced by a bolted configuration. All cranes in the fleet were inspected to ensure the same configuration was not present; if it was, it was corrected. Suppliers were informed of incident to ensure they no longer supply blocks with this configuration. Planned maintenance tasks were amended to ensure checks are carried out on condition of sheave guards.

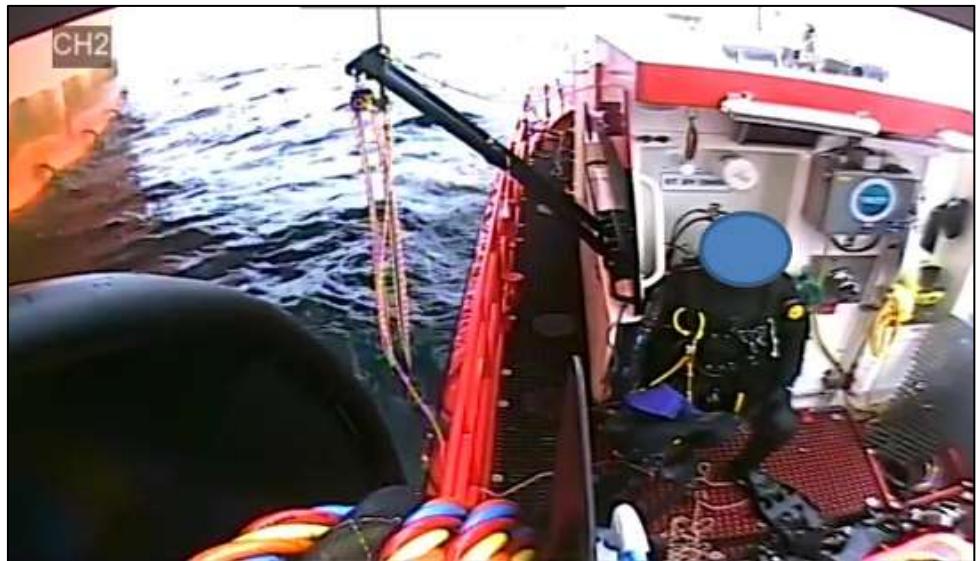
Investigation concluded that the incident occurred as a result of the LDC drifting forward whilst being made ready for transit, with the diver rescue davit in the deployed position. The deck crew on the LDC were preoccupied in the stowage of equipment and did not notice the LDC had drifted forward to the point where the forward mooring line was midships with the LDC. When the coxswain engaged the motor to depart the worksite, the mooring line had caught under the T-section of the diver rescue davit; when the LDC turned to starboard, the davit arm forcefully recoiled to its stowage position.

Showing mooring line caught on diver rescue davit in deployed position

- ◆ Revision of task plan to include the requirement to confirm all lines are released and the LDC is ready to depart prior to sail away from the worksite;
- ◆ Elimination of time limits for diver recovery drills;
- ◆ Revision of diving contractors' LDC operating checklists;
- ◆ Procedures for disconnecting moorings revised to include a hold point to confirm the LDC is ready for transit;
- ◆ Revision of LDC coxswain's job description with a more detailed responsibility for management of LDC marine operations and what actions to take in the event of any equipment failure;
- ◆ Revision of company LDC familiarisation procedure to include the requirement for diver rescue drills in sheltered waters as well as theoretical training when the majority of a dive team is changed out.

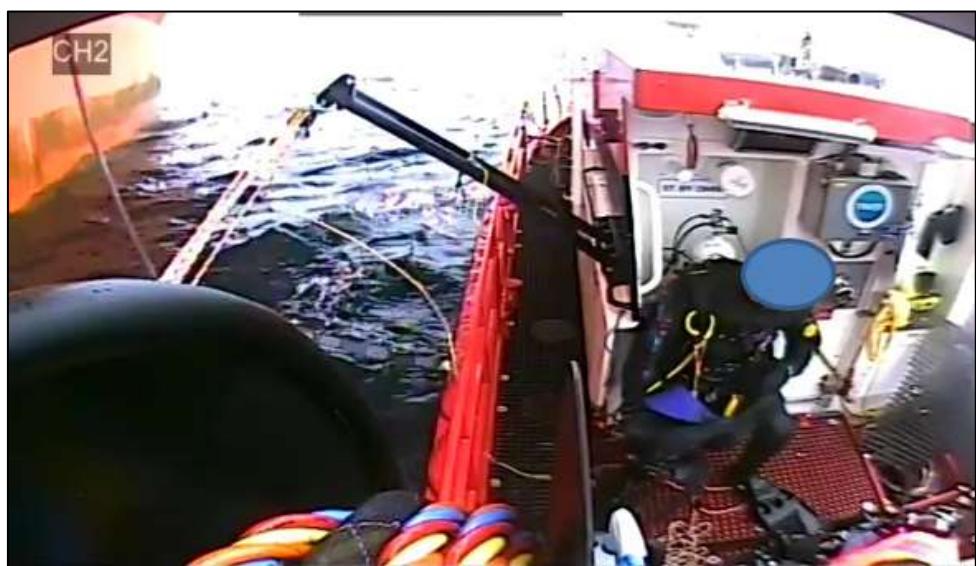
Showing tension created on the diver rescue davit by the entangled mooring line

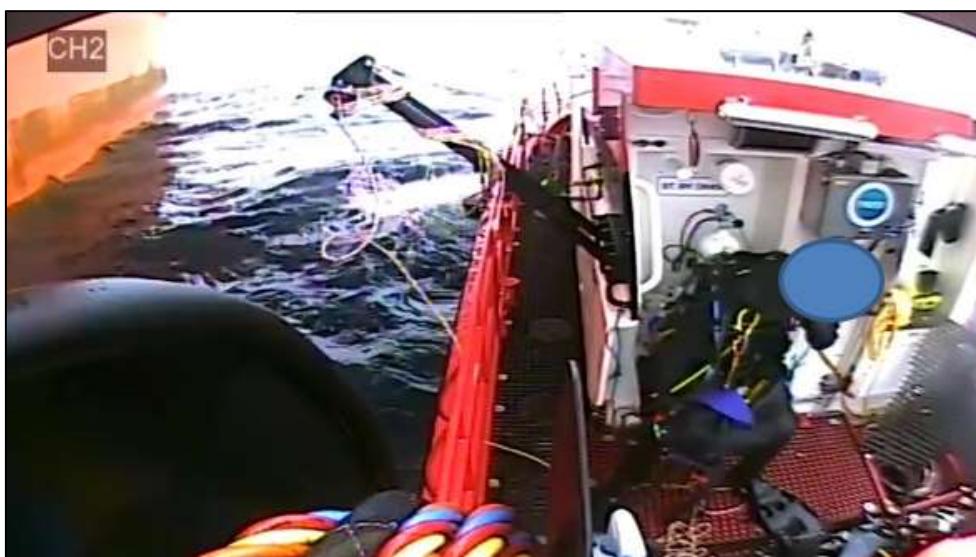
Showing block and tackle recovery device striking bulkhead
