MARINE SAFETY ALERT

Safety Alert 04-19

Confined Spaces: Silent & Invisible Killers

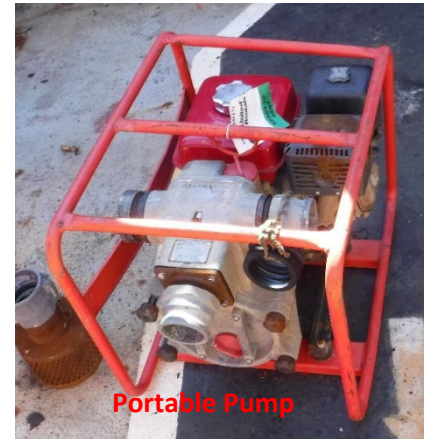
Ten crewmembers were onboard the MODU preparing it for a heavy lift transport to an overseas ship breaking facility. They were successful in dewatering three of the MODU's four legs. However, the de-ballasting system was inoperable in the fourth leg because piping and valves had been previously removed. To continue pumping, the crew rigged a portable diesel engine driven pump to discharge the tanks.

Each leg had six decks. The first two uppermost decks had access hatches that allowed easy transfer of crew and equipment between the decks. The remaining decks were accessed via manhole hatches that were too small to allow passage of the portable pump and had to be enlarged. As each ballast tank was fully discharged, the manhole cover at the bottom of the tank was enlarged and the pump was lowered. Once they reached the lowermost ballast tank, the pump was set up with its suction hose in the tank and discharge hose exiting the leg via a hole torched through its side shell plating. A second smaller hole was also cut to serve as an air supply vent.
