IMCA Safety Flash 20/20

July 2020

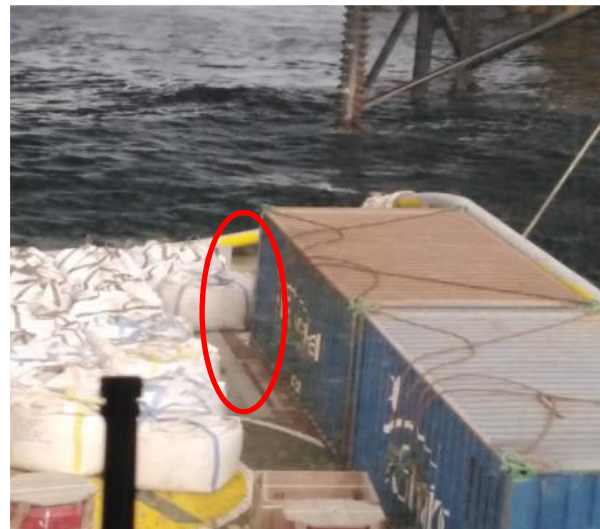
An AB got his leg entangled with a tag line during lifting operations. The incident occurred when a vessel was alongside a rig offloading cargo. The AB attached the aft tag line to a container, then laid out the tag line on deck and proceeded to inform the crane operator to lift the container. As the container was lifted from the deck, the tag line entangled the right leg of the AB and began to lift him from the deck. He was able to grab the tag line with both hands preventing it from constricting his thigh and so preventing a serious injury. Although he had a radio he was unable to use it as both hands were preventing the rope from tightening around his leg.

Approximate location of AB (red oval)

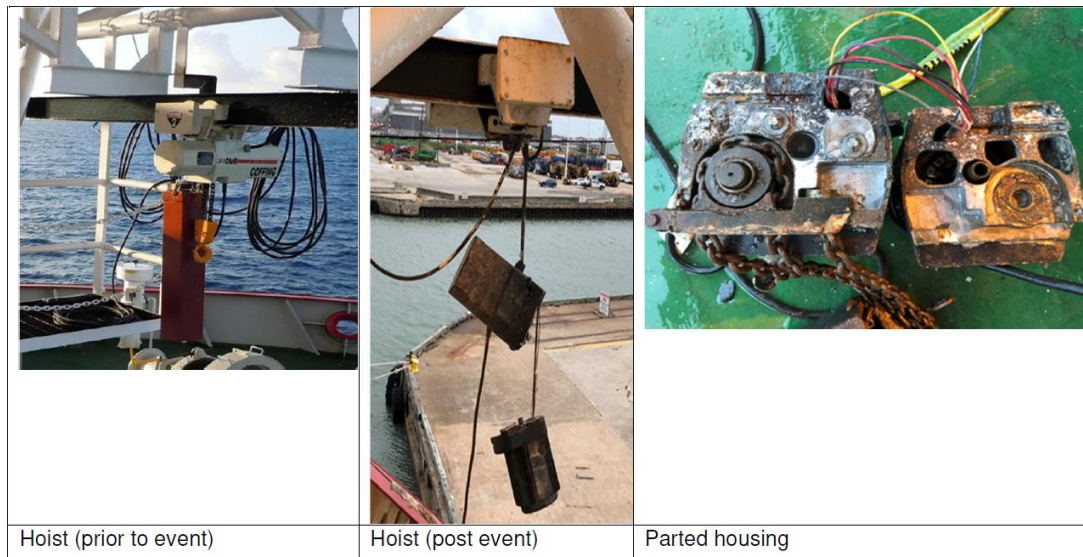
An electrically powered gantry hoist failed whilst under load dropping cargo and lifting equipment to deck. The incident occurred during a lift of 500kg of palletised provisions onto the vessel. The failure resulted in the provisions falling onto the deck. The gantry hoist housing included a chain box containing approximately 10m of 10mm chain weighing approximately 19 kg which dropped 4m (12ft) onto the deck.

The hoist motor / gearbox housing securing bolts failed due to excessive and previously unidentified internal corrosion.

- ◆ Review and improvement of:
 - Procurement process to emphasise the importance of ensuring that equipment is selected by a competent person, is suitable for its intended purpose and operating environment;
 - Mechanical lifting equipment procedure modified to further emphasise the importance of complying with the procurement process and the manufacture’s installation, use and maintenance requirements;
 - Enhanced arrangements for the management and control of equipment maintenance and inspection records and general record keeping;

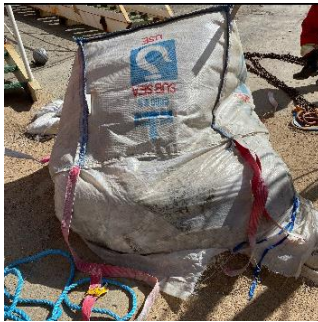
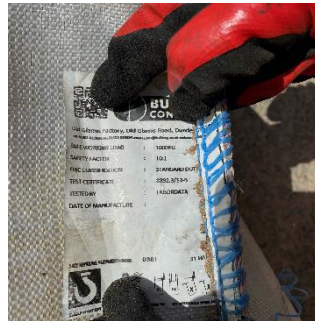
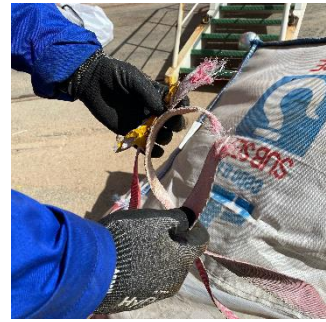
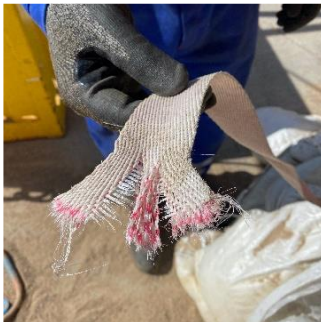
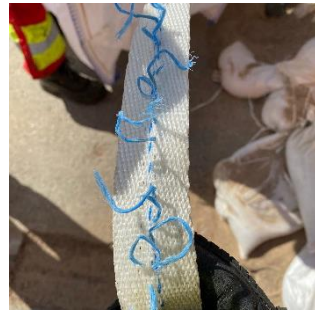
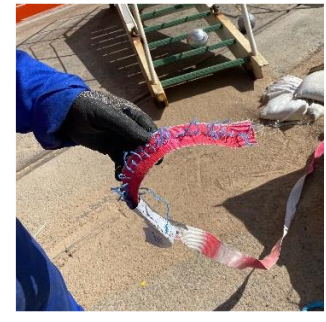
As the load was lifted to approximately 1 metre, there was a routine inspection of the load to check the handle loops and that the base of the bag was ok before lifting. The FIBC was raised to 3–5 metres when a distinctive tearing / ripping sound was heard, it was then the FIBC handle and stitching tore and the 900kg of sand bags fell onto the quayside. There were no injuries.

- ◆ Inspect prior to use ensuring they are:
 - free from damage that can compromise its strength;
 - free from any UV degradation (due to sunlight exposure);
 - free from chemical damage;
- ◆ Lift following manufacturer and supplier's instructions;
- ◆ Ensure the landing area is clear of sharp and protruding edges;
- ◆ Ensure the filled FIBC is stable and secure during transportation;
- ◆ Store in a suitable location protected from UV radiation and rain (long periods of storage);
- ◆ Pad out forklift forks when lifting through lift handles to eliminate sharp edges.

- ◆ Drag or push FIBCs;
- ◆ Stop/start suddenly when lifting (shock loading);
- ◆ Allow suspended load to swing uncontrollably;
- ◆ Lift by steel wires or similar devices which may present sharp edges or rough surfaces;
- ◆ Use an FIBC which has exceeded 2 years from the date of manufacture;
- ◆ Lift over personnel.

Note: If there is any doubt over the integrity of the FIBC, replace the FIBC or use a metal transfer basket/half height

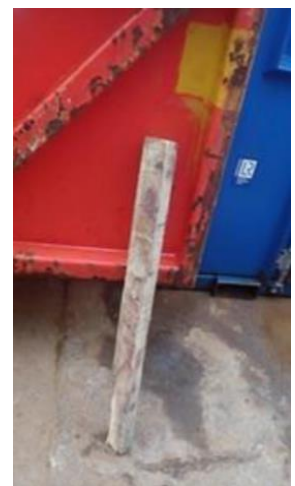
Marine Safety Forum Safety Alert 20-04 describes a potential dropped object (PDO) during cargo operations. A wooden baton of the type often used to support covers attached to open topped Cargo Carrying Units (CCUs), was discovered jammed against the underside of a cargo basket.

- ◆ Wooden batons are normally used to support the tarpaulin cover used on open top CCUs;
- ◆ Wooden batons are only held in place by being jammed against the sides of the open top;
- ◆ There is generally no securing mechanism holding the wooden batons in place;
- ◆ Batons need to be ‘knocked out’ before heavy cargo is lifted from the CCU by crane;
- ◆ Knocking out batons from high sided CCUs can result in the baton falling onto the persons removing it.

The MSF safety alert concluded: *Tarpaulins and batons do have their uses when required for covering cargo, but their use should always be risk assessed and evaluated against other cover types which may be readily available. The risk assessment should include but not be limited to:*

- ◆ *The type of cargo and the effects of its exposure to the environment;*
- ◆ *The manual handling issues that may be encountered by the end user;*
- ◆ *Consider the use of ‘cord strap’ or similar instead of wooden batons to support covers. (particularly on high sided open top units)*

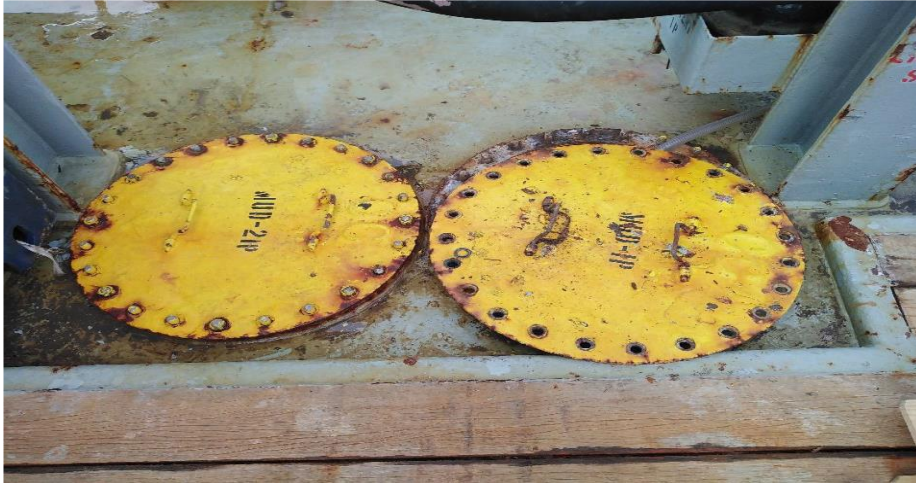
During a safety round on deck prior to cargo operations it was noticed that a manhole had been opened in order to pump out ballast water to replace a faulty valve.

The manhole cover or hatch nuts had been completely removed and the cover was only placed back on top and was left completely unsecured. There was no barrier tape nor any warnings placed to indicate that the cover was open and unsecured.

- ◆ Bypassing safety controls:
 - Crew did not follow company procedures;
 - No warnings were posted;
 - It did not occur to the crew doing this work to consider the potential risks of persons falling inside or slipping from standing on the manhole cover while so placed and not secure.
