IMCA Safety Flashes summarise key safety matters and incidents, allowing lessons to be more easily learnt for the benefit of all. The effectiveness of the IMCA Safety Flash system depends on Members sharing information and so avoiding repeat incidents. Please consider adding safetyreports@imca-int.com to your internal distribution list for safety alerts or manually submitting information on incidents you consider may be relevant. All information is anonymised or sanitised, as appropriate.

1 Yawing of wind turbine nacelle placed ship in line of fire

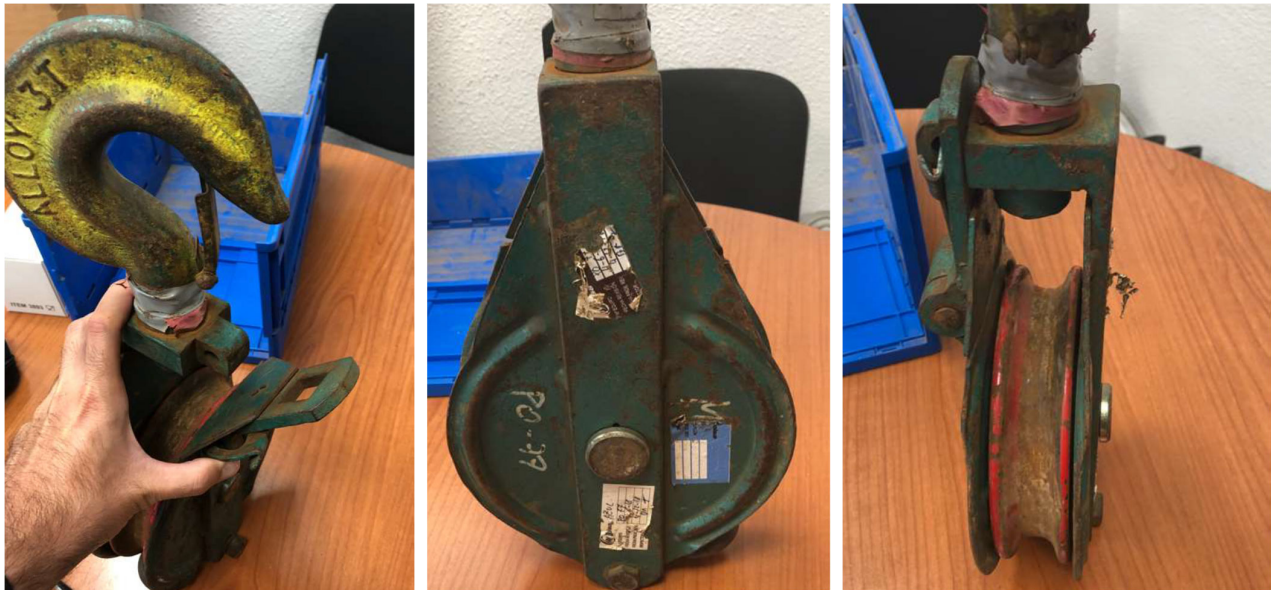
Suddenly the pulley above the person broke and the wire rope around the pulley and the pipe went down. The wire rope hit the person on its way down. Medical treatment was given onsite; he was then transferred to hospital where after several hours he passed away.

Images of failed pulley

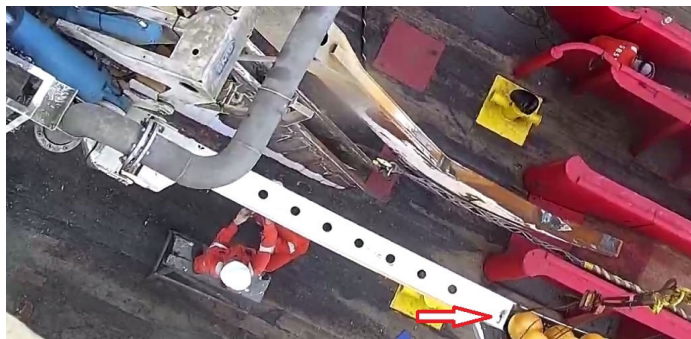
The plough depth skid, weighing around 320kg, was lifted at one end by the vessel crane; a fixed pad eye at the end of the skid was attached by a hook, sling and chain block. Suddenly the hook parted, and the depth skid fell down, knocking over both crewmen. Both landed badly; one of them sprained his leg; the other suffered a fractured wrist. Both were sent ashore by guard boat for medical treatment. Subsequent medical check showed that one of them suffered fractures of the left wrist and radial head (below the elbow).

Crew working under the depth skid which is lifted by crane. The red arrow shows the parted hook.

- Further crew training on correct lifting loose gear application, emphasizing that unqualified loose gear should not be used for any lifting work;
- The pad eye was modified and tested so that a standard and properly qualified hook can be used;
- Hazard Identification and Risk Assessment form for plough operation was reviewed and revised:
 - To include safe positioning of crew and,
 - To enhance supervision by requiring the team leader to check safety positioning.

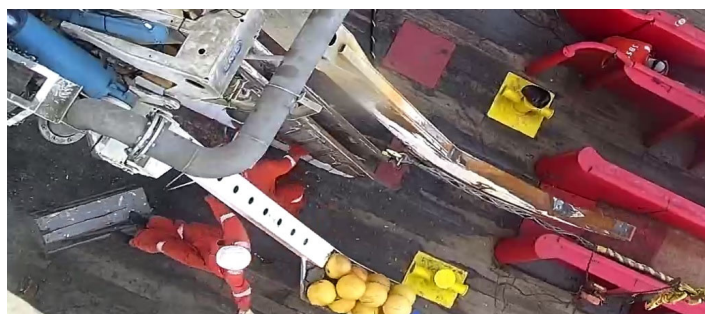
The skid in the fallen position

- It was shown afterwards that because the pad eye on the plough depth skid was too small for a standard hook, the crew used an entirely inappropriate spring snap hook to link the skid and the sling;
- The two crew were in the wrong place – under the load, in the line of fire.
