## 1 Failure of 64mm polyester rope in subsea mooring operations

## 2 ROV main lift failure

### 3 Importance of safety by design: acoustic beacon damage in splash zone

## 4 Oil leakage from cylinder head cover

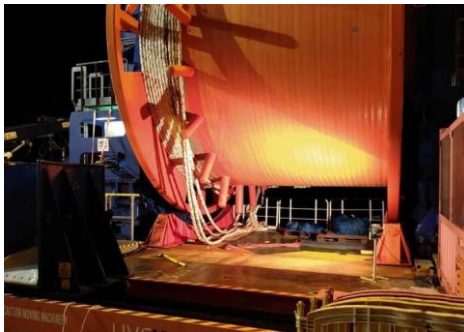
MLDW winch

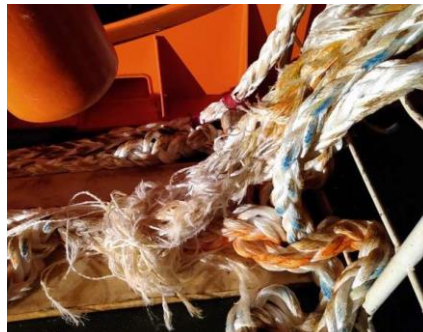
A 64mm polyester rope parted during the lowering of subsea equipment to depth. The failure occurred between the Mooring Line Deployment Winch (MLDW) and the pennant, due to overload caused by lack of synchronism between the crane and the MLDW winch. The operation was immediately stopped. No-one was injured, but damage was caused: there was a break in the balustrade of the cable lowering ramp and damage to the window of the MLDW control cabin.

Parted rope

- Tension on the rope increased leading to it parting;
- Company procedures were not followed;
- Cranes were lowered without giving sufficient slack on the rope;
- There was miscommunication and a lack of situational awareness during the operation;
- No-one stopped the job - STOP WORK authority was not used.

- Indicator installed to allow winch operator to see rope tension;
- Better practice developed on co-ordination of simultaneous movement of crane and winch;

- Reiteration of and retraining in, existing procedures;
- Encourage all in their right and responsibility to use the STOP WORK Authority and how to exercise it.

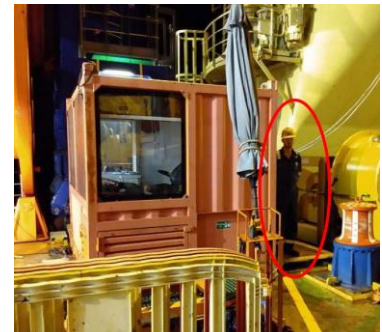
Place where the MLDW operator stood

Although the MLDW operator **three times** raised his concern to the supervisor to pay out extra line to reduce the tension, this was not recognised as a STOP WORK or other signal to stop and re-assess the situation. The supervisor was concentrating on moving the vessel into position as there were simultaneous operations (SIMOPS) taking place. A clear "STOP" was not used.

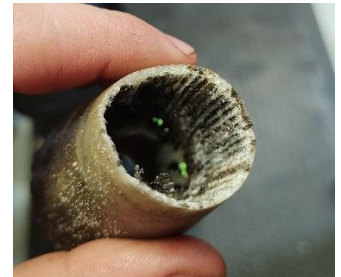
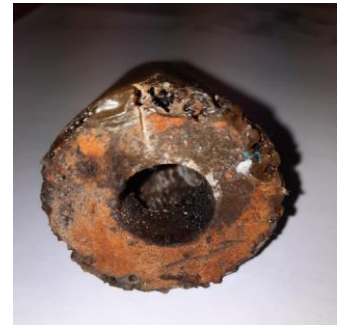
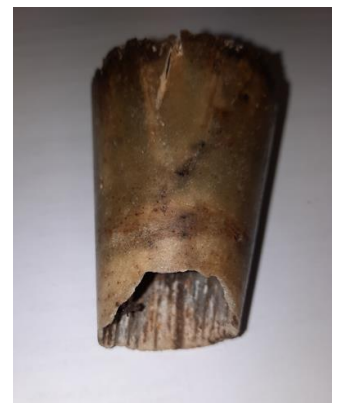
A termination failed during launch of an ROV for a test dive, and the ROV/TMS assembly fell to the seabed. No-one was harmed. The umbilical termination slipped through the wirelock socketing.

- The volume of the bullet/cone was too small giving too narrow a passage for the wirelock to flow and fill the bullet;
- Uneven distribution of strains, with the majority close to the outside perimeter of the cone;
- Too high force applied during docking;
- Excessive resin in the broad end of the cone changed the intended shape of it, thereby decreasing the cone's function.

- The root cause was suboptimal cleaning and strand distribution within too small a cone, which was difficult to work with. The cone was changed to a bigger one;
- Adjustment of docking head dampers.

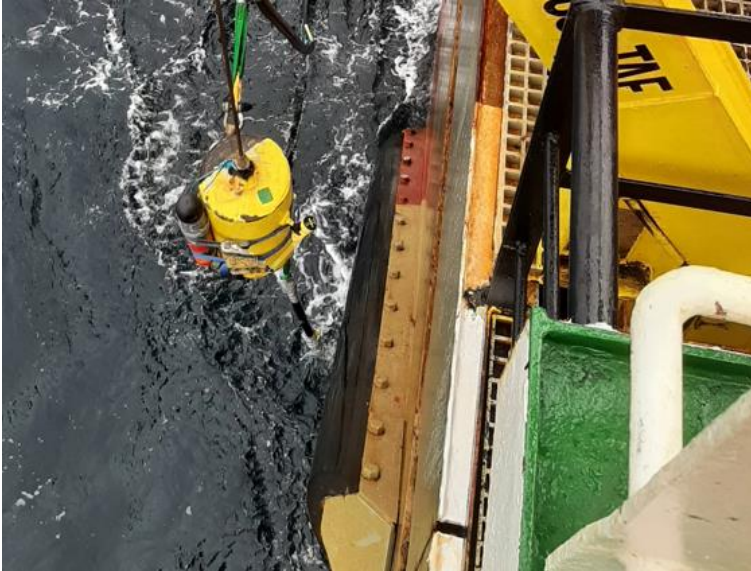
During recovery of tugger winches on an A-frame workstation, the headache ball experienced normal movement when exiting the splash zone. However, in this instance, the headache ball came into contact with the vessel fender and damaged an acoustic beacon. The damaged beacon was taken out of service and repair arranged.

*Location of fender in relation to beacon on the Headache Ball*

- The damage occurred with normal perpendicular movement of the headache ball as it went through the splash zone;
- The A-frame, due to its height, did not allow the outboarding of a load far enough away from the vessel hull;
- This was a known hazard associated with vessel design, however team onboard had previously worked around the problem during equipment overboarding and recovery.

- Design and install a protective cage for the acoustic beacon;
- Undertake a full design review with a focus on the Tooling Skid and associated tasks and systems, and also a review of the design of the A-Frame.
  - A-frame design modifications implemented, to extend the reach and keep the load away from vessel hull during overboarding and recovery.

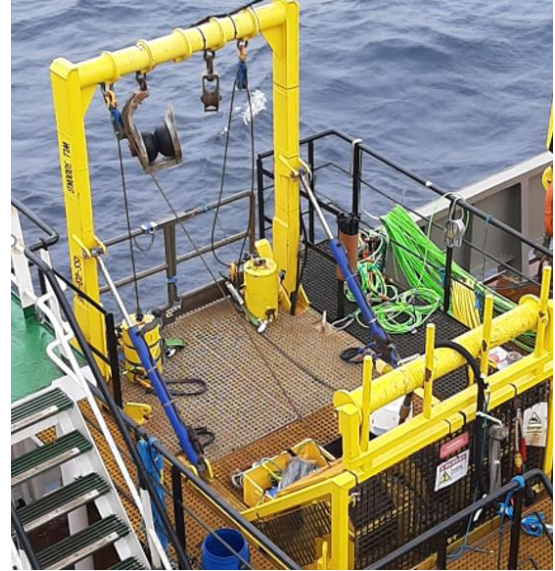
*A-Frame Workstation*

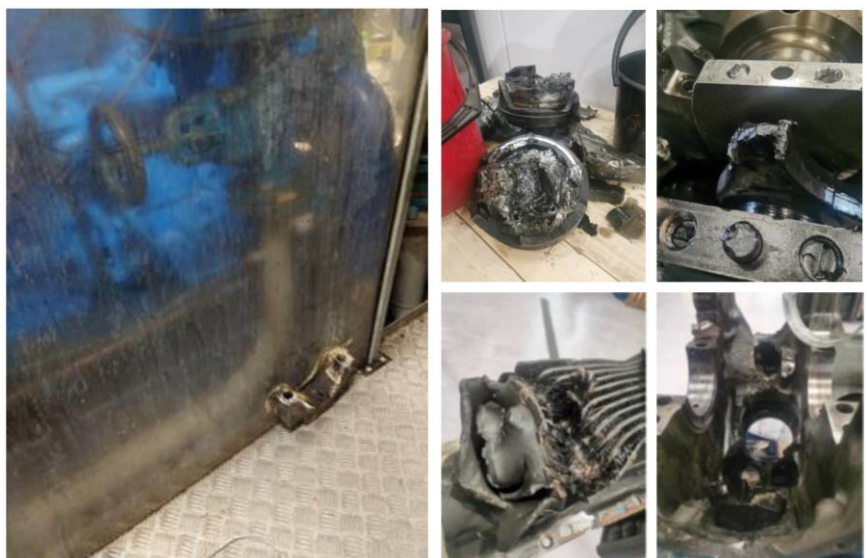
After investigation, it was found that a main bearing had worn out. It had been very hot at some point. When the main bearing cap was dismantled the upper bearing was located in the bearing cap,

with the result that the bearing had been turning on the crankshaft. This blocked the lubrication hole on the main bearing, and the con-rod at one cylinder received its oil supply from this main bearing. This meant that this cylinder con-rod also lost its oil supply. This was probably the main failure from the start. The investigation also noted that:
