IMCA Safety Flashes summarise key safety matters and incidents, allowing lessons to be more easily learnt for the benefit of all. The effectiveness of the IMCA Safety Flash system depends on Members sharing information and so avoiding repeat incidents. Please consider adding safetyreports@imca-int.com to your internal distribution list for safety alerts or manually submitting information on incidents you consider may be relevant. All information is anonymised or sanitised, as appropriate.

1 American P&I Club: unfamiliarity with semi-portable fire extinguishers

2 Lifejacket battery caught fire

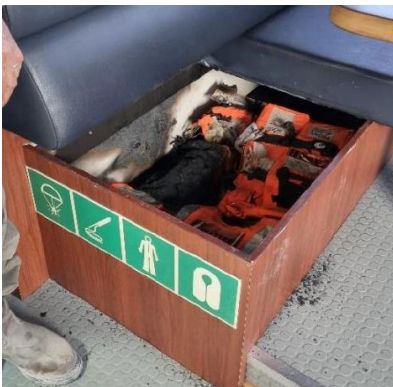
During an inspection on a vessel in cold lay-up, the lifejackets stored underneath a sitting bench in the wheelhouse were found burned and melted. No-one was harmed; apart from the jackets, nothing was damaged.

Burned lifejackets

A Lithium battery (3.6v) had exploded in one of the self-igniting lights. As the bench was in a properly closed position, without any gaps, the fire could not spread due to a lack of oxygen. Therefore the fire was not detected and did not activate a fire alarm, as the smoke was contained inside the storage compartment. Investigation showed that the battery of the “Lalizas 71209” life jacket light had expired five months earlier.

A possible cause could be that this battery was exposed to moisture before the lay-up period and water ingress affected the battery content after the lifejacket was put back in storage.

- Store such equipment in a secure, dry and cool place away from flammable materials;
- Keep batteries of any kind away from metal objects to avoid short circuit between the terminals;
- Lithium batteries in your work place:
 - Assess where Lithium batteries are present and check, if possible, the condition of the battery and cover;
 - Verify the expiry date of the battery;

- Regularly inspect batteries of lifejacket lights and other devices like radios as per planned maintenance schedule;
- If batteries are expired or damaged, remove them and dispose of them properly;
- For laid-up vessels, it may be appropriate to consider whether or not to remove Lithium batteries and other hazardous materials from vessels before going onto lay-up.

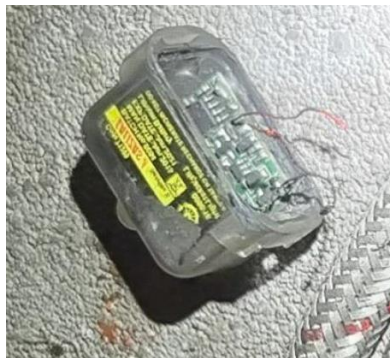
The lamp used in the lifejackets

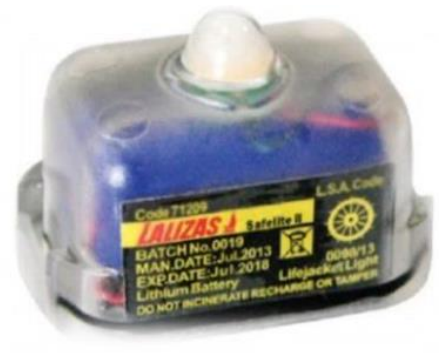
Lalizas 71209 lamp of lifejacket

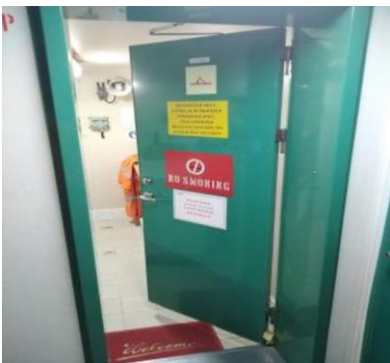
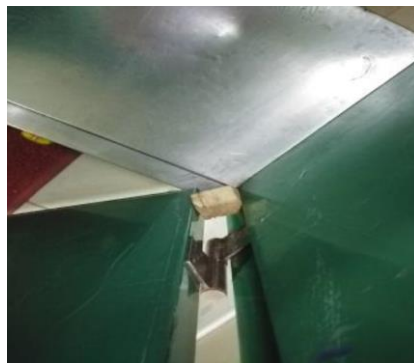
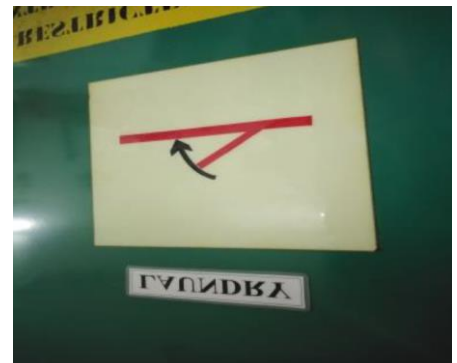
During a routine visit to a vessel in port, it was noticed that the Class A fire door for the laundry was intentionally wedged open with a wooden block.

Investigation revealed that the crew working in the laundry room had to wedge the door open to get the job done, but when the job was complete, the door wedge was left in place.

- There was no thorough risk assessment nor toolbox talk carried out; it had not been identified that the door had to be wedged open.
- The site was not inspected once the job was completed – the fire door was left wedged open.

- If any safety systems need to be deactivated or disabled for the purpose of a job or task, this should be clearly noted and discussed in the risk assessment, and control measures applied accordingly;
- Job sites should be inspected once all work is completed to ensure that all deactivated or disabled safety systems are restored and working properly;
- IMCA notes that consideration ought be given at the design stage to ensuring that jobs and tasks, so far as is reasonably practicable, can be undertaken without deactivating or disabling safety controls.

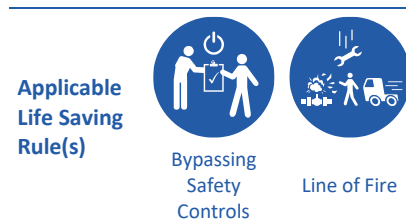
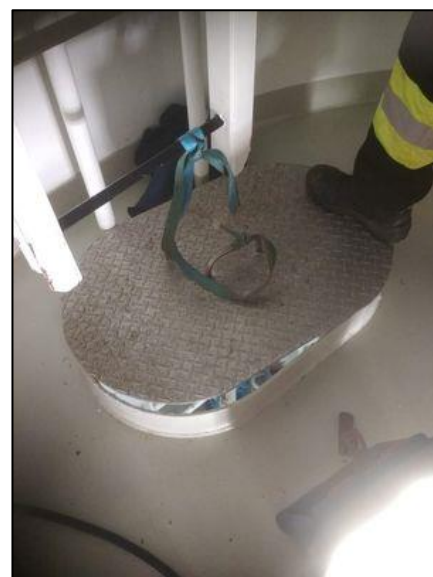
Two service engineers were performing an inspection inside an offshore crane pedestal. Inside, there was a ladder running the full height of the crane pedestal, with a hatch on the middle level of the pedestal. The first person went down the ladder, and unintentionally shifted the hatch cover into such a position, that when the second person went down the ladder and stepped onto the hatch cover that had shifted, it caused the hatch cover to tip over and fall to the room below. As a result the second service engineer fell through the hatch.

- The hatch cover shifted slightly out of position;

- There was a lack of awareness when entering crane pedestal.

- Poor hatch cover design – cover not secured. It ought to not have been possible to leave the loose hatch in such a position.

- Test and check – in this case the cover plate was never fully tested to ensure sure it was safe for unintentional shifting when persons might step on the edges;
- Look for similar hatches - ensure all hatch covers are properly designed and secure to prevent unintentional opening or shifting.
