1 Fatal crush incident between platform supply vessel and fast rescue craft (2012)

2 High potential: electric shock near miss

3 Fire at sea – some timely reminders (Safety4Sea)

4 NTSB: watertight doors – vessel sank after flooding

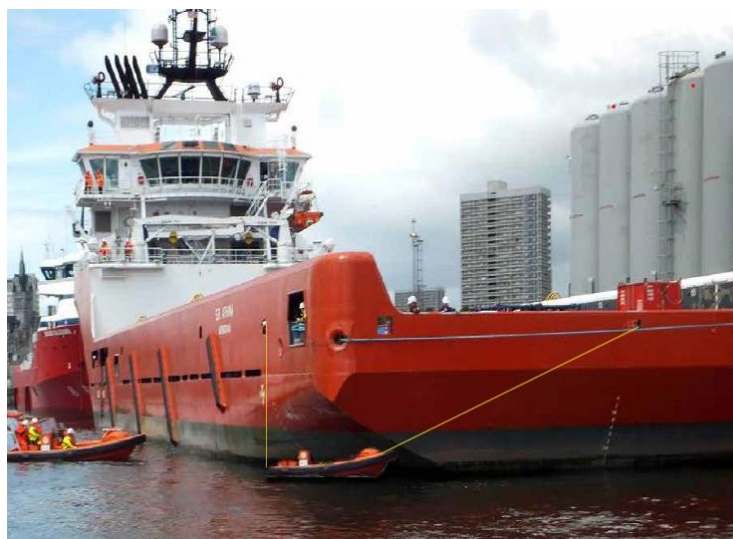
On 10 June 2012, the bosun on board a platform supply ship was fatally injured when he was crushed between the ship's hull and the lifting frame of the ship's fast rescue craft (FRC). The bosun was the FRC's coxswain and the FRC was being positioned alongside the supply ship's port quarter to repair a small area of damaged paintwork. The bosun suffered severe internal chest injuries and was evacuated ashore for medical treatment. He died soon after arriving at hospital.

- The FRC was being set against the port quarter of the platform supply ship by the prevailing swell and tidal stream and the bosun was possibly trying to push the FRC away from the supply ship's hull;
- The use of the FRC as a painting platform had not been properly planned and the risks involved had not been formally assessed;
- There was a failure to call for emergency medical assistance in a timely way: the severity of the bosun's injuries was not immediately recognised, and his transfer to hospital ashore would probably have been quicker if it had been arranged through the coastguard rather than the ship's agent.

- Raise awareness of vessel crews regarding the importance of completing risk assessments **when undertaking new or unusual tasks**;
- Ensure that prompt action is taken when a medical emergency occurs on board;
- *“Those responsible for operating...vessels...should have in place the necessary training, guidance, procedures and rules to ensure informed and appropriate responses to medical incidents of uncertain severity. These*

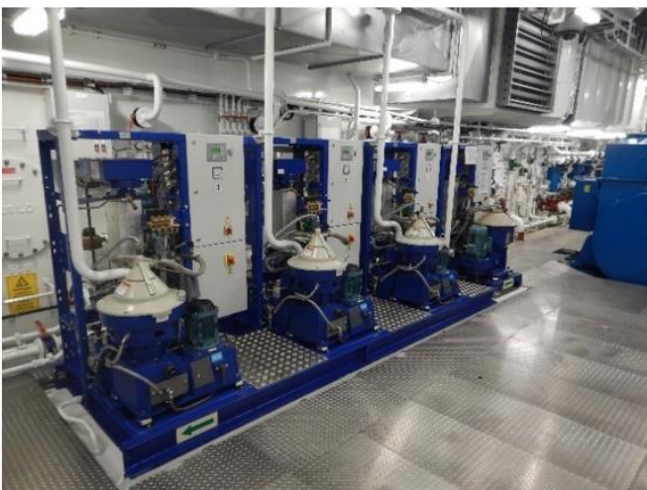
The electric motor junction box cover was removed, and access to the wiring was good. Measurement was carried out using a multimeter. When he was about to replace the cover of the junction box, it touched one of the three phases and he suffered a minor electrical shock in his fingers. He was uninjured but had himself checked by the medic who confirmed this.

- The engineer decided on his own, without discussing with anyone else, to proceed and measure the phases on a live electric motor without a Permit to Work nor Lock Out/Tag Out in place;
- He was wearing safety/rubber boots, coverall and safety glasses but not approved gloves.

- Failure to manage change: the engineer moved from doing a task which did not require PTW and LOTO, to a task that did. Had he stopped the job and correctly assessed the risk, it is likely that safety barriers would have been in place and risks mitigated;
- Energy Isolation: he did not identify the energy source and did not isolate it when the cover to the connection box was taken off and on. This resulted in him working on live equipment without proper PPE;
- Work Authorization: he did not identify that a Permit to Work was required before measurement of the phases. In addition, this task was not a part of the original plan and was not discussed with anyone.

- To avoid similar incidents in the future, it was agreed that no job be started before all necessary safety precautions have been discussed by a minimum of two crew members from engine department (any job, even if Permit To Work is not required);
- The company implemented the IOGP's Live-saving rules. These statements simplify the important questions personnel need to ask themselves before starting work.

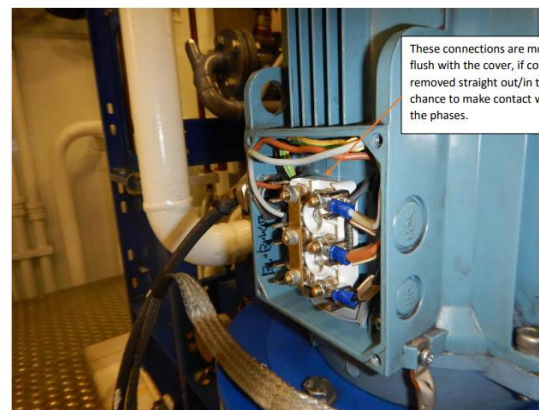
LO separator – MDO purifier rack

Motor Spec:

ABB M3AA 112 MB-2 3-phase CL.F IP55 IEC60034-1
3GAA111102-QSEAL1 +VC AMB.50°C AL 565595-16
No.3GV1311086072003
690V, 60Hz, 3460 r/min, 6,4kW, 7,2A, 0,88 cos phi
Bearing type : DE 6306 2Z/C3 & NDE 6206 2Z/C3

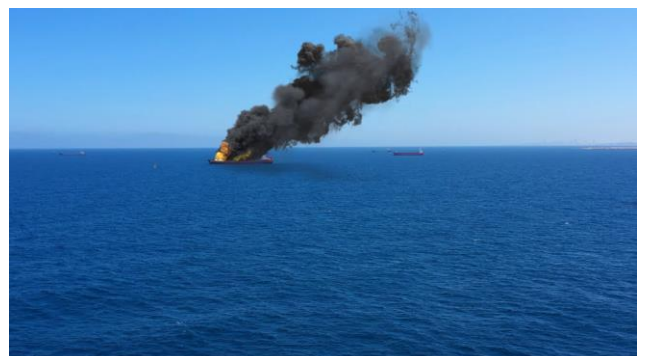
- Oil leakage: Leakage from high-pressure fuel oil pipes is the most common risk for fire onboard as oil from these pipes

can accidentally fall in high temperature areas due to the machinery involved.

- **Do:** Insulate any hot surface with a temperature above 220 °C to prevent any oil encountering a hot surface.
- **Don't:** Invest in poor quality materials regarding pipes and/or associated fittings.

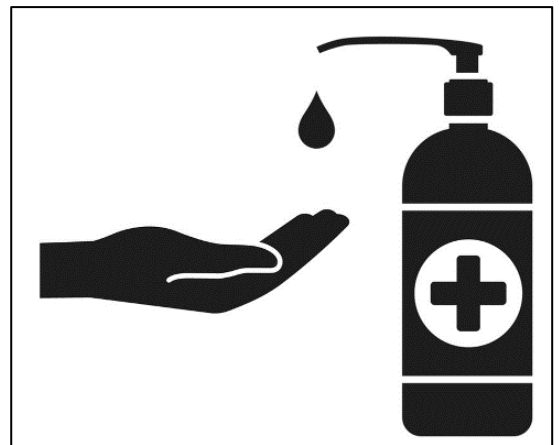
A technician banged an elbow whilst climbing out from under the slipring on a wind turbine generator. The technician notified the site manager that it was just a little scratch, and resumed work. Three days after the incident it started to get red. The following day, four days after the incident, the technician went to hospital and was started on antibiotics. The technician returned to work two days later and the infection appeared to have got worse. The infection that had set in over the week now required surgery to clean out the area of infection as the antibiotics did not work. What had initially started as a first aid case that was not properly cared for turned into an LTI and a much more significant injury to the technician.

- The technician and supervisor did not appropriately address the cut on the elbow with proper first aid techniques to clean the wound;
- The technician waited too long to address a worsening infection to the point that surgery became necessary.

- Difficult ergonomics in the work area contributed to the original incident;
- Improper first aid treatment and wound care;
- Improper incident management and follow-up care.

- Reinforce first aid training:
 - Infection control and wound hygiene during first aid: Ensure a full understanding of the importance of proper cleaning of cuts, grazes, burns etc.
 - Ensure that wounds can heal appropriately to avoid infection.
- Ensure good communication and that seemingly “minor” incidents are being followed up on from supervisor to employee.
