1 BSEE/USCG: Dealing with extreme weather events

2 American P&I Club: Extreme bollard pull

3 Lost Time Injuries due to a failed mooring line

4 LTI – Struck when anchor wire end pulled free of drum clamps

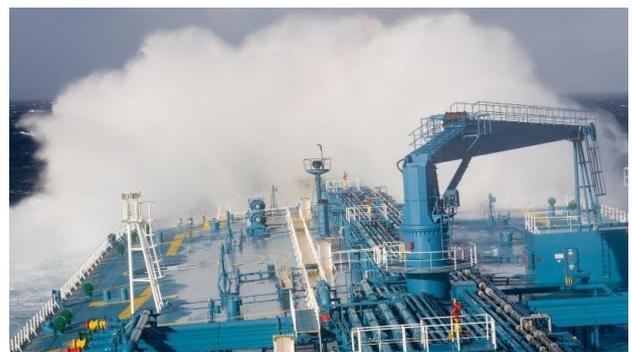
The Joint Safety Alert addresses an extreme weather event involving a Mobile Offshore Drilling Unit (MODU) conducting well operations in the Gulf of Mexico. The MODU, with 115 personnel onboard, lost 11 marine riser joints and a lower marine riser package (LMRP) and polluted the Gulf of Mexico with 88 barrels of miscellaneous fluids in its failed attempt to evacuate the area and evade Hurricane Ida.

- The operator and contractor representatives failed to promptly start Temporary Abandonment (TA) procedures. The temporary abandonment was delayed as the operator and contractor jointly decided to conduct a crew change during an operation and reduced staffing and time constraints;
- Over-torqued bolts and equipment breakdowns prevented the drill crew from retrieving the marine riser and LMRP, causing further delays;
- The MODU's Master stopped work so the crew could make storm preparations, such as placing covers on riser hatches. The Master and marine crew maneuvered the MODU with 12 riser joints and LMRP still hanging under the moonpool at speeds between 1 and 3.5 knots. Still, they could not evade Category 2+ hurricane-force wind and high/rough seas. The riser subsequently broke just below the rotary sending 11 riser joints and LMRP to the seafloor.

- Ensure all considerations and associated risks are documented and discussed with the operations team;
- Determine a "decision time" to act in the face of an extreme weather event. The decision to continue operations should not depend on a forecast track to the asset location. Don't wait on a definitive weather forecast to react;
- Document contingencies for when extreme weather conditions cannot be evaded or when evacuation is impossible. Ensure Hurricane Plans or Extreme Weather Plans are up to date; identify search and rescue assets available to conduct a mass evacuation of personnel;

- Review Extreme Weather Plans before hurricane season to verify which plan takes precedence and reflects actual company operations and practices. Also, discuss documents with involved personnel, and identify and correct any training gaps.

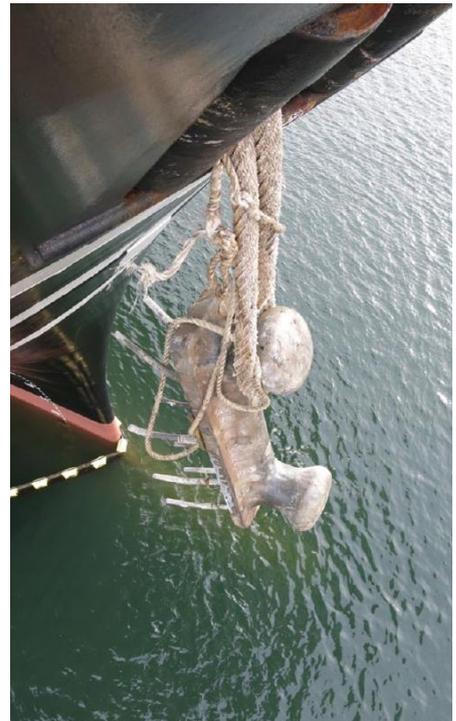
A large container vessel had just begun cargo operations. Approximately two hours later, the bollard holding the bow lines was pulled out of the dock. At the time of the bollard failure, the wind was mild, and the current was minimal. The bow of the vessel swung outboard slightly, and the stern swung into the dock. The stern of the vessel contacted the fendering system but neither the vessel nor the fenders were damaged. There were no injuries nor damage to the vessel. The repair to the bollard exceeded \$37,000.

Upon investigation, the four bow lines from the vessel had all been attached to the same bollard, the one that failed. The two forward spring lines were both attached to a different bollard. The two aft spring lines were both attached to yet another bollard. The four stern lines were paired to two different bollards astern of the vessel.

The normal practice of the crew was to place no more than two mooring lines on each bollard, but the pilot and line handlers had attached all four to the same bollard because a container crane was partially blocking access to the next bollard forward that would have otherwise been used.

Some of the bolts attaching the bollard to the dock had sheared and some of the bolts were pulled out of the mounting intact. Each of the four bow lines was on a self-tensioning mooring winch. The combined load of the four winches together exceeded the bollard’s rated load.

- Do not overload bollards with multiple mooring lines. If the load capacities of the bollards are not known, find out, and then adjust the mooring plan accordingly so the bollards will not be overloaded;
- Management of Change:
 - When deviating from a normal mooring practice such as only putting two mooring lines on a bollard, the specific risk of overloading a bollard should be evaluated based on the capacity of the bollard, the number of mooring lines that will be placed on that bollard, and the settings on the self-tensioning winches;

- If cranes or other dockside equipment block access to bollards that would normally be used, or if bollards that would normally be used are already being used by other vessels, the options should be discussed, and the risks should be identified and assessed before proceeding.

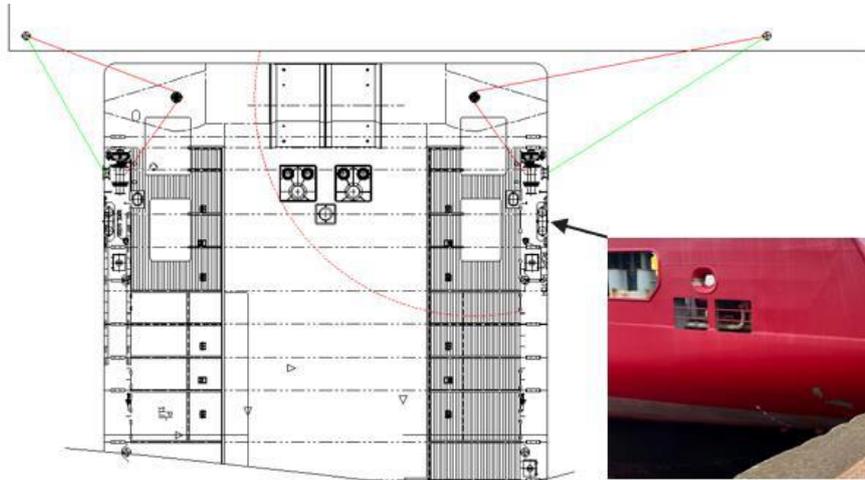
- The mooring line failed as a combination of several factors described below;
- The stern to berth mooring was not covered by the Risk Assessment for the mobilisation.

- It was believed that the right amount of thrust was being applied to the vessel by the bridge team;
- There was friction on the rope from the rail on the quayside;
- The crew involved thought they were standing in a safe area;
- The length of the port aft mooring line had been shortened to take up the slack;
- It was easier (less work, more convenient) to moor via the dolly rather than the Panama fair lead.

- Ensure that the stern to berth mooring operation is fully and suitably risk assessed to cover all relevant scenarios;
- When arrangement on quayside allows, route the mooring line directly to chock on hull side (green line) instead of over guide roller on the stern (red line) to avoid line of fire/snapback zone on working deck. (see illustration)

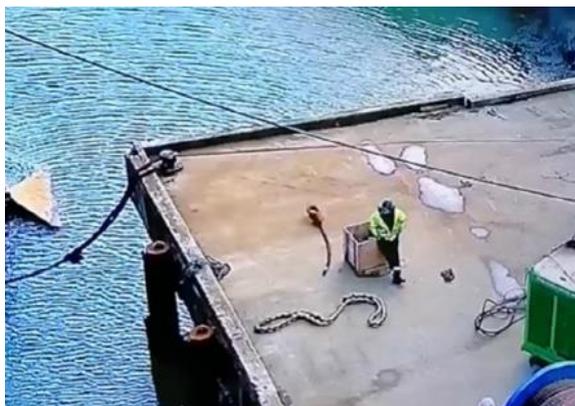
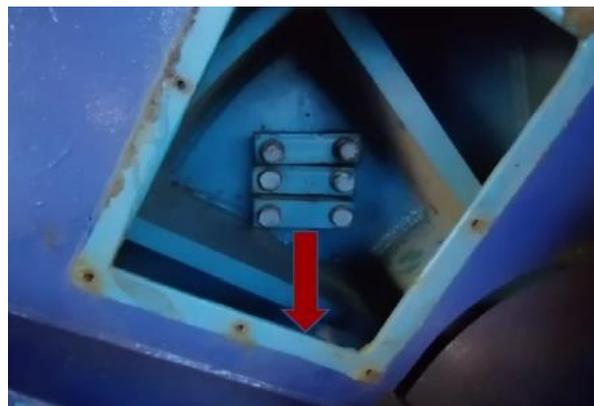
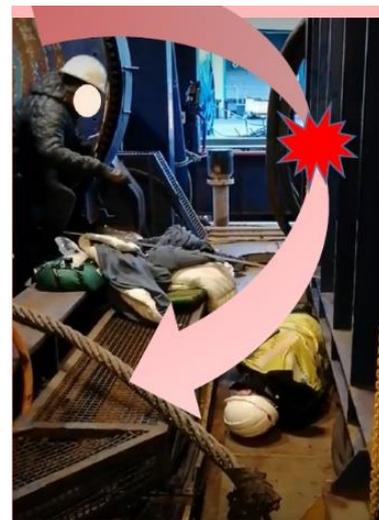
A person was seriously injured when he was struck by the end of a 58mm anchor wire. The incident occurred when crew were working on replacing out several 58mm anchor wires. The injured person was walking behind an anchor winch which had a single turn of wire remaining on it. The vessel moved off the quay. Tension came on the wire, which was connected to a spooler ashore. The stoppers in use failed, and the wire end pulled free of the already loosened clamps, whipping over the drum. He was struck across the shoulders/lower neck and suffered several skull fractures when he was pushed into an adjacent bulkhead by the impact, before falling to the deck semi-conscious.

- A generic 'mooring operations' risk assessment was being used. Toolbox Talks had been conducted and documented, but these were based around a clearly inadequate risk assessment (and nobody questioned it during the TBT);
- The stopper arrangement was inadequate. Wires must only ever be stoppered to a suitable strong point using chain stoppers, as detailed in the [Code of safe working practices for merchant seafarers \(COSWP\) 2021](#);
- Safety chains had not been deployed behind the winch. At that stage of the operation, there was a 'Line of Fire' hazard (an alternative route would only have taken about twenty seconds more);
- Insufficient attention was being paid to the tension on the wire by the spooler operators;
- Perceived time pressures and fatigue may also have been factors.

- More thorough planning and more thorough risk assessment would have eliminated most of the several factors which contributed to this incident.
- Adequate time and resources should be allowed in operational plans to allow for effective risk assessment; both vessel crew, project crew and shore-based management have responsibilities in this respect.

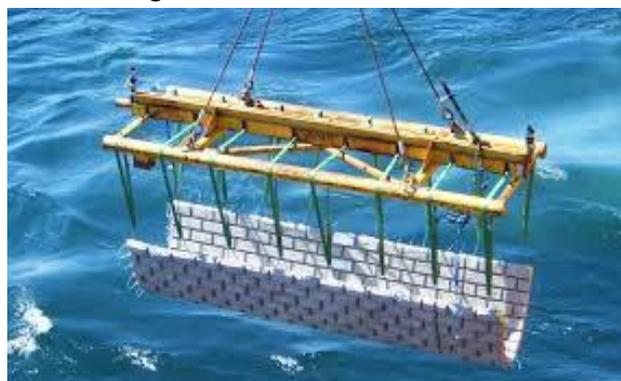
During the overboarding of a mattress stack (3x 150mm mattresses) using a mattress frame, the mattresses made contact with the port side bulwarks causing damage. Before and during the lift, the weather conditions were suitable for the operation.

As the load was lifted outboard, a swell caused vessel motion which led to a pendulum effect on the mattresses. The mattresses then hit the port side bulwarks causing damage. No-one was injured.

The immediate cause of the damage was that the mattress stack made contact with the port side bulwarks during vessel motion due to swell as the load was overboarded.

- Further engagement with deck crews to discuss worksite, crane / task specific challenges or difficulties they face during lifting operations. A series of “Times out for safety” were used to:
 - Present the scenario, explain that everything was done as it should have been
 - Explain the challenges associated with the lift because of deck / crane design including crane speed and limitations
 - Discuss anything the teams found challenging – with a view to proactive learning
 - Record and share as appropriate any concerns, challenges or ideas to improve things.
- Review lift plans and lift planning procedures to ensure prompts are provided to consider the limitations of the crane to be used including speed, line out, route for the lift etc.
