1 LTI: Diver suffered crush injury to finger

2 High potential incident - Foot trapped under ram cylinder

3 Fall leading to serious personal injury

4 Chemical burns to body

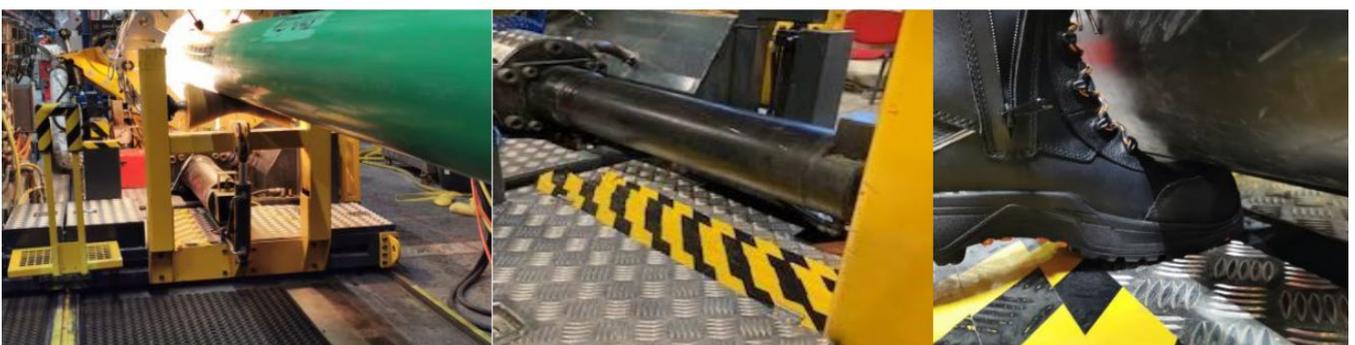
Showing coating machine associated ram and re-enactment of foot entrapment

The process is semi-automated, but at the end it requires the helper to step up on to the IMPS platform to access the pipe: the design of the IMPS system is such that it allows access to a hazardous area without adequate controls being in place;

There was no physical guarding in place to prevent foot placement under cylinder ram;

Identify any moving equipment components that pose a risk of entrapment at your worksite and apply suitable controls e.g., guarding, access restrictions or automatic cut-off;

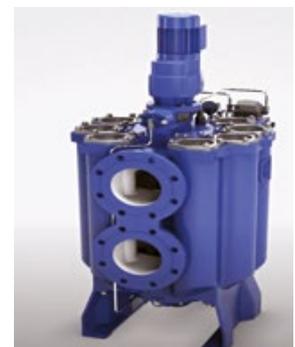
The filters were not isolated properly from the compressed air pipe and the isolation valves were not labelled as closed as required by the relevant work permit;

The filters were not checked for being under pressure and draining of the filter was not carried out before opening the cover;

A Typical modern fuel oil back-flush filter
