1 Diver Finger Injury – Scrubber Blower Fan

2 BSEE: Unsecured Pressurized Hoses Result in Hand Injuries

3 Cook's arm scalded while removing food from oven

4 LTI: fractured finger during anchor handling

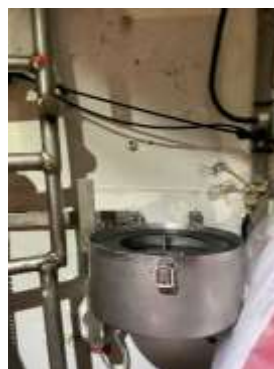
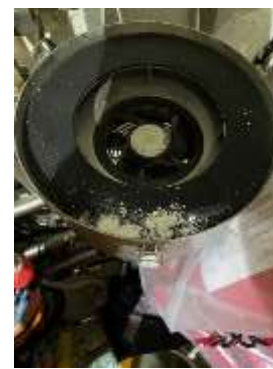
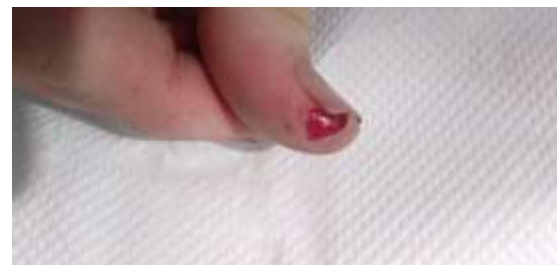
A diver suffered a minor hand injury when he put his hand on part of a fan which should not have been exposed. The incident occurred on a vessel carrying out mobilization; a diver was in the starboard bell carrying out bell checks. He placed his hand on the soda sorb fan motor housing (scrubber). The fan motor was running to improve air flow through the bell. There was no soda sorb canister attached leaving a small exposure point to the fan which nipped his thumb causing a small injury.

- Fan not switched off;
- Risk assessment did not include hazard posed by the rotating fan, nor the requirement to switch off the fan when the canister was removed.

- Reviewed equipment design: considered adding a guard (seen as undesirable as this would restrict gas flow) or altering the design to include an automatic cut off (this may fail);
- Updated appropriate company risk assessment to include requirement to switch off the fan when the canister was removed during bell entry;
- Appropriate signs or labels were also considered.

Another solution may be to fit an empty cannister to the fan. This would protect the diver's fingers from the fan while not wasting any CO2 absorbent.

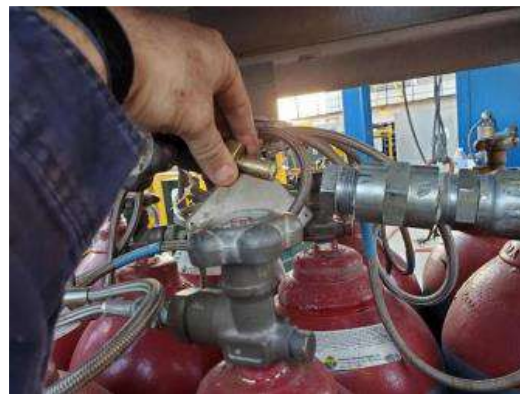
Incident 2: Crew were in the process of rigging up three nitrogen bottle racks to blowdown and purge the reel during rigging down operations. After a successful connection to the reel, the three nitrogen bottle racks were opened to pressurize the line. A valve at the reel was opened to begin purging the reel. After opening the reel valve, the nitrogen hose connecting the second bottle rack failed at the brass fitting, sending the pressurized hose whipping around. The injured crew member was struck in the hand, resulting in two broken fingers and multiple lacerations. The hose then struck a second worker in the arm, causing bruising and swelling of the forearm. The injured person was not wearing impact gloves at the time of the incident.

In both cases, the injured parties were not wearing proper impact gloves to help reduce the severity of a hand injury. Moreover, in neither incident was the appropriate safety device/equipment installed to keep the pressurized hose secured correctly in the event of a mechanical failure.

In incident 2, the job safety analysis (JSA) did not address the procedure for blowing down the reel dry and other associated hazards.

Incident 2: Failed Hose Connection on Bottle Rack.

- Emphasize the use of properly fitting gloves (e.g., impact, chemical, or a dual glove) in the JSA to reduce or eliminate the severity of sustained hand injuries;
- Depressurize the line entirely or depressurize to a much lower pressure before manipulating valves under pressure;
- Ensure that during pressure testing, hoses are secured to prevent them from moving. Avoid stressing small threaded connections by properly supporting hoses and tubing;
- Use a whip check across a pressurized hose connection to mitigate uncontrolled movement in the event of connection failure;

- Verify that all valves are in the correct position before pressurizing equipment;
- Determine the correct PPE before handling chemicals. The materials used in some protective gloves may provide excellent protection against specific chemicals but may be ineffective against others;
- Ensure full and comprehensive review of every job task and associated hazards during the creation of the JSA;
- Use **Stop Work Authority** when equipment is unsafe or if you discover a new hazard!

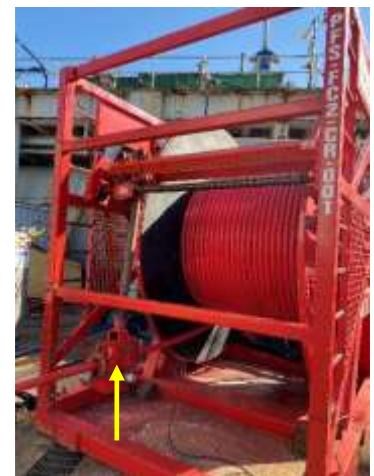
Incident 1: A flexi coil hose was filled with salt water during a pressure test and tested to 10,000 psi for 10 minutes. The pressure was bled to 6,000 psi through a needle valve at the pump's discharge following the successful test. Once the pressure was bled to 6,000 psi, a worker began releasing pressure from a ball valve on the upstream end of the flexi coil hose. While doing so, the flexi coil hose backlashed and pulled the valve from the worker's hand, causing the ball valve to contact the coil reel of the unit. The ball valve came apart when it hit the unit, and the handle contacted his right thumb, causing a laceration. The injured worker stated he was wearing latex gloves at the time of the incident. Right before opening the valve handle, he had been handling hydraulic oil.

Incident 1: The spot where the contractor's right thumb was pinched between the ball valve and the horse head.

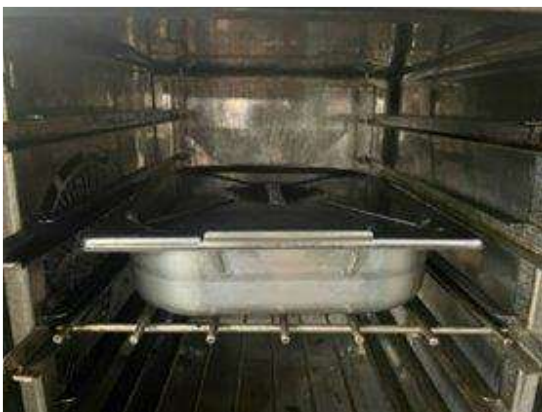
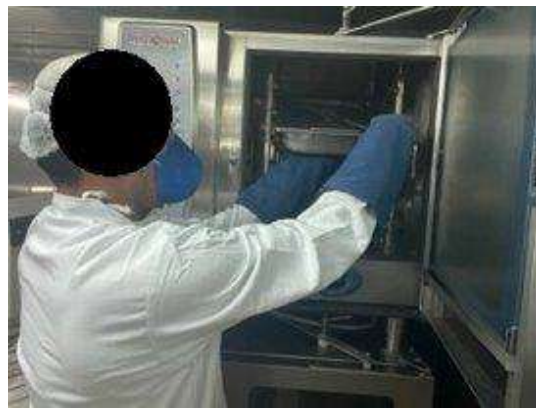
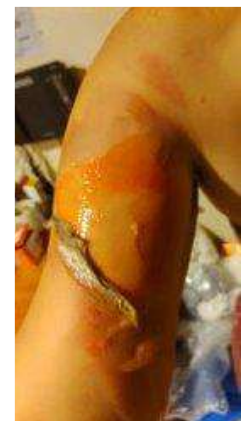
At a meal time the chief cook opened the upper part of a combined oven to remove a tray of rice that was being kept heated. The tray was at head height for the injured person. Whilst removing the tray, scalding hot water (condensed steam) on the surface of the lid dripped onto the cook's arm causing a scald injury. The accident was a medical treatment case and the cook had to be sent ashore for treatment.

The lower oven (which would have been safer) was not working and the upper oven was used instead for hot food storage. As the cook was shorter than the height of the oven it was not possible for him to see the condensed steam on the surface of the lid when he removed the tray.

Our member determined that the root causes of the incident were inadequate communication and previously damaged equipment. Contributory factors were inadequate inspection and inadequate risk identification and/or risk assessment.

- Fixed the lower oven and amended the Planned Maintenance schedule;
- Reviewed the risk assessment and procedure for this task;
- Further encouraged crew to report that equipment had failed;
- Replaced the lids with PVC plastic (film stretch);

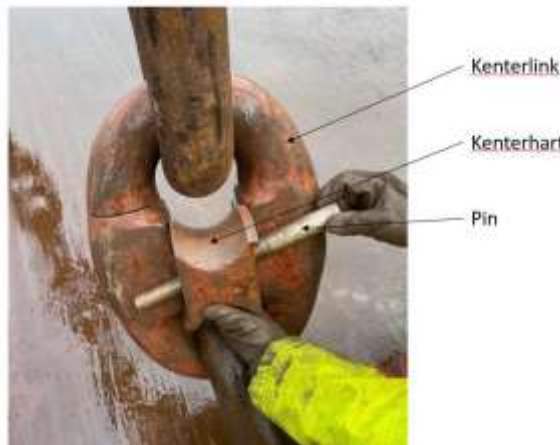
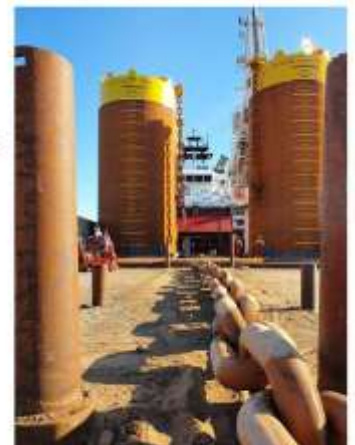
Suction Anchors and Mooring Chain

A crew member suffered a serious finger injury when he got his finger trapped. The incident occurred when a vessel had been installing mooring elements, suction anchors and mooring chain. Whilst handling chain, the injured person got his finger squeezed when loosening a bolt (pin) from the central part of a Kenter link (Kenter heart). He went to see the medic onboard and was treated, but was unable to do any practical work on deck the next day. When the vessel arrived back in port he was sent for X-rays, which revealed that the fingertip was fractured. He was then sent home on sick leave.

The injured person was sitting on deck hitting the Kenter heart down to drive out the pin. The pin is a conical shape, and so it must be done the correct way or else it will be driven firmer into the Kenter heart. If this is done the correct way, the pin comes out easily. While he was hitting the heart with the pin down to a hard surface the wrong way, it didn’t loosen but slipped and his finger got squeezed/pinched between the deck/chain and Kenter heart.

- Lack of training & knowledge – the injured person had previous experience on deck on various vessels, but was new to this vessel and anchor handling operations. While he had received training and he was supervised working on the aft deck. He did not know about the conic shape of the pin in the Kenter heart.

- Insufficient supervision – whilst there were personnel working around him on deck and he was a part of a “buddy” system, he was not being overseen at the time of the incident;
- Lack of effective risk assessment - the risk assessment for the specific job was done in the beginning of the campaign *before the injured person was onboard*. The team did not effectively perceive the risks in the situation and the injured person did not stop to get advice from his colleagues.

- A higher focus on training and supervision of inexperienced or new personnel;
- Communicate incident effectively: New employees represent an increased risk of injuries and need special attention during their first shifts and time onboard. Increased activity in general, also means increased number of new employees onboard the vessels.
- Could impact gloves be helpful in some operations on deck?

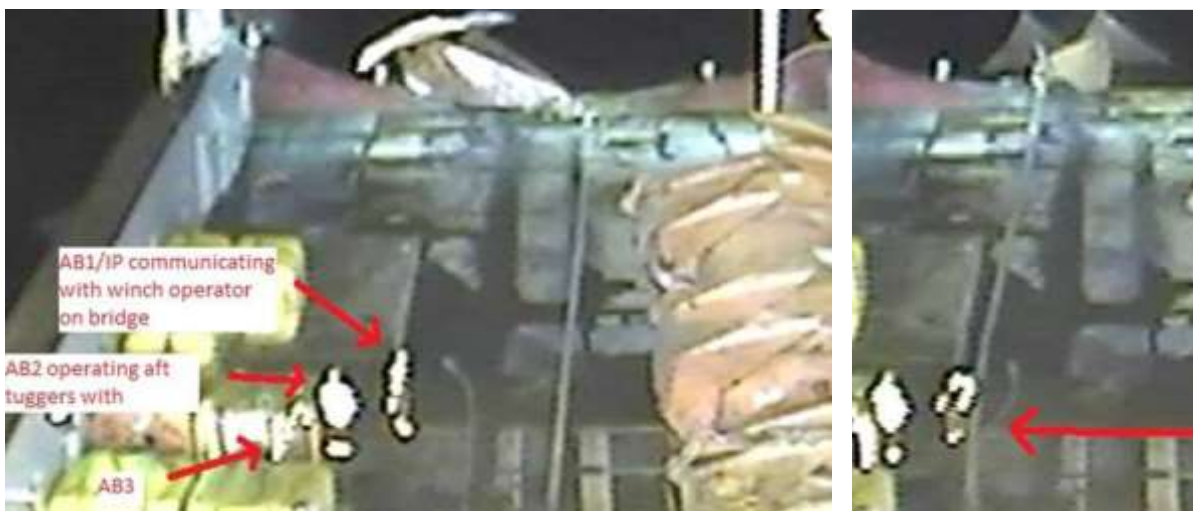
When the anchor was pulled backwards, it started to lose its initial “heading”. When approaching the stern roller, the anchor was at a 45 degree angle to the vessel heading. This was not identified as a risk since all involved persons were at a safe distance from the anchor. As the weight of the anchor passed over the roller, the anchor straightened up as expected, but this also created an unexpected swing of the chain going forward to the main winch. The chain swung from the port side and approx. two meters to starboard and subsequently struck the left safety boot of one of the AB’s causing an injury.

This specific anchor had a bridle with shackles attached underneath. So, when the anchor moved, it was “riding” on these shackles. This made it particularly difficult to “steer” the anchor. Instead of stopping and re-positioning

the wrongly positioned anchor, the crew continued to pull it over the stern with a 45 degree angle; no-one anticipated the sudden and excessive movement of the anchor chain across the deck.

- Insufficient risk assessment and job preparation – much more thorough risk assessment and tool box talk, including discussion of safe positions, snap back zones, clear deck policies etc.;
- There was poor situational awareness. Crew noticed the angle of the anchor but did not realize the positioning of the deck crew;
- When pulling an anchor over the stern, the anchor should be straightened up if it comes with an angle. This will reduce the likelihood of equipment damage and potentially dangerous situations for the deck crew. Vessel to review and improve operational routines;
- Emphasise the “Stop the Job” policy. Everyone has the right/responsibility to stop the job if they see that something is not how it should be.
