1 Focus on third-party dropped objects

2 Hydraulic Oil Leak to Sea from Downline Fitting

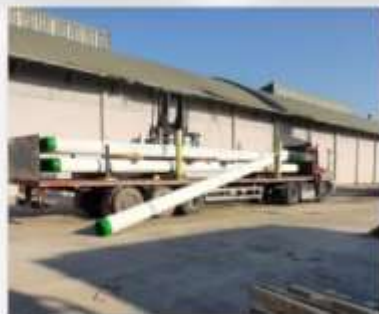
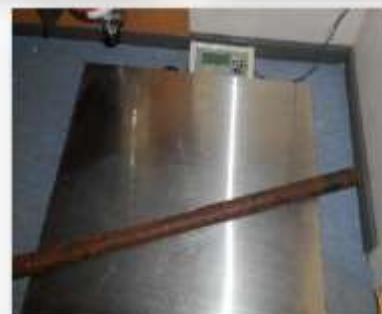
The dropped object incidents have included many high potential near miss dropped objects which under different circumstances could have resulted in debilitating personal injuries. The dropped objects have been all manner of items, from heavy pipes, rigging failures through to nuts and bolts, that all had the potential for personal injury.

- Rigging failures;
- Weld Failures;
- Overhead gantry crane failures;
- Dropped pipe during pipe handling;
- Snagged rigging during pipe transfer;
- Incorrectly secured rigging.

- Inadequate procedural control that did not identify the correct process and risk management to be followed during pipe handling;
- Inadequate acknowledgement, adherence, understanding and assessment of risk controls in the risk assessments – truck inspections, banksmen/additional spotters not positioned correctly, toolbox talks not identifying the hazardous activities;
- Certifications of lifting equipment not adequate for expected use case;
- Incorrect equipment being used for transferring pipe;
- Human factors, risk perception and competency of personnel involved in operations;
- Inadequate quality control and inspection;
- Inadequate planned maintenance systems in place.

- During the contracting process ensure that third-party HSE Management Systems (HSEMS) have fit for purpose risk controls in place to prevent/mitigate dropped objects;

- Set clear expectations with third-party contractors in respect of lifting and pipe handling activities.
- Formal understanding of differences between company and third-party contractors’ levels of oversight, mode of control and accountabilities – BEFORE starting work;

- Audits, inspections, and verifications of third-party operations to ensure that proper risk management controls are in place to prevent dropped objects;

- Ensure third parties consider and align with industry good practice;
- Remember the “7T’s” – **Take The Time To Think Things Through**;
- Support third-party contractors to ensure a focus on risk perception and considering regular “fresh eyes” reviews of work tasks and equipment use;

- On all worksites ensure that the obligation and expectation to exercise the **stop work authority** is clearly communicated and understood by all parties.

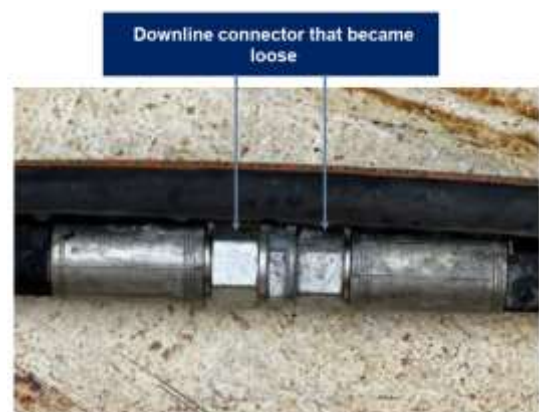
The downline was disconnected, recovered to deck and inspected. The leak was coming from a BSP fitting 40m from the diamond wire saw connection point.

BSP fitting which came loose

- Immediate Cause: the fittings became slack: It is not known when the fitting slackened. It is suggested that a combination of handling on deck, energising and de-energising were contributory factors;
- Underlying Cause: checks were omitted: Fittings were not checked for tightness when overboarding the diamond wire saw and downline;
- Root Cause: the checklist used did not prompt the check of all fittings for tightness, only visual checks.

- Added additional supports on fittings attached to the tugger over and above existing controls;
- Ensured that physical checks for tightness were conducted;
- After a review of feasibility, the bight of the hydraulic hose was removed;
- Checklist was updated to include checks for the tightness of fittings;
- Incident was shared with other users of similar equipment.

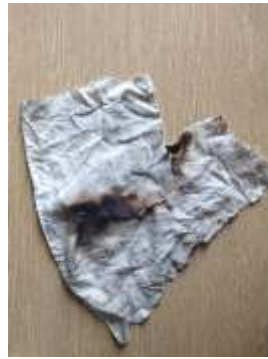
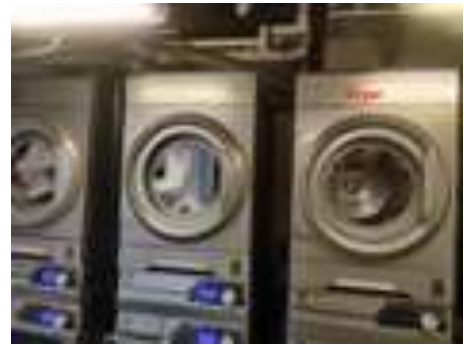
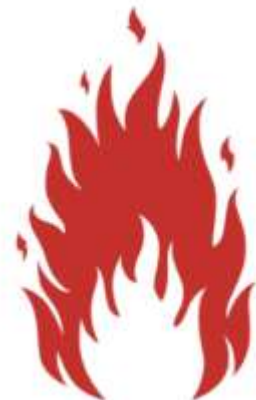
The power supply to all the dryers was immediately switched off. The smoke (there was no fire) was found to have come from an oily rag in the pocket of one of the coveralls being dried at the time. There were no injuries and some minor damage to clothing.

- An oily rag in the pocket of one of the coveralls being dried at the time – existing, known, laundry procedures were not followed – realistically, someone forgot to check the pockets of their overalls before putting them in the wash.

- Updated risk assessment with additional controls;
- Renewed signage in laundry to
 - remind crew to check all pockets prior to laundry.
 - remind crew to segregate oil-soiled work clothing when doing laundry.
- Arranged separate laundry collection point for clothing that may be oil-soiled;
- Dryer to be set at normal temperature – drying laundry at too high a temperature can greatly increase the risk of combustion;
- Laundry procedure to be made part of sign-on & vessel induction training.
