1 MAIB: Flooding and sinking of the survey workboat *Bella*

2 Vessel collision with underwater objects in harbour

3 Oil leakage from vessel crane onto quayside

5 Connection failure during lifting operation

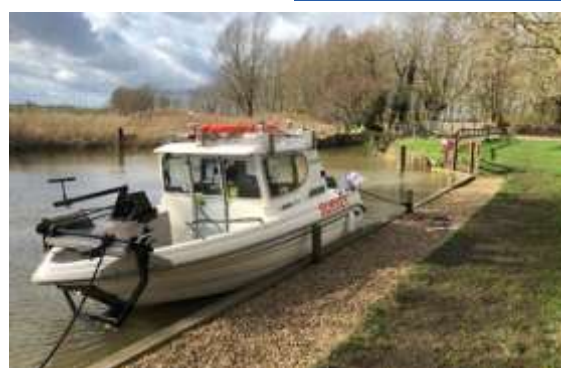
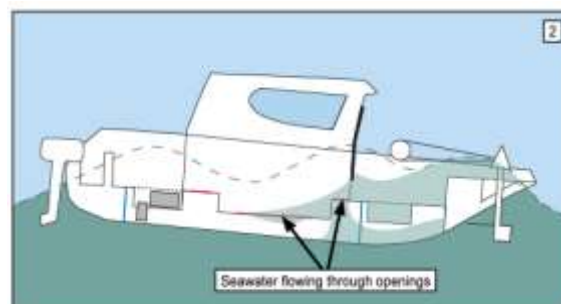
Waves break over bow and flood forward cockpit and sole locker. Seawater flows over door sill and enters wheelhouse, flooding void space between deck and hull moulding

- In moderate seas, *Bella* shipped water over the bow that made its way into the wheelhouse and then into the void space between the deck and the hull. With no buoyant volume or in-built buoyancy, the boat was soon overcome and sank;
- Investigation identified weaknesses:
 - In the commercial certification applicable to the boat, which resulted in it being inappropriately certified as a workboat suitable for operations at sea, and,
 - In the owner’s safety management system.

- The boat sank because it became swamped with seawater and had insufficient reserves of buoyancy or means of flotation to remain afloat;
- The vessel was vulnerable to swamping even in moderate sea conditions because the addition of the multibeam echo sounder gantry had significantly reduced its forward freeboard;

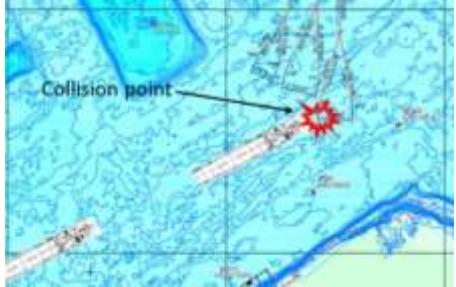
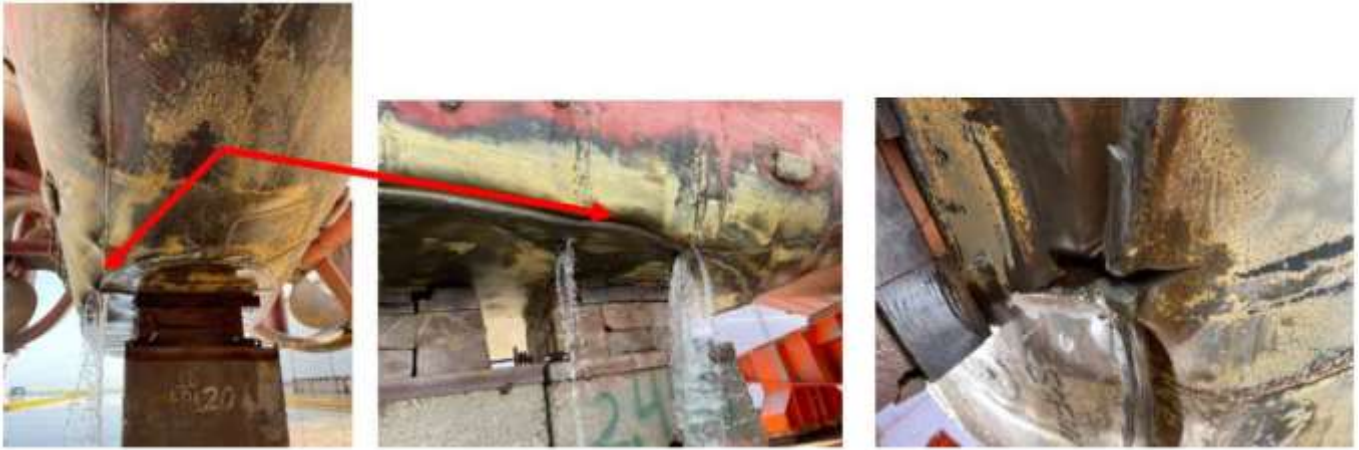
The vessel collided with uncharted underwater harbour pilings.

- There were no proper navigational markings - the piles were not marked with floating buoys;
- The most recently updated charts for the harbour, provided by the authorities six months before this incident, did not reflect the exact co-ordinates of the underwater piles;
- The pile height and the water depth information provided on the chart did not match the “under keel clearance” calculation done by the bridge crew on the vessel.

- Bridge crew should calculate “under keel clearance” considering draft versus water depth, height of subsea objects, vessel stability, weather conditions and squat effects when navigating through a potentially hazardous area;
- If possible, avoid navigating through areas for which notices to mariners or similar warnings are in place. If there is no option but to do so, it may be appropriate to seek shore-side management approval.

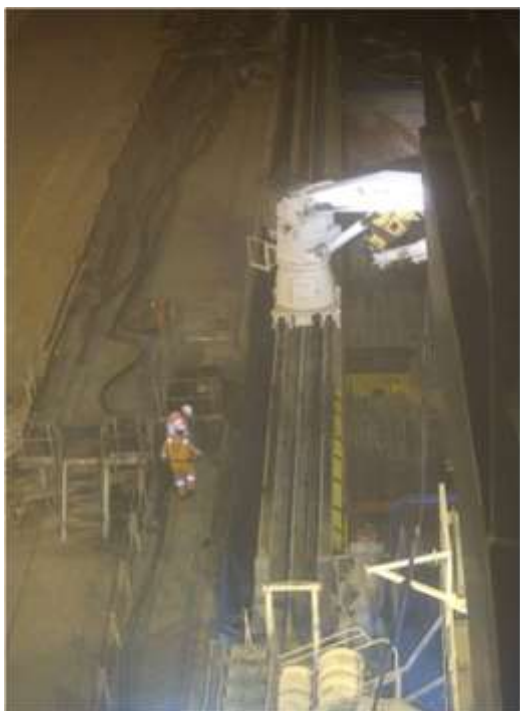
Inspection taking place in poor light conditions – missing the leak

- During inspection it was discovered that there was a rupture in a hydraulic hose of the vessel crane.
- Though a search for leakage to the quay took place, poor lighting meant that the crew failed to notice any sign of oil spillage;
- There was a lack of compliance with incident reporting requirements - this incident was initially left unreported by the vessel crew;
- It was subsequently discovered that the crew were unaware of the requirements to report any releases or spills to the environment.

- Ensure crew properly understand the need to report any releases or spills to the environment;
- Ensure planned maintenance of hydraulic hoses – regular visual inspection to be instituted, and regular and immediate renewal of hoses based on their physical condition.

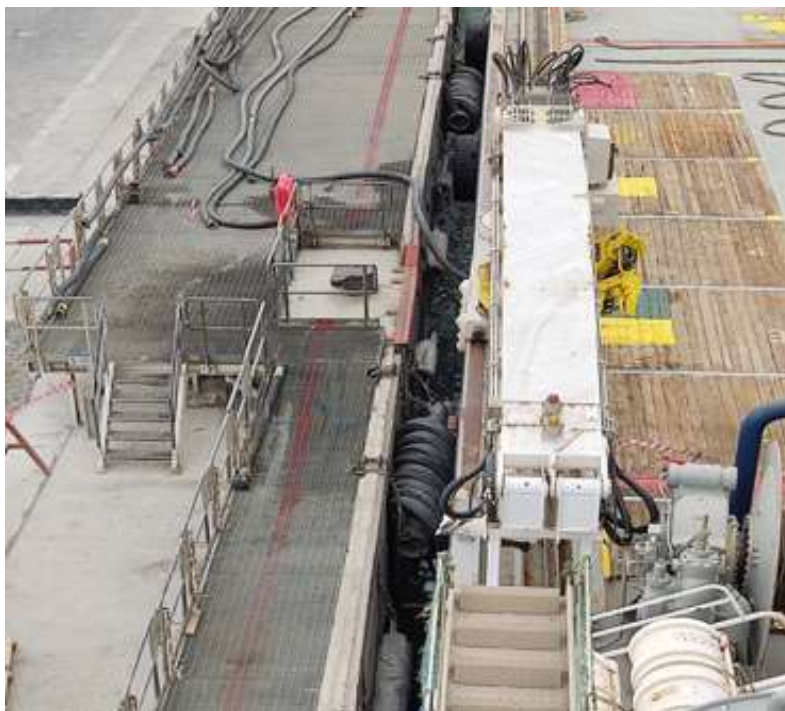
View of the spillage area in the morning

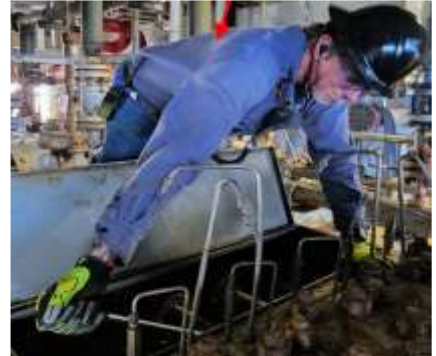
Recent injury due to excessive force and awkward body position (this is a re-enactment)

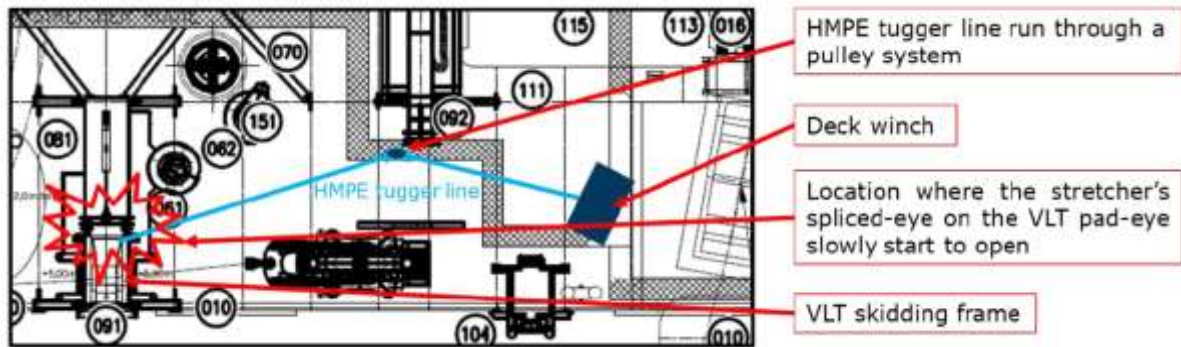
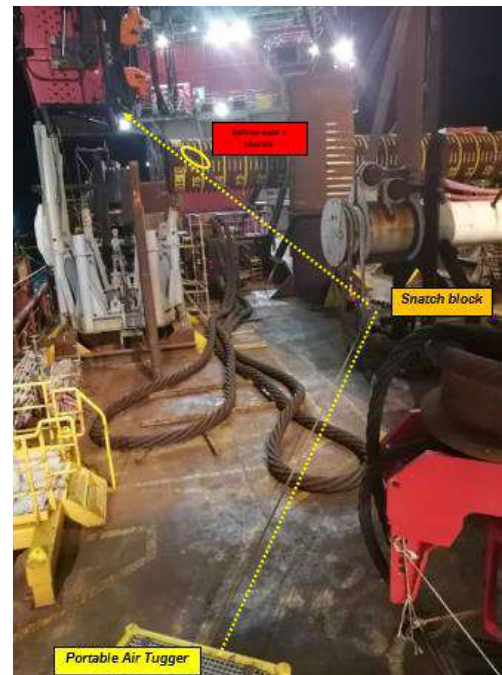
To guide the equipment onto the skidding frame, a tugger line was connected to the VLT by means of a self spliced-eye. The tugger line was made of HMPE (High Modulus Polyethylene) spooled on the dedicated deck winch.

- Amount of force applied to the tugger line;
 - The tugger line arrangements/connections weren't engineered
- Quality of the tugger line splice:
 - The spliced eyes were prepared on board by the crew;
 - Written instructions from the manufacturer for a high performance splice of a 12 strand rope was available on board;
 - The crew experienced in splicing could not demonstrate having received formal training;
 - The quality of the splice wasn't checked against the written instruction;
 - The splice was covered with duct tape and therefore impossible to inspect and to notice any partial damage/excessive wear/fatigue;
 - The spliced-eye was choked on the VLT's pad eye without use of a shackle, resulting in a small bending radius where the fibre rope is wrapped around the edges of the pin hole and pad-eye plate increasing the risk of damage to the rope and the spliced eye.

- Ensured that splices are only made by competent, qualified and trained personnel;
- Ensured crew were aware that the Maximum Breaking Load (MBL) of a tugger line is reduced by applying a spliced-eye;
- Splices in general should not be covered by tape as it prevents regular visual inspection, use the original equipment manufacturer protection covers instead;
- Spliced ropes should be part of the vessel maintenance regime as per manufacturer's instructions;
- Avoided the choking of tugger lines, using suitable shackles instead.
