IMCA Safety Flashes summarise key safety matters and incidents, allowing lessons to be more easily learnt for the benefit of all. The effectiveness of the IMCA Safety Flash system depends on members sharing information and so avoiding repeat incidents. Please consider adding safetyreports@imca-int.com to your internal distribution list for safety alerts or manually submitting information on incidents you consider may be relevant. All information is anonymised or sanitised, as appropriate.

1 Diving instructor killed – incorrect valve threads (IDSA)

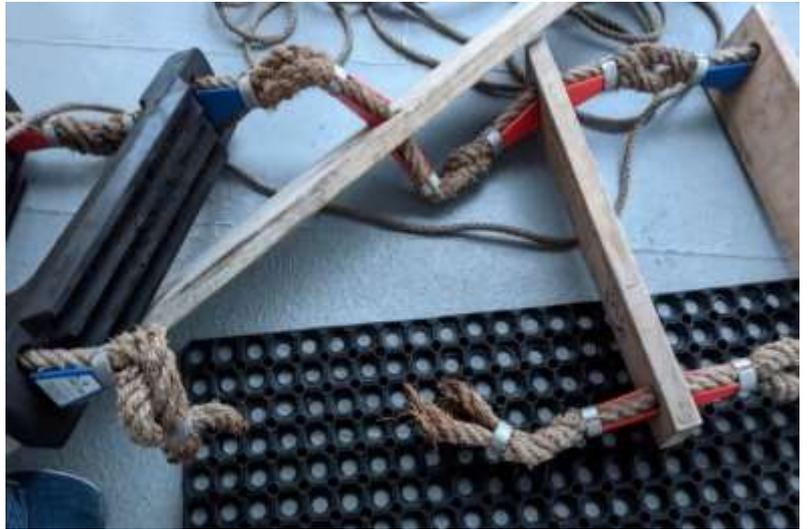
Whilst undertaking pilot boarding operations during the hours of darkness, a side rope on the pilot ladder parted when it was being weight tested by the pilot. The pilot was not injured; however if the ladder had not been weight tested by the pilot, it could have failed whilst it was being climbed, resulting in a fall from height into the sea.

- The pilot ladder had not gone through a 30-month strength test because the requirement to do so had not been uploaded into the vessel's planned maintenance system;
- It was known that the pilot ladder was in poor condition, but it was decided to continue to use the ladder beyond its operational life knowing that the vessel would soon be de-commissioned;
- The vessel did not carry a spare / second ladder.

- A Pilot ladder is essential safety equipment and should always be serviceable / available for use;
- Safety critical equipment should be inspected before use and any deficiencies found should be reported and rectified;
- The defective pilot ladder was replaced with a new ladder;
- Carry a minimum of two pilot ladders and replace them every two years;
- Ensure vessel planned maintenance systems are up to date and include everything that should be included.

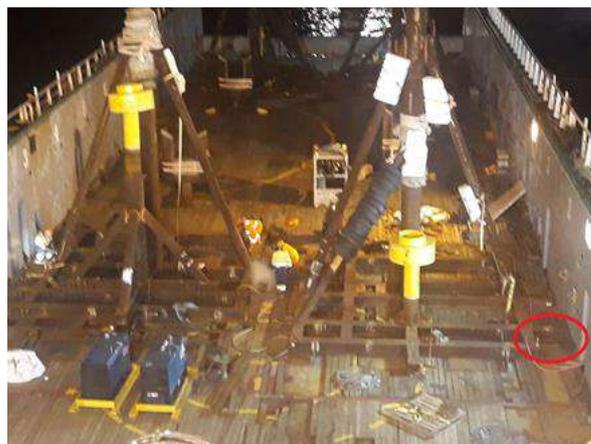
On a member's vessel alongside, a small fire started following hot work conducted by the client's welding sub-contractors. The incident occurred during the welding of jumper stands on the main deck. After completing their work, the welders left the vessel without notifying the bridge, and the Permit to Work was closed. Shortly thereafter, an AB discovered smoke coming from a rag left over the welded area. The small fire was

- There was inadequate communication between the third-party welders and the vessel crew;
- There was no joint inspection (by vessel crew and third-party welders) of the work before the welders left the vessel and the Permit to Work was closed;
- There was no fire watch.

Smouldering rag was found at place marked by red ring

- Closer liaison with third-party contractors to ensure understanding of requirements for
 - Monitoring of work;
 - Opening and closing of Permits to Work.
- Ensure joint inspection and agreed acceptance of work done by third-party contractors before allowing them to leave or closing Permits to Work;
- Ensure fire watches are set.

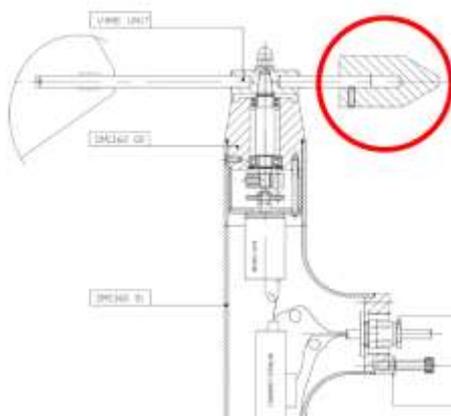
A small part weighing 0.3kg fell 20 meters from an OMC-160 wind speed and direction sensor installed on a vessel's main mast. Two wind speed and direction sensors were installed on the vessel's main mast; they consisted of a wind speed sensor and a wind direction sensor. The wind direction sensor was of the wind vane type unit and had a counterweight (length 6 cm/diameter 3 cm; 300 grams) fixed to it. This counterweight was only secured to the wind vane by a single grub screw. The grub screw came loose causing the counterweight to fall off. There were no injuries, nor any damage to the vessel or equipment.

Before: single point failure – one grub screw

- The counterweight was secured with only one screw, and this single point failure was not identified during the previous DROPS surveys;
- The OMC-series wind sensors are designed for minimal maintenance and as such were not part of the vessel's planned maintenance system;
- The original grub screw worked loose because of vessel vibration.

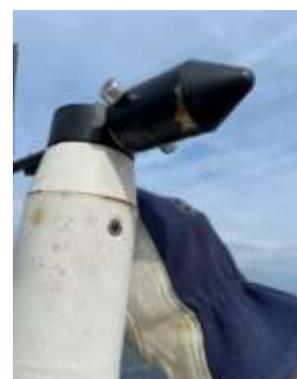
After: new securing method – two grub screws

- The crew secured the counterweight by drilling one more hole on the opposite side of the existing one, and thus used two new screws to secure it. In addition, Loctite was applied to secure these screws;
- After checking for similar situations on the main mast, the same modification was done to the counterweight on the second direction sensor;
- Check if there is anything similar in your work area that could fall from height following a single point failure, or, is not included in the vessel planned maintenance system – check all instruments on masts;
- Check fixings at height very thoroughly. Particularly worthwhile and important when access is difficult.
