1 High potential near miss: Uncontrollable movement of auxiliary whip line

2 Uncertified lifting gear found in use

3 Dropped objects in dry dock

4 Air hose connection failure

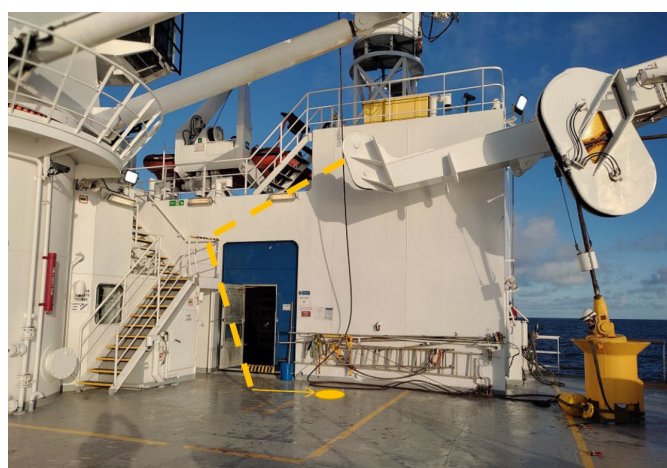
When starting up, a vessel main crane started behaving in an uncontrollable and potentially hazardous way. The block and hook were hoisted up to the sheave, when the auxiliary wire parted due to the forces applied. The block and hook were ejected forward until they hit a stair railing, approx. 4m forward of the sheave. Then the block and hook fell approx. 3m down to deck, and bounced before coming to rest. Six people were involved in the operation and found to have been at high risk had conditions been slightly different. Two crew were involved in un-hooking; three were in a nearby deck workshop with no barrier in place between them and where the block and hook landed, and the crane operator was in the crane cabin. When realizing something was wrong, the two personnel on deck quickly vacated the immediate area. No-one was harmed.

Yellow dotted line showing estimated movement of hook/block during the event

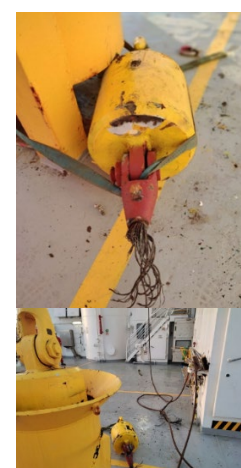
damaged hook, block & wire

The main crane auxiliary line encoder unit was damaged due to water ingress, and gave the wrong input to the crane, causing uncontrolled movements of the auxiliary wire as the crane was started up.

- Repairs:
 - The faulty encoder was replaced with a new encoder with drain plug;
 - The crane was repaired and inspected by the crane manufacturer. In addition, an inspection by a competent and independent third-party expert was carried out;
 - A safety bucket was installed on deck for the auxiliary crane hook. This will prevent use of anchor point which will then prevent need for personnel to un-hook at crane start up.
- Procedures and risk assessments
 - The risk assessments and procedures for crane operations (including barriers) were reviewed and updated;

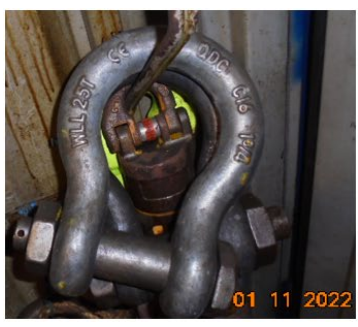
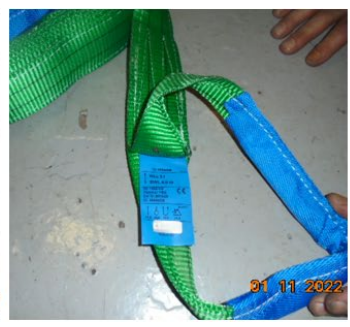
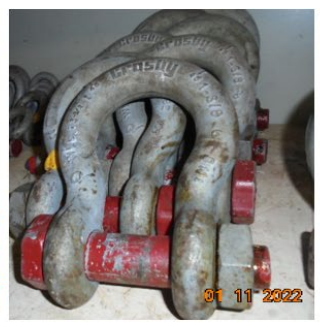
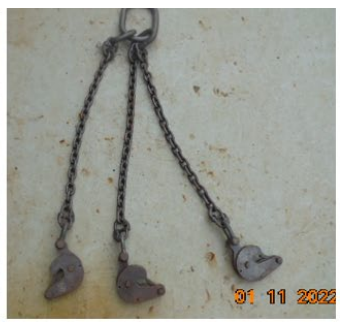
A number of shackles and other lifting equipment were observed in use onboard a vessel with no certification or inspection reports available. Some equipment was colour coded by the crew and deemed as being in good condition; other equipment was not included in the vessel lifting gear register, nor was it colour coded. Further investigation revealed that lifting equipment had been left onboard and not removed after the end of the previous project, on which client-supplied lifting equipment was used.

- Company lifting equipment inspection processes were not followed: *“Authorized competent person to conduct the lifting gear inspection process on an 6 monthly basis with further issue of inspection report”*;
- Client-supplied lifting gear was not removed from vessel, nor quarantined;
- This same equipment was not presented to the vessel lifting gear inspection onboard, conducted by the lifting inspection contractor;
- There was a lack of awareness of both relevant lifting equipment regulations and of local and corporate safety management system standards.

- An overall check of the lifting gear and relevant equipment was initiated and all identified non-compliant equipment was quarantined;
- Onboard discussion arranged for crew to better understand:
 - There should be no use of lifting equipment unless it has been thoroughly examined, tested and certified;
 - Colour coding of lifting gear or equipment should not be applied by crew without there being a relevant certificate or inspection report available.
- All lifting equipment available on board to be presented during testing and examination provided by competent authorized party.

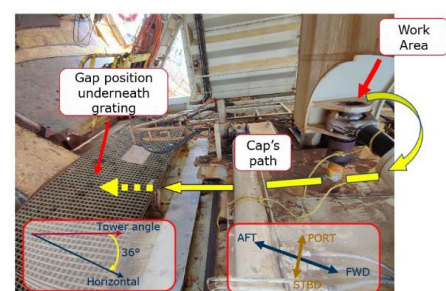
A hydraulic cylinder clevis pin "cap" slid from the tower during workstation maintenance and fell 14 metres into the dry dock. A team of technicians were working to remove a hydraulic cylinder on the workstation of the vessel tower. To remove the cap, seized to the cylinder pin by rust, one of them used a hammer; the cap bounced outwards and fell 40cm down onto a platform below. Due to the tower angle of 36° the cap then slid towards an uncovered gap and fell to the dock bottom. A

Path of 1.1 kg cylinder pin cap

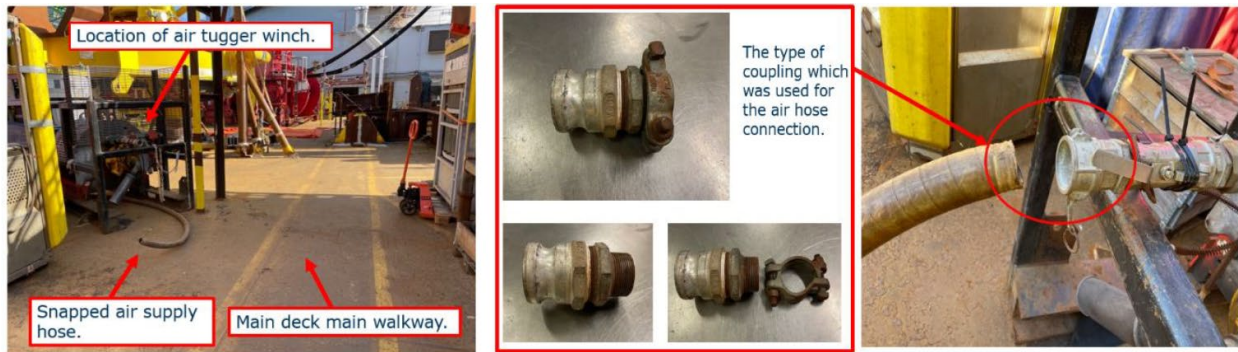
An air supply hose on an air-driven tugger winch snapped out under pressure from the cam lock adapter. A main deck air-driven tugger winch supplied through a 5cm air hose with a nominal pressure of 8 bar was connected by a cam lock coupling to the winch. This arrangement had been in place for several months. Shortly after using the winch the supply hose ejected from the cam lock adapter.

- The wrong type of adapter had been installed on the air hose. Why this was, could not be determined;
- Investigators assumed that the final check to ensure that the work equipment could be operated safely had been not performed properly, since a pre-use visual check should have highlighted the issue;
- The “male thread” adapter was inserted inside the hose and had been tightened by a hose clamp using a “homemade” connection;
- Whip checks, also known as safety whiplash arresters, to prevent serious injury from hose or coupling failure were in place, but not installed correctly;
- A company internal safe use of work equipment assessment checklist had not been used and filled in as required;
- There was inadequate maintenance, control and supervision on materials and equipment used.

- The crew installed the correct type of coupling as an immediate corrective measure;
- Install “hose barb” type cam lock adapters according to the manufacturer hose couplings and accessories specifications;
- Always use whip checks at each hose connection and from equipment to hose to prevent serious injury from a hose or coupling failure;
- Ensure regular, adequately resourced, and planned maintenance of equipment;
- Re-emphasise the hazards of stored pressure.

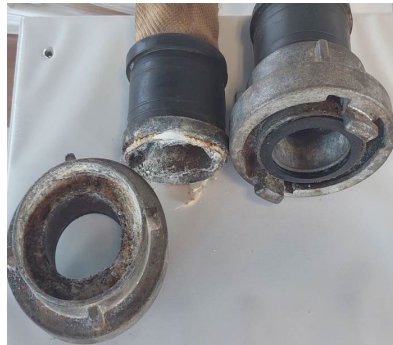
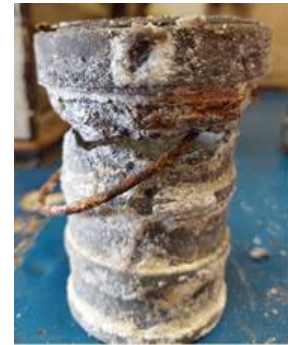
Electrolytic corrosion. Initial investigation indicated that this hose appeared to be of a different type from most of the hoses onboard which were made up with an aluminium 'floating' flange. This hose had a Storz 'C' coupling, which was thought to have flanges fixed to the hose neck. Removal of the rubber sleeve covering the seizing wire revealed conventional Monel seizing wire, and indications were present that water had been retained in the fabric outer sleeve under the rubber sleeve.

Inside the coupling, a steel retaining ring was found buried in the powdery aluminium oxides, confirming that the coupling was in fact the same as the others onboard. But due to corrosion, the floating part was tightly seized on the hose barb shaft.

Damage to failed fire hose coupling

- Examine existing fire hose couplings for corrosion, seized floating flanges, and any inability to rotate freely;
- If replacement is required, ensure appropriate fittings are specified – brass may be preferred over aluminium;
- Ensure planned maintenance systems cover appropriate detail for the inspection of fire hose fittings, with specific reference to examination for corrosion;
- Ensure that all personnel involved in the day to day use and maintenance of fire hoses are briefed on the potential issue of electrolytic corrosion.

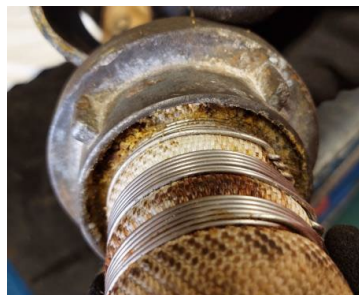
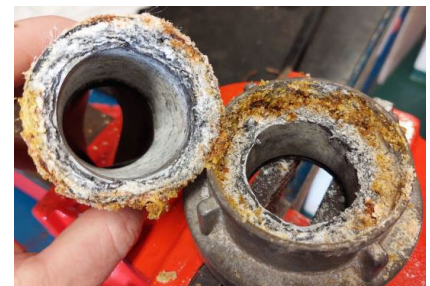
Investigation of the coupling from the other end of the hose showed no immediate signs of concern. However, there were some small pitting marks evident on the inside of the hose neck and removal of the rubber sleeve showed more indications of corrosion. Attempts to free off the floating flange caused the fitting to fail. It was also noted that corrosion was almost as advanced on this coupling as on the fitting which failed.

Second end of hose, fitting in similar condition
