## 1 Compressor fire

**2 Near miss: Foreign body in diver’s helmet, resulting in fall of gas pressure**

## 3 Battery explosion during routine maintenance

#### 4 Poor control of work in dry dock

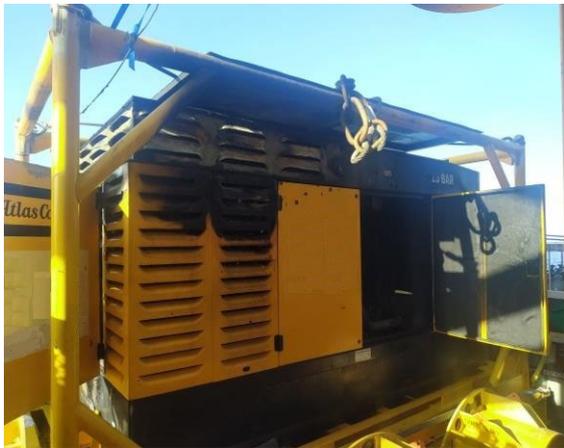
There was a fire in a 25bar high flow diesel driven screw compressor installed on the back deck. The incident occurred on a diving support vessel operating within the 500m zone of a platform. The compressor was a long-term rental unit being used to provide ancillary air for subsea operations. It had had been running for 30 minutes at the time of the fire, and there were no indications of anomalies leading up to the incident. The fire was extinguished quickly and safely. There were no injuries.

*Compressor on deck*

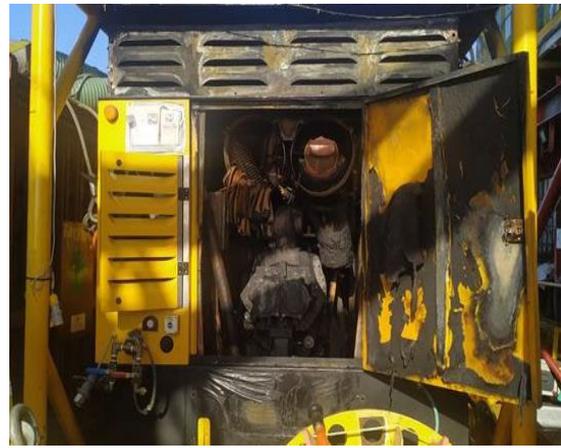
*Damage to interior of compressor*

- There was a short circuit within the compressor electrical junction box, which melted insulation on cables both inside and outside the junction box;
- The radiant heat from the melted wires compromised the integrity of a nearby oil scavenger line;
- The scavenger line end fitting parted, which released compressor oil under pressure inside the compressor cabinet. This oil ignited, causing a fire which was fed by air being drawn across the compressor by the engine cooling fan.

- The Original equipment manufacturer (OEM) maintenance regime did not require the physical testing (i.e., insulation resistance checks) of wiring at each major service interval;
- The hired compressor was considered “standard equipment” within the company and did not require detailed pre-mobilisation inspection/surveillance activity;

- When procuring temporary equipment to be used in the offshore environment:
  - Assess the potential fire hazard, and if applicable check the unit for in-built fire suppression capability and audible/visual alarm system set-up;
  - Temporary equipment used in the offshore environment should be considered as non-standard, and procurement of such equipment should be subject to careful and appropriate checks;
- Before mobilizing mobile deck equipment onto vessels, consider the required inspection/surveillance necessary, inclusive of any run-up test and review of maintenance and operational history;
- Once temporary mobile deck equipment is mobilised, ensure that a safe use of work equipment assessment is completed;
- Deck plans should reflect the safe positioning of equipment and consider requirements for exclusion zones around adjacent equipment in event of fire.

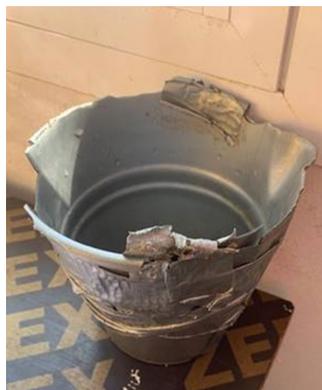
- A foreign body found its way undetected into the helmet during pre/post-dive cleaning. It is thought that the likely cause was the foreign body – a small shard of plastic - entered the regulator body and restricted the action of the lever arm.
  - The bowl or utensil used for cleaning helmet parts was an old and broken plastic pot;
  - The foreign body was identified as being part of the old and broken plastic pot used as a cleaning utensil;

*Plastic pot used to wash the internals of the hat.*

Inappropriate or sub-standard cleaning technique for such an item as literally vital as a diver's helmet.

- Consider how something so minor could have such an impact on a diver's gas supply;
- Reiterate the importance of pre-dive checks and of the need for absolute cleanliness in divers' life-saving equipment;
- Our member introduced spray bottles to eliminate the chance of particles entering the helmet during cleaning.

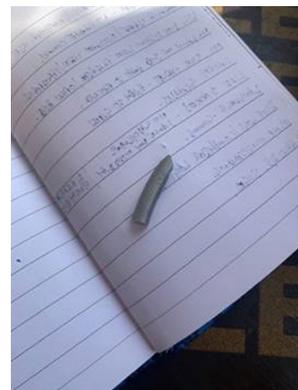
*Foreign body from the plastic pot broken off (22mm).*

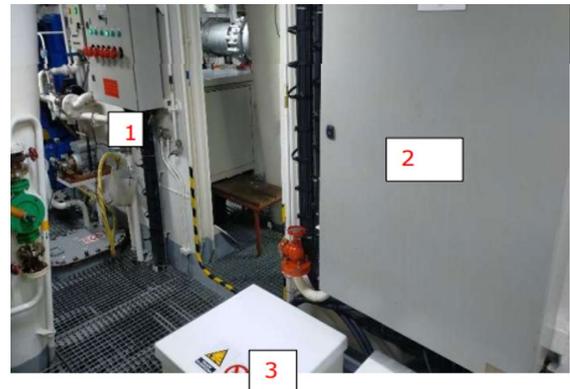
1. Battery disconnect switches
2. External power supply
3. Battery box

A chief engineer suffered minor injuries in a battery explosion when disconnecting a cable from the battery. The incident occurred onboard a harbour tug. The chief engineer was planning to replace a battery disconnect switch that had failed. While disconnecting the positive terminal, both terminals were inadvertently short-circuited with a spanner and the battery exploded causing injuries to the chief engineer. Operations were stopped, first aid was given and the tug returned alongside. After assessment at hospital the chief engineer returned to the tug with only minor injuries. The tug was out of service for four hours.

The battery was inadvertently short-circuited with a spanner.

- Protect battery terminals with plastic caps to avoid accidental contact;

- Ensure proper PPE (gloves, apron, face shield) is used when working on batteries;
- Consider the use of tools appropriate for battery handling;
- Changes to vessel planned maintenance system:
  - Follow manufacturers recommendations for battery maintenance;
  - Increase the frequency of battery maintenance inspection to gain better control of batteries in a poor state;
  - Consider the installation of battery chargers with temperature sensors.

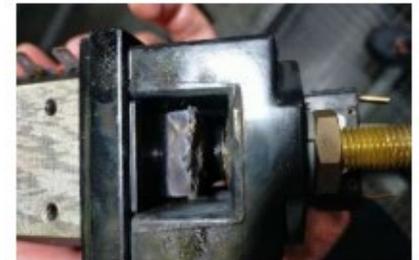
damaged switch

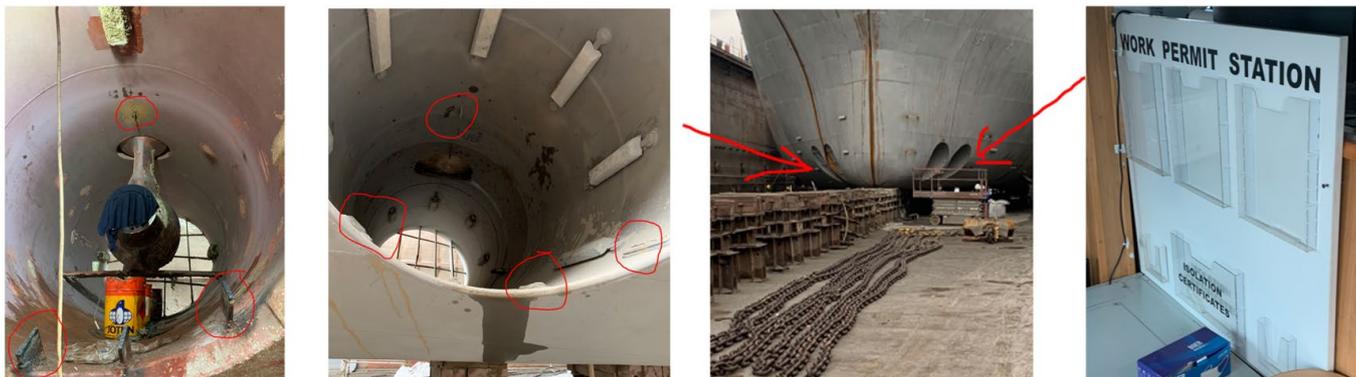
Examples included mesh cutting, pad-eye welding works on a vessel’s hull, and an empty PTW station.

Discussion revealed a significant misunderstanding amongst the crew, that activities conducted outside the vessel and in the dry dock itself would be controlled by contractors with no involvement of vessel management. The potential hazards to vessel and crew were not considered.

- Lack of control of third-party activities: contractors working on the vessel hull were left unattended;
- Lack of Task Risk Assessment: risk assessment was too generic and did not cover task specific issues;
- Both company standards and procedures and locally applicable safety requirements were not followed.

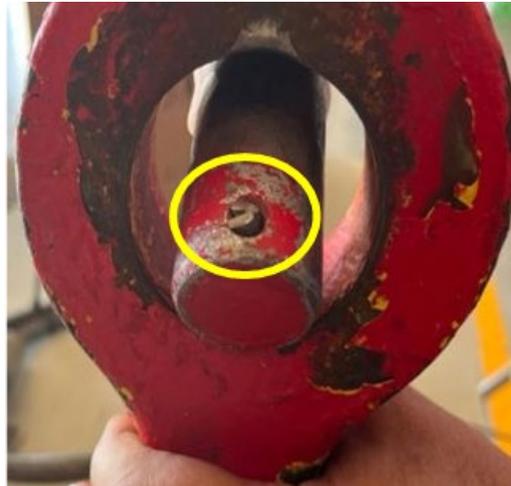
Figure 1

The incident investigation found that the cotter pin at the end of the hook pin had sheared (See Figure 1), which allowed the washer to fall and the pin to back out. When the pin backed out, it caused the ear on the connection to distort (See Figure 2), resulting in the hook failing. The investigation also found there was an inadequate pin configuration design. The pin installed on the hook assembly had a smooth composition (See Figure 3). The operator determined that a threaded bolt with nuts and keepers (See Figure 4) was the proper pin design for ensuring the stinger remains secure throughout lifting operations. BSEE notes that following this event, the operator inspected their other facilities and found the same improper arrangement on additional cranes.

- Inspect all cranes on the facility and verify that the hook assembly has a threaded pin with nuts and keepers;
- Retro-fit any stingers equipped with an improper stinger hook pin configuration;
- Verify all crane components are in alignment with current manufacturer recommendations;
- Add “assessment of the pin condition” into the pre-use inspection checklist, which should be completed before conducting lifting operations.
