2 Finger crushed under Tether Management System (TMS) protection guard

Engineering Advice Note (EAN) No. 183

URGENT SAFETY ADVICE - TMS8 SIDE PROTECTION GUARDS

3 Sudden and uncontrollable move of A&R head

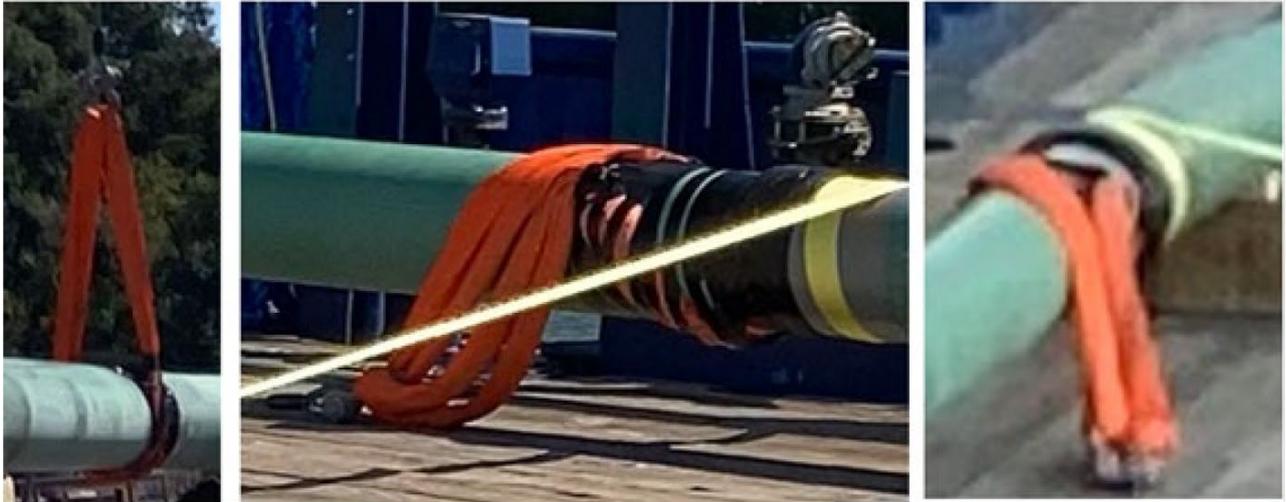
- A 4-ton lift bag was identified in the procedure but was not available;
- The inverter rigging was not one size fit all, as the bags were different sizes, thus creating a scenario where diver rigging was required to lengthen or shorten the existing rigging;
- There were changes of personnel during the job:
 - Superintendents were changed out;
 - The bell run was split such that the diver that de-rigged the spool was not the same diver as inflated the lift bag that came loose.
- During the job, a finger incident occurred on the bell clump basket, and there was a safety stand down.

Black Duct Tape added to “hold” the rigging in place

- Ensure one single person is accountable for rigging, reporting to the Superintendent and collaborating with the dive team;
- Improve management and installation of rigging configurations;
- Ensure written procedures are not generic, are up to date, and reflect the details of the task in hand;
- Minimise multitasking to eliminate distractions and fatigue;
- Be additionally vigilant and ensure there is thorough communication:
 - At crew change and at shift change;
 - Between shore-side or yard and vessel;
 - Between crew of different departments – dive, deck, bridge, project, etc.

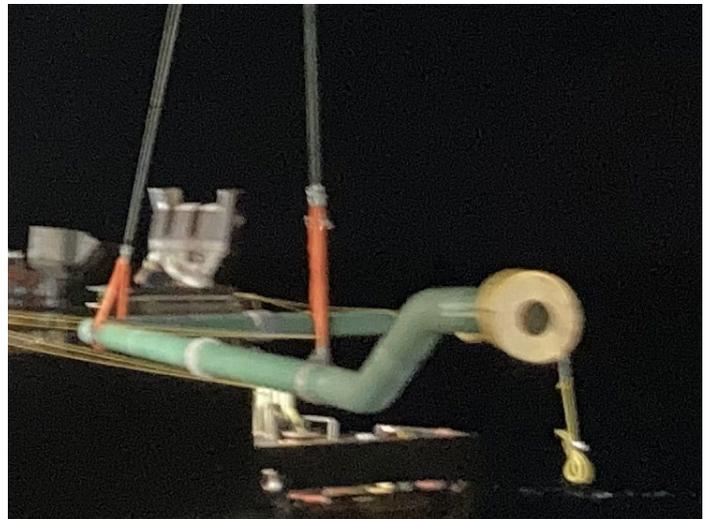
Note the middle leg is not choked, as per the drawing, change not noticed, nor articulated to the divers

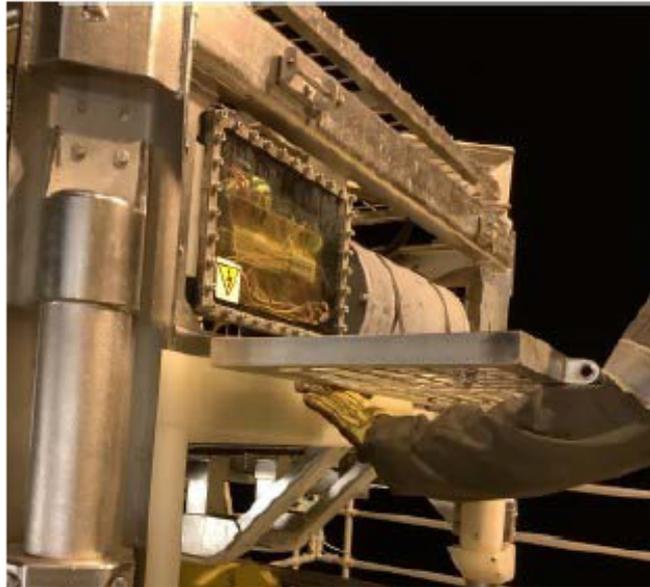
Picture #1

A worker suffered a crushed finger when the protection guard of a Saab Seaeye TMS8 Tether Management System fell on their finger. The worker was closing and securing the protection guard and lost grip on the guard. The guard fell down and trapped the left ring fingertip between the guard and the TMS frame. Upon removal of the glove it was identified the fingertip was damaged. The injured person went straight to the medic, who verified that the injury warranted hospitalisation, and the injured person was taken to hospital onshore.

- With the two top pins removed the TMS guard can fall down if not safely supported – as when grip is lost;
- It was cold; there was no weather protection – cold hands;
- The worker was keen to complete the task in hand;
- The worker was not wearing the correct type of gloves;
- The task not fully risk assessed; there was no specific procedure/training to follow for guard removal.

An incident occurred whereby a person working on a Saab Seaeye TMS8 sustained a finger injury as they were closing/locking a protection guard on the TMS8. The person lost grip of the guard and with only the lower pins being secured, the guard fell back down and the persons ring finger got caught between the guard and the TMS frame (see example picture #1).

The design of guards and securing method is under review for potential improvements. In the meantime a procedure for safe guard removal and refitting was generated and issued to all TMS8 owners as detailed in the bulletin copied at the foot of this incident.

Please follow the below procedure to remove and refit the guards in order to prevent this type of incident from reoccurring.

- Correct PPE to be worn when handling the guards.
- 2 people are recommended for safe removal and refitting.
- Never remove the top pins first as the guard will fall down if unsupported, risking injury or damage.
- Do not attempt to work with the guard only secured by two pins (either top or bottom).
- Do not prop or tie up the guard in any way.
- Complete removal of the guard from the TMS8 is required before any further work is carried out.

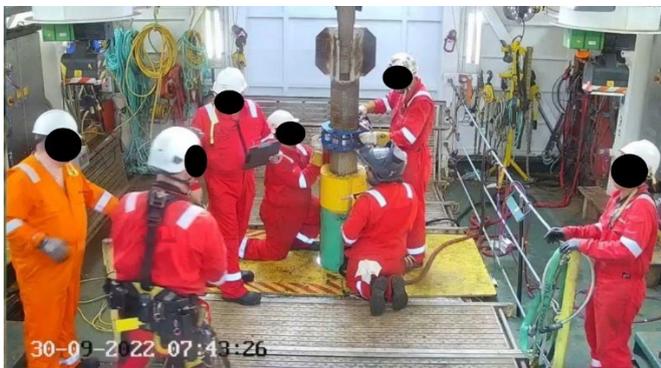
Crew members were nearby (see images) but no-one was injured.

Showing work area before event

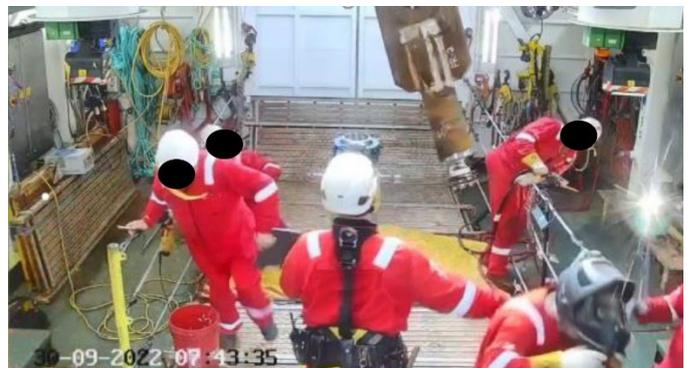
The A&R head was then lifted into position using the workstation crane. With the A&R head lifted into position, an external pipe clamp was used to help with line-up and to secure the head in the required welding position. As the final adjustments were being made, the A&R head assembly was moved upwards and then ejected in an uncontrolled manner from the pipe end. It swung uncontrollably for a short period but did not drop as it was still supported by the workstation crane. This was brought under control quickly by one of the deck team.

Showing A&R head ejected due to pressure

- There were no vent holes in the A&R head, as was specified by the client;
- The 'suck and blow' effect from the residual water in the pipe had not been recognised as a risk, as this incident/event had never occurred at this magnitude before;
- There were more people present (and hence at risk) than strictly necessary.

- A renewed focus on controls, barriers, and risk management where Line of Fire risks have been identified;
- Can the task be done safely with fewer people present?
- Challenge norms and specifications and assess if they introduce changes with additional risks;
- Consider and plan for "suck and blow" effects for similar operations.
