## 1 Inspection notice from Crosby on certain products

## 2 Uncontrolled movement of spreader bar

### 3 Equipment starts unexpectedly

## 4 Near Miss: steam and water released from filter

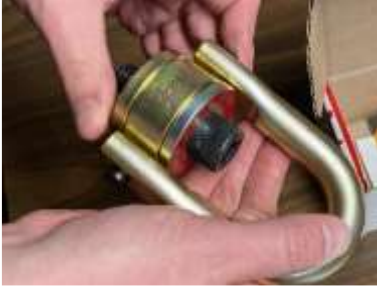
Locate hoist ring assembly and visually inspect for any issues.

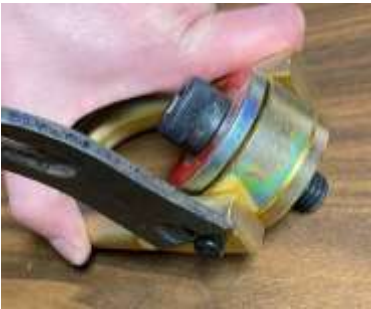
The inspection can be accomplished by taking a small flat rigid object (such as a thin pry bar) that can be inserted under the head of the hinge pin and prying outwardly on the hinge pin.

Alternately, the inspection can be accomplished by grabbing the head of the hinge pins (with small pliers) and pulling outwardly while twisting.

A small amount of axial movement of approximately 0.04" (1mm) may be detected, but the hinge pins should not come out of the bail and body of the hoist ring. Additionally, the hinge pins should not rotate relative to the body. Perform the inspection on both hinge pins.

If any hoist rings are found with inadequately secured hinge pins, please remove from service, and notify Crosby Technical Support at 1-800-220-8509 or [crosbytechsupport@thecrosbygroup.com](mailto:crosbytechsupport@thecrosbygroup.com) for immediate replacement.

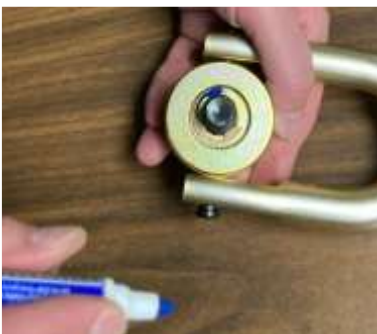
After the inspection, the hoist rings should have an identifier added, that indicates the inspection was performed and found to be acceptable.

In this case we placed a blue paint pin dot next to the E-Clip.

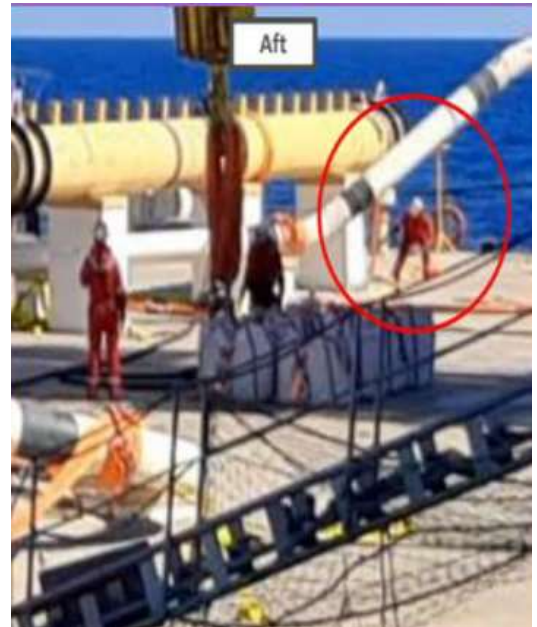
A vessel was set up alongside a barge in preparation for the subsea deployment of a 16" (40cm) spool. The spreader bar sea-fastenings were removed by the deck crew and as the crane raised the rigging, the spreader bar rotated uncontrollably causing it to fall from its supports, with the forward end landing on deck and aft end landing on the spool.

The potential for rotation was unforeseen; a rigger who was nearby had to move quickly to get out of the line of fire. There were no injuries.

- The roll potential was identified by the onshore mobilisation team; however, it was not communicated to the offshore team;
- The procedure and lift plan did not detail the correct sequence for sea-fastening removal and lifting;
- There was a failure to identify and manage change requirements;
- The design / drawings presented at the risk review were not detailed enough to allow robust assessment of associated risks;
- The hazard of roll potential was not identified at design stage and was not detailed in design requirements.

- Emphasise requirement to carry out a tool-box task before starting a task, and after a worksite inspection, so that all participants are made aware of all foreseeable hazards and implement suitable and sufficient control measures;
- Perform post-task debriefs, considering the following:
  - What went well?
  - What was different than planned or expected?
  - What could have gone better?
  - What surprised you?
  - What changes were made to address the issue or condition discovered?
  - What hazards/safeguards/issues still require follow up?
  - What would you change or do differently next time?
- Ensure sea fastening design requirements and the need for suitable technical review of full lifting operation is communicated.

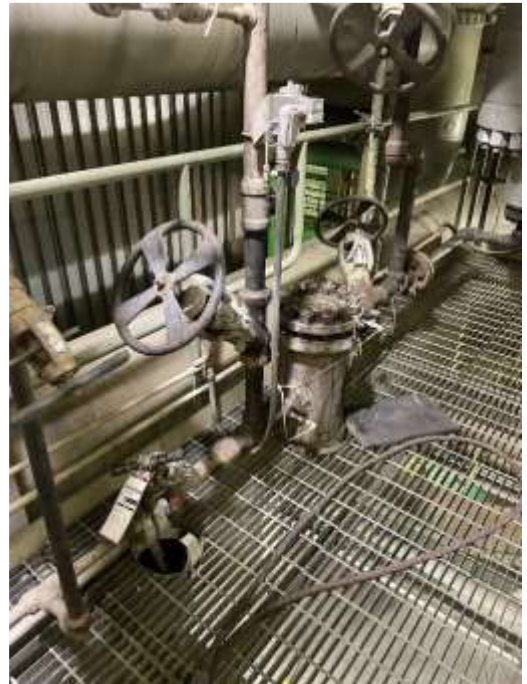
A mechanic was given a work order to clean out strainers from a boiler circulation pump. The mechanic was got to loosening the last two bolts, and stopped to wait to hear a “pop” indicating the lid coming up. The “pop” was a little bit more than was expected. As the mechanic waited for approximately 10 seconds, it was noticed that the pressure started getting more volatile with more air and water coming out. The mechanic moved out of the way, and called the control room to let them know what was going on. An operator and a supervisor responded and went to a valve that they thought might still be partially open. They attempted to try and close it. The supervisor tried with a bigger valve wrench and was able to turn the valve two more turns to close it off.

- The valve did not fully close when operations attempted to isolate it.

- Procedures were changed so as to open the bypass on the filter first, then isolate the inlet and outlet of the filter. Open drain valves upstream and downstream and then open the purge upstream and downstream, ensuring zero energy is exhausting.

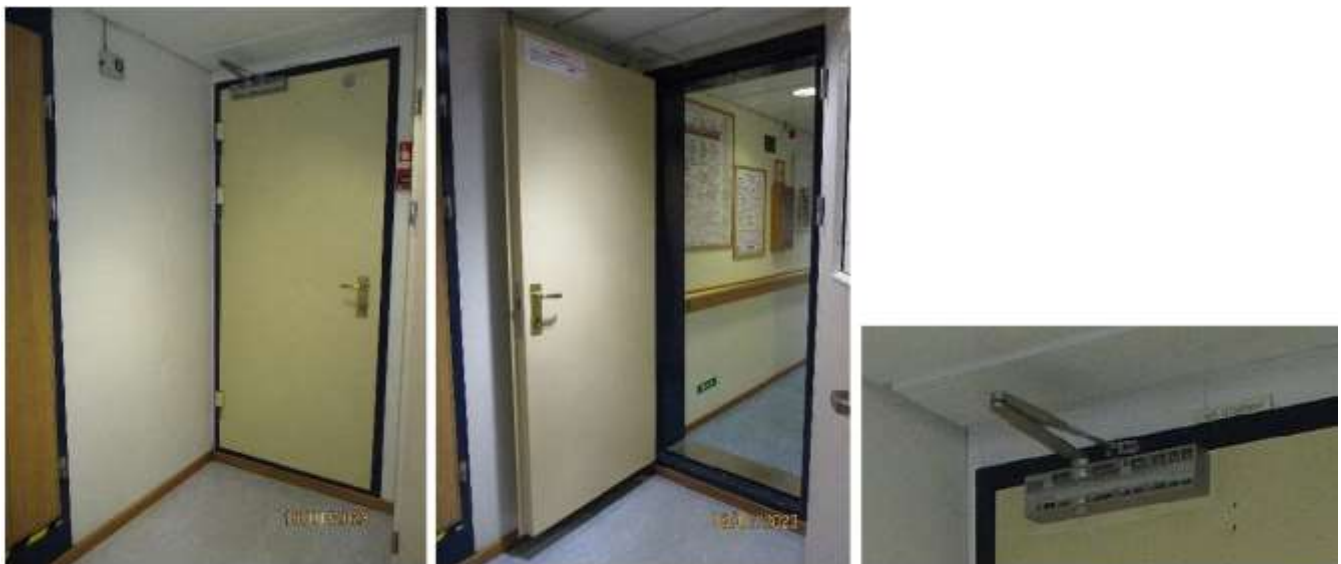
**Fire Doors and Closing Mechanism**

- Fire doors have been found to not close and seal properly;
- Fire doors have been modified to alter the speed of closure;
- Fire doors have been tied back to prevent closure.

- Ensure that no fire doors are modified or tied back to prevent closure or modify the speed of closure;
- Ensure all fire doors close automatically, by the self-closing mechanism and seal completely, including any hose ports;
- Ensure that routine maintenance and inspection regimes are followed;
- Ensure that where any defects are found, these are reported immediately.
