1 Differential pressure: dummy choke ejected close to divers

2 Crane boom stopper fell to main deck

3 Fire alarm activation in engine room

5 Close approach of AHTS vessel to offshore rig

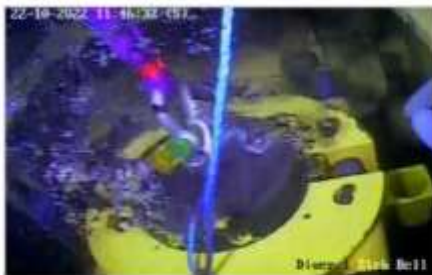
A dummy choke insert was ejected from a water injection (WI) tree by force of differential pressure, while divers were working nearby. A Dive team was removing a dummy choke insert and replacing it with a choke valve insert. The WI tree had been subject to hydrate remediation works. With no hydrates evident, limited trapped or pressurised gas was expected and tested barriers and isolations were in place. During the removal of the half shell clamps that retained the dummy choke insert, unexpected differential pressure from the flowline forced the dummy choke insert (85kg in water) out of the choke valve body at significant force. The two divers were loosening the clamp bolts around the dummy choke and were therefore close by when it ejected. Neither diver was in the direct line of fire; both were unharmed.

Image 1 – Initial gas release

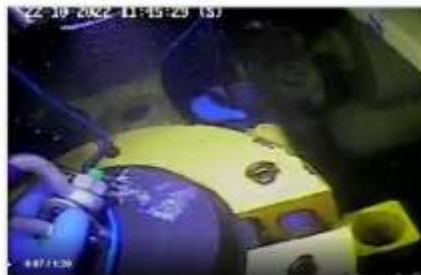
Image 2 – Diver loosening bolts

- Divers continued to work to loosen the clamp while gas/fluid was escaping from the choke, as the team had assumed that previous venting had been successful, and that they were safe to proceed;

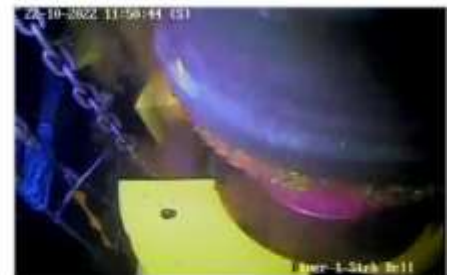
Image 3 – Dummy choke ejection

- During the design of the dummy choke insert, the decision was made not to include a test port, which would have allowed venting of any pressure built up in the flowline. The port was not part of the supplier's standard design, and there was not enough time to approve a design change to include the port;

- The project procedure instructed that the Subsea Pressure and Monitoring Manifold (SPAMM) should be left closed, so there was no local vent path from the flowline;

- When pressure differentials in the system were noted prior to the dummy choke removal, there was no recognition that readings were not as expected, and no discussions within the team relating to venting off the remaining pressure;

- Our member notes that *"the key point throughout was the failure to understand the exact pressure within the flowline, which was the residual 2 bar head of pressure from the riser after Floating Production Storage and Offloading (FPSO) venting"*.

- Design safety in at the early engineering phase of a project – in this case, inclusion of a test port;
- Ensure procedures and risk assessments are clear, unambiguous, and explicit in their requirements (rather than leaving things vague, ambiguous and implicit). This is particularly important when dealing with a pressurised system and/or with stored energy;

- Divers and Dive Supervisors should confirm a local vent is open before starting any work on pressurised systems;
- If any step in a procedure doesn’t look right (e.g., local vent to be left closed when working on a pressurised system), **STOP the JOB**: Call an all stop and seek clarification.

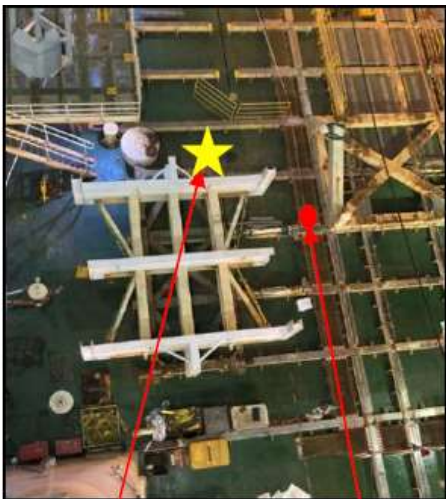
- The area where the knuckle boom stopper pad landed was not a restricted area, access up and down the deck was via a dedicated walkway, inboard of the boom, 5m away from where the boom stopper landed;
- The knuckle boom stopper pad was only attached to the backing plate by adhesive and then the backing plate bolted to the boom stopper frame structure.

Pad landing point - Banksman Position

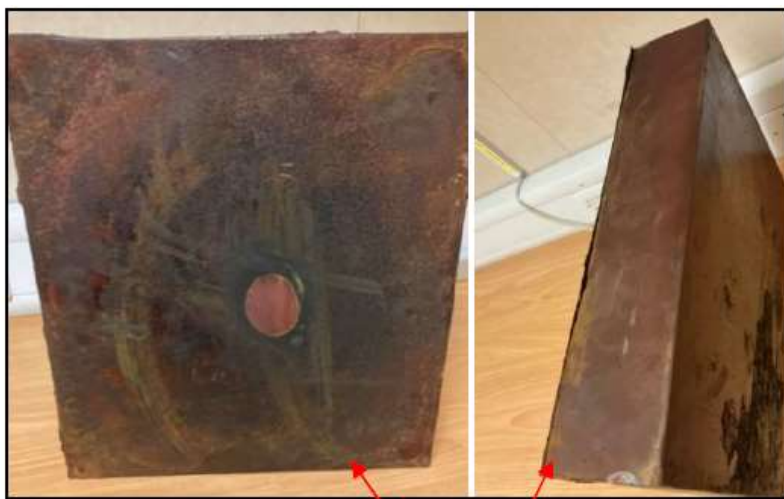
Knuckle boom pad

- Vessel technicians modified the backing plate by securing the boom stopper pad with 8 x M16 countersunk cap screws, Loctite and centre dab, and then it was reinstalled by a rope access team. The metal backing plate was

secured with M20 bolts using nyloc and Loctite, preventing any repeat of the boom stopper becoming detached.

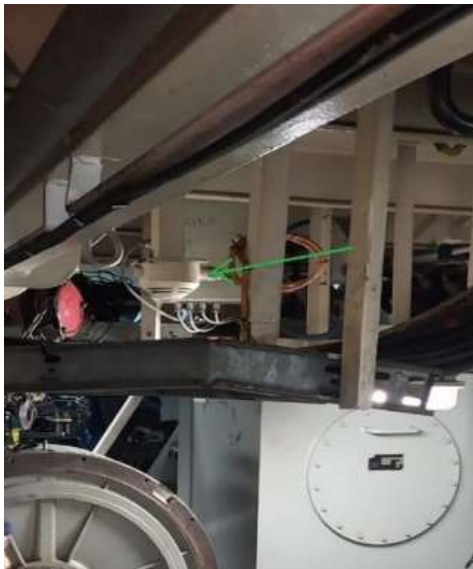
Smoke detector over the affected Shaft Generator

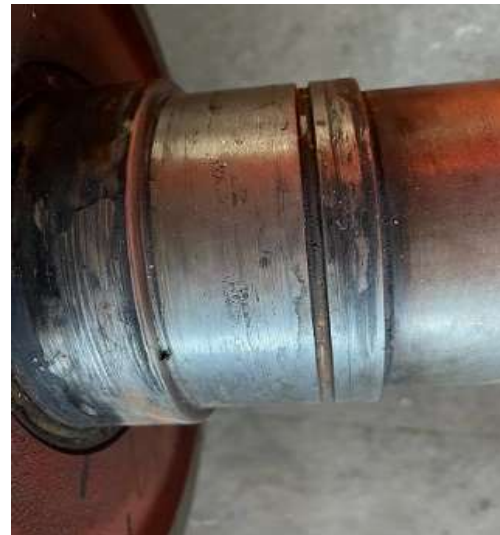
Rotor of Shaft generator/ failed bearing part caused overheating and smoke

- The temperature sensor installed in the Starboard Shaft Generator was providing inconsistent readings since the most recent overhaul; this had not been reported by the engine crew;
- Our member highlighted two particular concerns:

The smoke was caused by a failed diesel generator bearing. After disassembling the starboard shaft generator it was observed that grease in the bearing had overheated; this had generated dense white smoke.

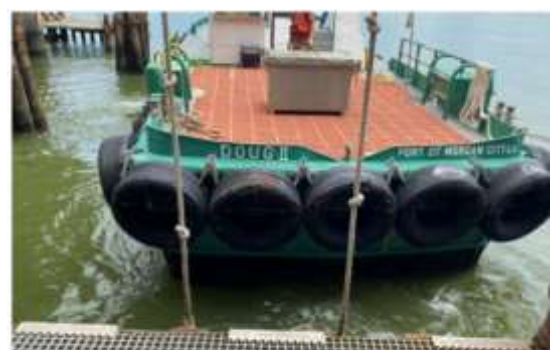
A recent example of an injury incurred during a swing rope transfer, is a fractured foot sustained by a worker attempting to use a swing rope to board a satellite platform from a work boat. As the Captain manoeuvred the boat, the worker placed his foot on a bumper tyre to position himself for the swing. The worker's foot slipped between the tyre and the boat when the tyre hit the platform, resulting in injury.

View of Boat Stern Where Swing Rope Injury Has Occurred.

- All offshore personnel transfers are treated as stand-alone operations;
- Formal risk assessment is conducted before a transfer occurs;
- There is “Stop work authority” for all persons involved.

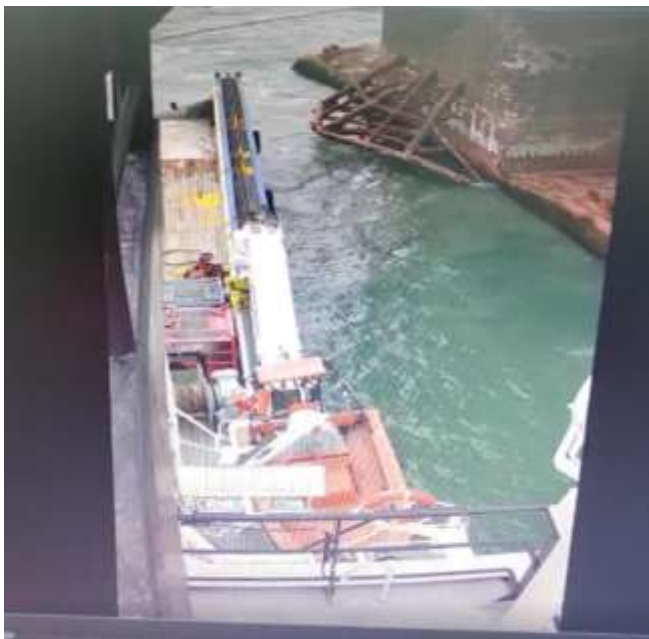
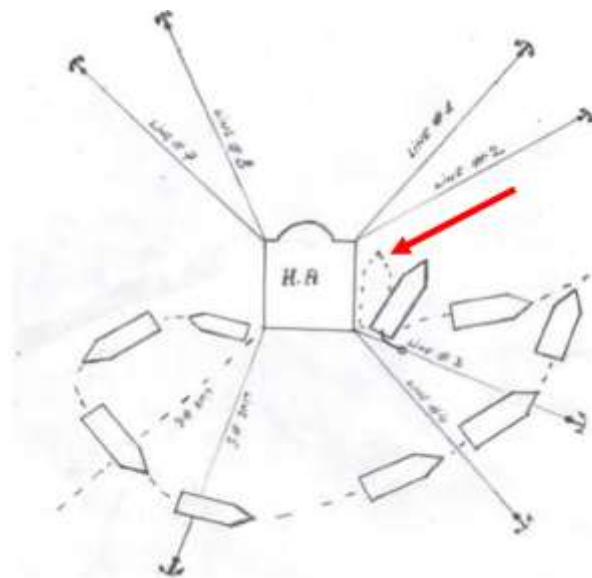
An AHTS vessel made a close approach to the mooring lines for an offshore rig. The AHTS was involved in anchor handling operations for the rig. The vessel passed anchor line #6 to the rig and started to move towards anchor line #3. Control of the vessel was transferred from forward to aft console. Once in position, the vessel received the PCP (Permanent Chasing Pennant) of anchor line #3 by rig crane and it was secured on the Karm fork. The rig’s crane was released, but the chaser’s collar slid on the anchor line towards anchor #3 and pulled the stern of the vessel to starboard, resulting in a bow side close approach to mooring line #2.

A line drawing showing the AHTS vessel’s movement from anchor line #6 to anchor line #3

- Further review identified that the bow thruster electromotor was off. Machinery required for safe manoeuvring of the vessel had been disabled. The electromotors for the tunnel thrusters had been switched off by the chief officer to rest the machinery as the vessel was leaving the 500m zone. This fact had not been communicated to the Master;

- Ensured that critical vessel equipment is not switched off or its operational mode changed without the approval of the person in charge on the bridge;
- Manual transfer of vessel control to be followed by mandatory thorough checks of all propulsion relevant to the operation;
- Developed comprehensive work instructions for bridge transfer control.
