1 Hand injury while using manual torque tool

2 Loss of redundancy in diving bell launch and recovery (LARS) PLC system

3 Hand injury in medical airlock

4 Painter line snapped and hit crew member in the face

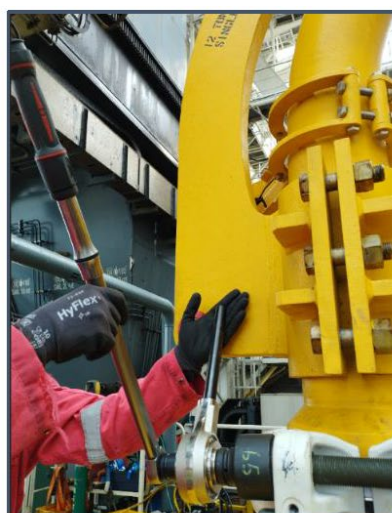
A deck engineer was torquing Grayloc clamp bolts connecting the gooseneck connector onto the second end of a flexible, using a manual torque wrench with a force multiplier attached. A project engineer was in the moonpool area to verify the torque settings on the wrench, as stipulated in the task plan. The project engineer stepped in to assist the deck engineer and they began torquing the bolts together. During the torquing of the last bolt, the project engineer placed his left hand on the reaction bar of the force multiplier as torque was being applied. His hand slipped and was trapped between the reaction bar and the gooseneck causing a hand injury.

Photo #1: Injured Party (IP) hand placement at time of incident

- Ask yourself “What should have been done differently?” to prevent this injury event?
- If it’s not safe, stop the job!
 - Reinforce the expectations with supervisors to stop work if workers from outside the assigned and briefed work team become involved in the task. The natural inclination may be to offer to help: this is not always safe or appropriate;

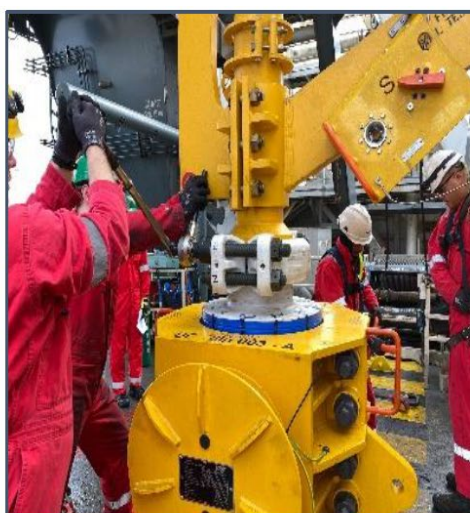
Photo #2: Personnel Positioning

- Those supervising and those in control of the task did not intervene when the project engineer got involved in the work;
- The pre-job briefing received by the injured person before travelling offshore did not include any advice, in terms of roles and responsibilities, on what activities project engineers do and do not get involved in;
- The project engineer who was injured was not involved in the deck engineer's Toolbox Talk (TBT) even though he had a specific role in the task plan to verify the torque tool settings;
- The project engineer was not trained or qualified for the task he was participating in.

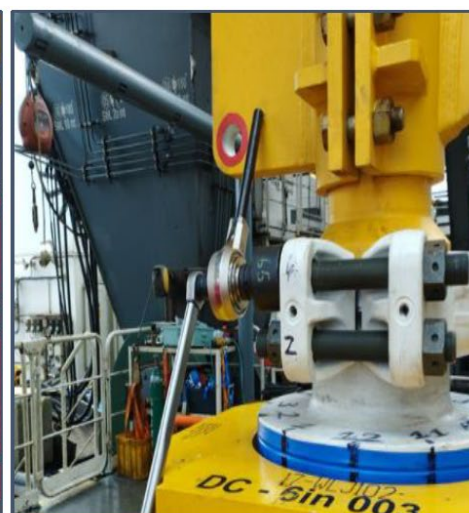
Photo #3: Manual torque tool with force multiplier

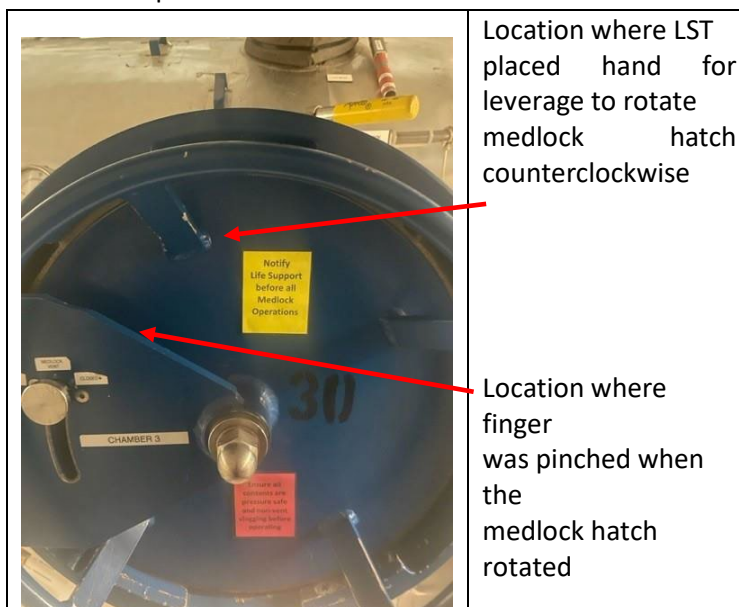
An LST (Life Support Technician) suffered a finger injury whilst operating the medical airlock ("Med-lock") on a dive chamber. The LST (Life Support Technician) was closing the Med-lock door but was unable to rotate the door to the fully closed position, indicating that the hatch needed to rotate further clockwise. The LST attempted to rotate the hatch counterclockwise in order to be able to open the door and inspect it. The Med-lock was stiff to rotate. For leverage to assist with rotating the Med-lock, the LST placed his hand on the flat bars that brace the operating wheel. The hatch moved suddenly and because his hands were on the brace and not on the wheel itself, his hand got pinched between the brace and the Med-lock door hinge plate, causing an injury.

The hatch was stiff, and the LST had his fingers in the wrong place at the wrong time.

Location where LST placed hand for leverage to rotate medlock hatch counterclockwise

Location where finger was pinched when the medlock hatch rotated

- Maintain proper lubrication on the door. Added Med-lock maintenance to planned maintenance programme;
- Added warning signage to the Med-Lock, for appropriate hand placement, along with clear instructions;
- Updated the vessel familiarization to include Med-lock operations and demonstrate operations.

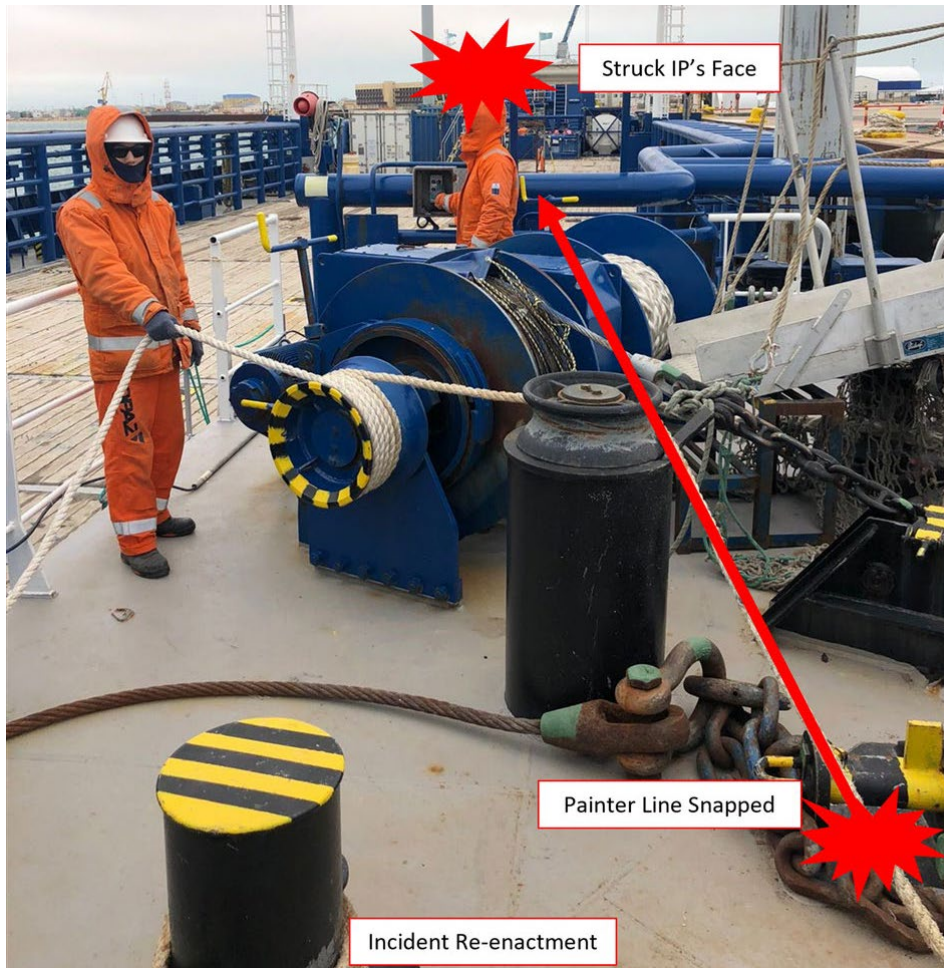
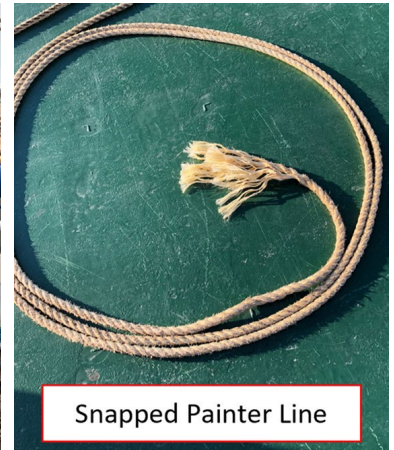
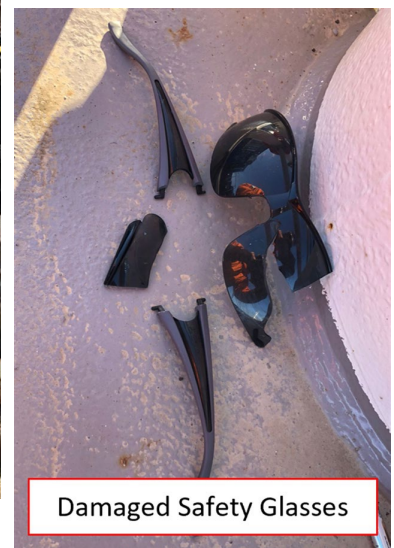
A painter line snapped during towing operations, and the flying end struck a worker in the face. The worker was wearing full PPE (helmet and safety glasses) and had it not been for the helmet and safety glasses there could have been a more serious injury. The safety glasses were destroyed.

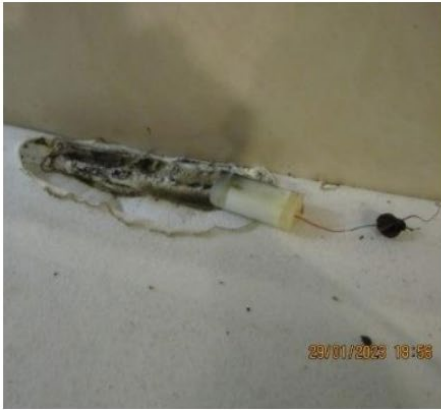
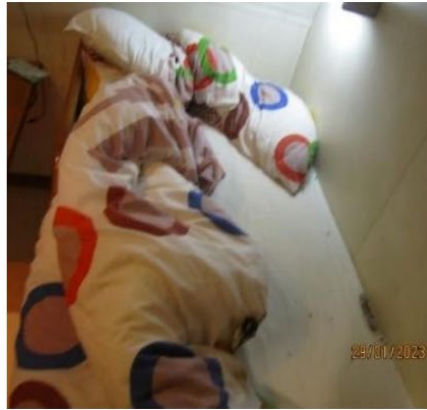
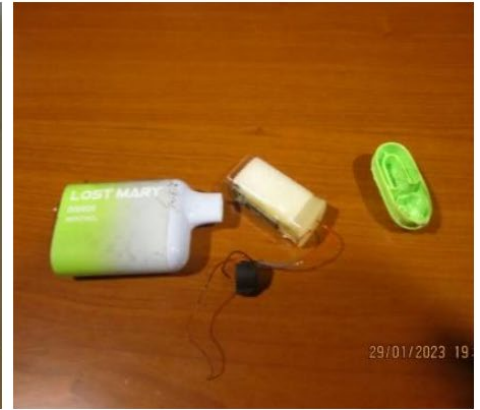
On investigation at the cabin in question, a slight smoke and smell of burning was noticed. The crew member explained that the disposable vape self-ignited on the table at which he was sitting in the chair with laptop on his lap. He immediately jumped and tried to extinguish burning vape with hands, but realising it was hot, automatically threw it onto his bed where the vape continued to burn on the mattress. He used two T-shirts to choke the fire.

- The company Smoking Policy, which forbade the use of e-cigarettes, was not followed; the company mandated that these devices should not be taken onboard vessels;
- The bedding used by the crew member in the cabin was not standard company issue, and thus did not comply with IMO SOLAS regulations.

- Ensure compliance with company policy on smoking and vaping, and the non-use of e-cigarette devices;
- Closer attention to e-cigarette devices when carrying out ISPS checks on board;
- Ensure bedding onboard is compliant with IMO SOLAS regulations.
