# MSF: Multiple LTIs - Vessel gangway fell from quay causing injuries

Safety Flash Published on 16 May 2025 Generated on 11 June 2025 IMCA SF 09/25

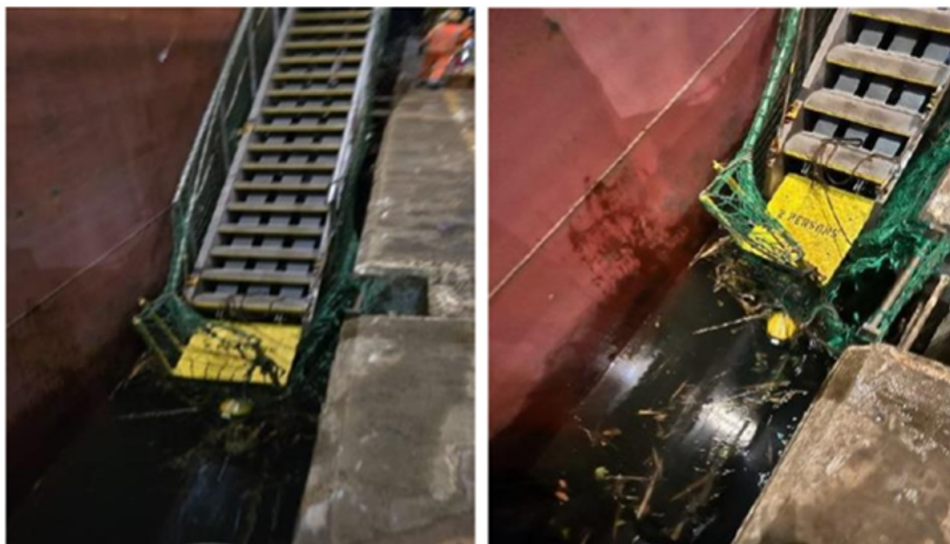
- Tidal movement of the vessel caused the gangway to move position, and the gangway roller encroached on the ladder void, causing it to be less stable.
- Vessel gangway procedure requiring supervision at all times, was not followed. At the time of incident, the gangway hoist wires were slack enough to for the gangway to drop approximately three meters.

- Markings on the quayside, around the ladder were faded and of insufficient colour and size to raise awareness of potential quayside hazard.
- The injured person was not wearing his chinstrap when going up the gangway resulting in him losing his helmet during the fall into the water, where he narrowly missed striking the quayside fender.
- A large painted sign showing the maximum load of the gangway was faded.
- There was no life buoy present at the lower part of the gangway supplied by the vessel as per local regulations.

- Position vessel gangways away from ladder voids.
- Review operations to ensure that written procedures are followed in practice.
- All employees must wear PPE correctly.
- All signs on the vessel and on the gangway should be clear in providing information regarding maximum load, capacity and potential hazards.
- Carry out pre-work gangway and vessel checks before work starts and at suitable intervals throughout.
- Encourage the use of **stop work authorities** if unsafe situations are observed.
- Review markings for quayside hazards such as ladder voids to ensure they are suitable.
