## Transport Malta: fatality after steel plates fell onto crew member

Safety Flash   Published on 16 May 2025   Generated on 11 June 2025   IMCA SF 09/25

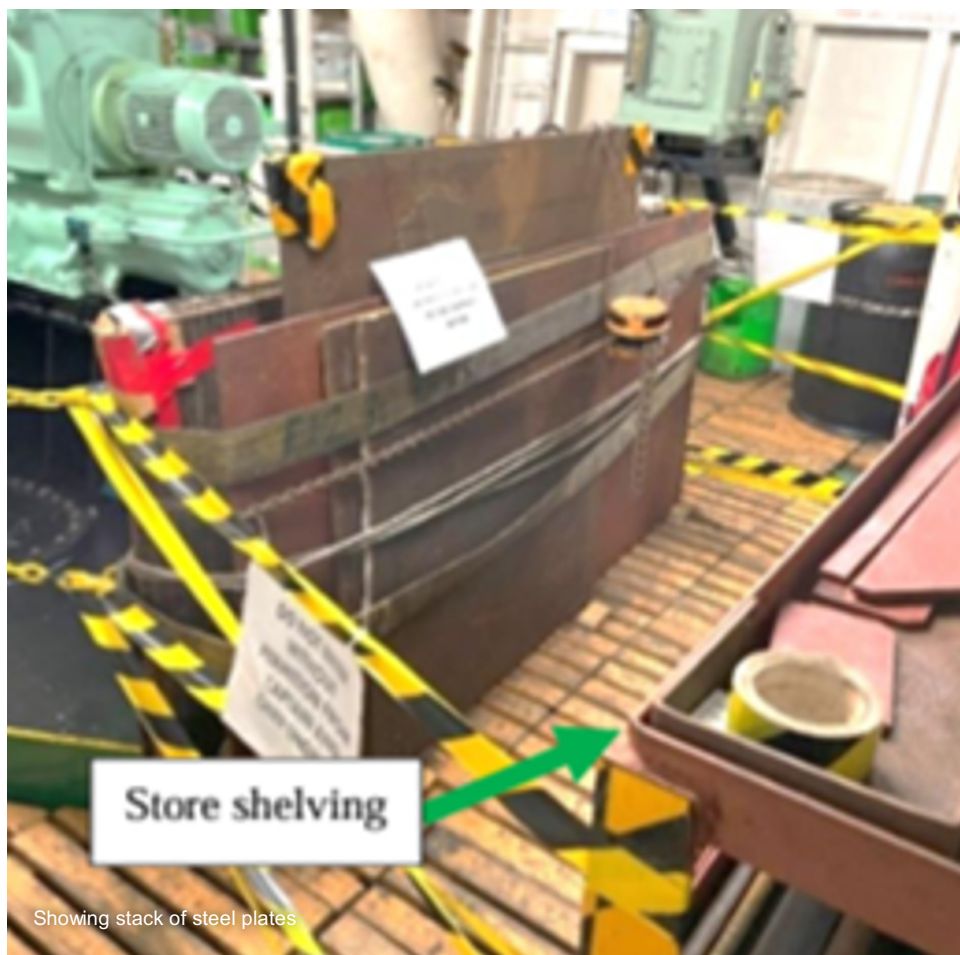
The safety investigation concluded that the second engineer was alone in the steering gear compartment. A stack of heavy steel plates that was stored vertically and free from its lashings, tipped over on him, possibly as a result of the natural movement of the vessel in a seaway. The weight of the plates meant that it was quite impossible for him to stop the plates falling on him, or to free himself. He was trapped against the store shelving in the steering gear compartment.

Showing stack of steel plates

- The incident occurred with no witnesses present.
  - Whatever work the second engineer had been or had intended to be doing, was unplanned.
  - The stack of plates had a total estimated weight of approximately 1.2 tonnes. The first plate seen in front of the stack weighed about 188 kg.
  - The lashings used to secure the stack of plates had been slackened.
  - The safety investigation identified several weaknesses and limitations in the arrangement.
- In order to select and take out a steel plate from the stack, the complete lashing arrangement had to be released.
- The stowage position and lashing arrangements of the steel plates did not allow for the use of either a hoist or lifting clamps to transfer / shift the plates safely.
- The second engineer was in effect “working alone” and there was no system in place for raising the alarm or getting assistance.

- Look closely and carefully at how to safely stow heavy steel plates – question the current arrangements. Could more safer and more formal

arrangements be designed for storage of steel plates?

- Are we storing spare materials on board that need not be on the vessel at all? Could spares themselves become a hazard?
- Look closely at work arrangements where crew members are, *in effect*, working alone.
