## Head Injury in Engine Room

Safety Flash Published on 14 August 2025 Generated on 14 August 2025 IMCA SF 14/25

A Chief Engineer sustained a head laceration injury.

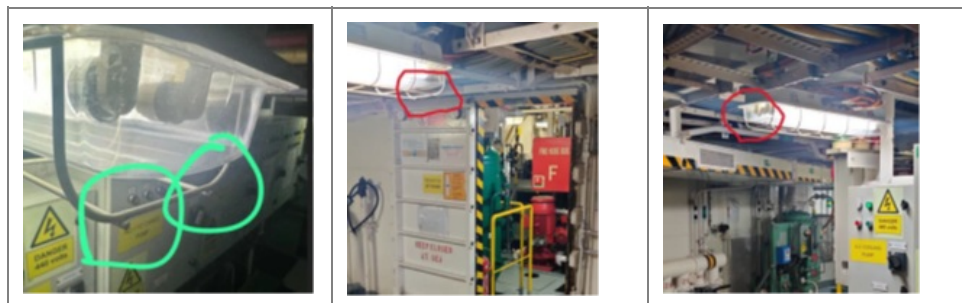
A Chief Engineer sustained a head laceration injury after accidentally striking his head on the sharp edge of a lighting protection grille rod installed at a height of 168 cm in the engine room.

*Location of lighting and lighting protection grille rod hazards.*

- The head-room was low, and the lighting protection grille was lower still at 168 cm above deck, posing a physical hazard at head level.
- The “protective” grille was itself harmful, with sharp, unprotected rod ends which created a risk of laceration or impact injury.
- No adequate PPE (safety helmet) was worn at the time of the impact, increasing injury severity.
- This obvious hazard was overlooked during installation and routine checks following installation.

- Consider a hazard hunt to identify all snagging points (risk to head/body)
  - Could there be some you hadn't thought of, or that were missed the first time around?
  - Reassess familiar spaces, not just obvious major equipment areas. What about the mess, the corridor in the accommodation etc etc.
- Can the hazard be engineered or designed out – that's ideal but not always practical;
- Can some form of protective pad be applied?

- Can sharp edges or low-hanging objects be appropriately marked?
- Does everyone know about the hazard? Is it worth a reminder at the tool box talk? “Watch out when you go past here, there’s a low bit where you have to duck to get through.”
- Think through hazard awareness and reiterate PPE use (such as helmets in machinery spaces).
