## Shore-side crane boom collides with vessel mast

Safety Flash Published on 14 August 2025 Generated on 14 August 2025 IMCA SF 14/25

During shipyard lifting operations, the boom of a dock crane made contact with the vessel mast.

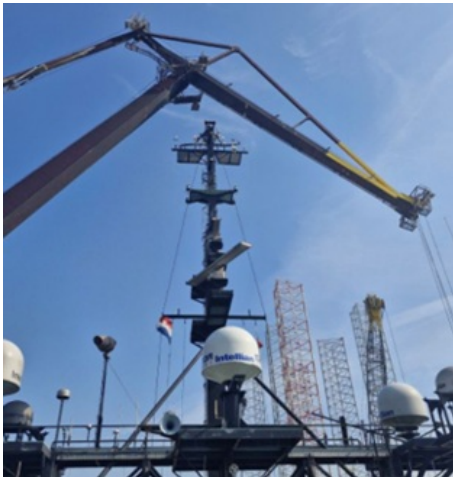
*Boom adjacent to mast after the incident*

- The yard crane operator was simultaneously driving the dock crane, slewing, and booming out, without maintaining visual control during the operation. This was in contravention of the yard's own lifting procedures.
- The dockyard crane operated independently, without waiting for signals from the banksman on the vessel.
- The banksman was not positioned to effectively observe potential obstacles.
- The dockyard crane operator lacked clear visibility and could not see any potential clashes.

- Ensure that all stakeholders – vessel crew, third party crew, dockyard crew, management - understand just how critical is the role of the banksman in lifting operations.
- It is vital to have clear communication between the banksman and crane operator.
- Ensure the dockyard management have received all the right information they need before the vessel goes into dock and before operations begin. This should include:
  - Vessel “General Arrangement” drawings, including details of potential obstacles;
  - Vessel dimensions.

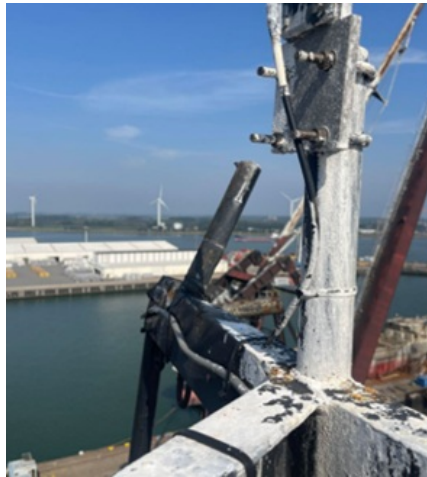
As a result of the collision, a wind sensor and GPS sensor were dislodged and fell to deck. Additionally, a fixing clamp was later found on the main deck, approximately 30m away.

*Damage on the mast*

This was a high potential incident; both the wind sensor and the fixing clamp could have struck a person, potentially causing serious injury or even fatality.
