Safety Flash

Dropped object due to over-ridden limit switch

Safety Flash Published on 2 October 2025 Generated on 3 October 2025 IMCA SF 18/25

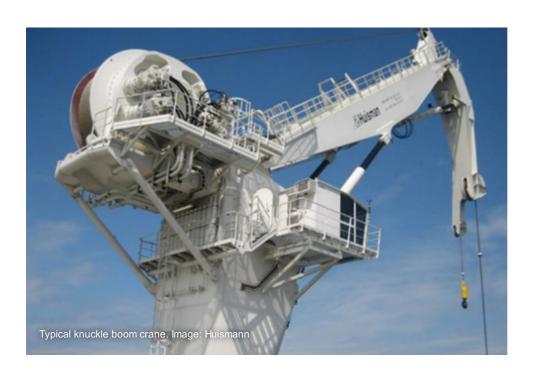
As the wire came in, the mini beacon (positioned just above the hook weight – weighing approx. 6kg) contacted the safety limit switch clump weight, resulting in the beacon coming loose and falling to the main deck (approx. 4m). One of the two wire restraints for the clump weight parted, and a cable from one proximity sensor parted. There were no injuries.

- The crane being used for the task was an Active Heave Compensation (AHC)
 Knuckle Boom design.
- This was the Crane Operator's first rotation onboard this vessel. However, the Crane Operator was experienced in the operation of similar AHC Knuckle Boom Cranes.
- During the lift the Crane Operator had the boom down and knuckled in, this reduced the length of wire usable to "lift" the load.
- The override function on the crane is activated via a screen and disables both
 a physical and software limit switch for the crane. Both switches are verified
 weekly as part of the ship's PMS. However it is worth noting that when the unit
 is in operation it is only possible to check the software switch function.

- Limit switches and safety devices are there for our protection:
 - Don't override safety devices (limit switches) as part of "normal" operations – where this is critical it should be handled accordingly with standalone risk management (i.e. through a Management of Change process).
 - If there is the temptation to override safety devices is present during "normal" operations, a re-assessment of procedures or re-design of equipment may be indicated.
- Procedures and equipment design should make it easy to do things safely
 and difficult to do things unsafely.
- Our member took the following actions:
 - Reviewed company lifting processes to ensure they adequately address:
 - Vessel Specific Familiarisation.

- Lift Planning for Knuckle Boom Cranes (i.e. using the characteristics of the crane to achieve the desired outcome).
- Maintenance / verification of safety systems while the crane is in operation.
- Management of handovers.
