# ATSB: Undocumented modification contributed to steam burns

Safety Flash    Published on 7 November 2025    Generated on 10 November 2025    IMCA SF 20/25

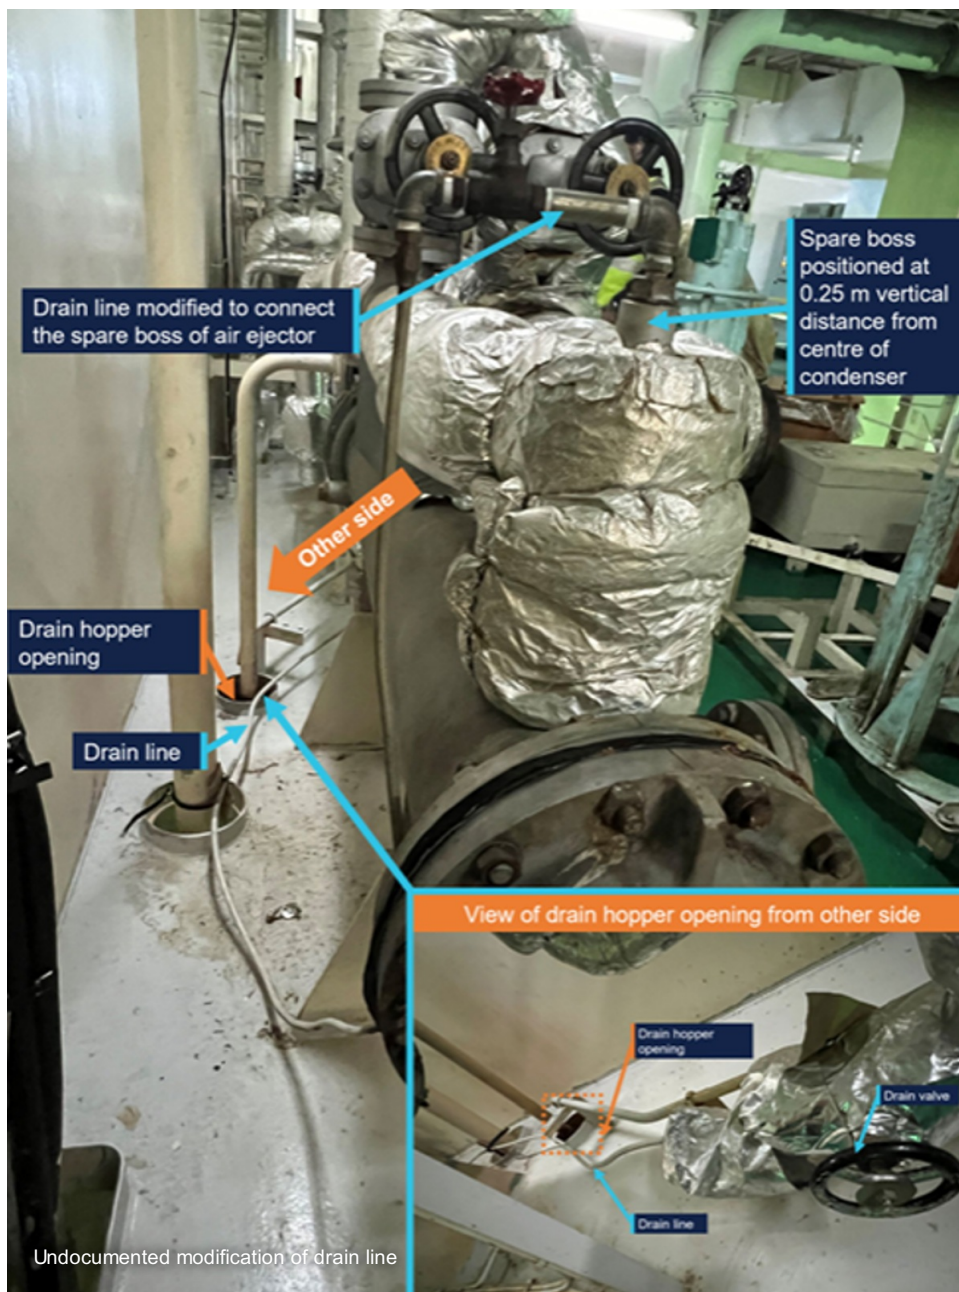
An engineering team was conducting maintenance on the main deck steam valve for the heating system of an oil tanker. After the system was isolated, the team removed the valve bonnet, and residual hot condensate was suddenly released, resulting in burn injuries to three crew members. After receiving first aid on board, the crew members were transported to shore for medical treatment.

- Investigation found the crew had not allowed adequate time for the steam system to cool before starting work on the cargo heating system main deck steam valve.
- The investigation also found a permanent modification to the steam drain line had been implemented on board this vessel without documentation.
  - The ATSB noted that this undocumented change, which was not incorporated into a risk assessment or formally reviewed, likely introduced a system vulnerability that undermined the effectiveness of the steam system isolation.
  - Moreover, the ATSB found the modification was not identified during routine technical inspections or multiple company superintendent visits to the ship.

- Since the incident, the drain line on this vessel was returned to its original

design configuration.

- A fleetwide campaign was started to identify any unauthorised modifications to shipboard piping systems.
- Crew were encouraged to remember that modifications should be undertaken only after appropriate consultation and always in accordance with a formal Management of Change process.
