## Smoke in the battery room

Safety Flash    Published on **7 November 2025**    Generated on **10 November 2025**    IMCA SF 20/25

**Smoke was observed in the battery room of a vessel alongside.**

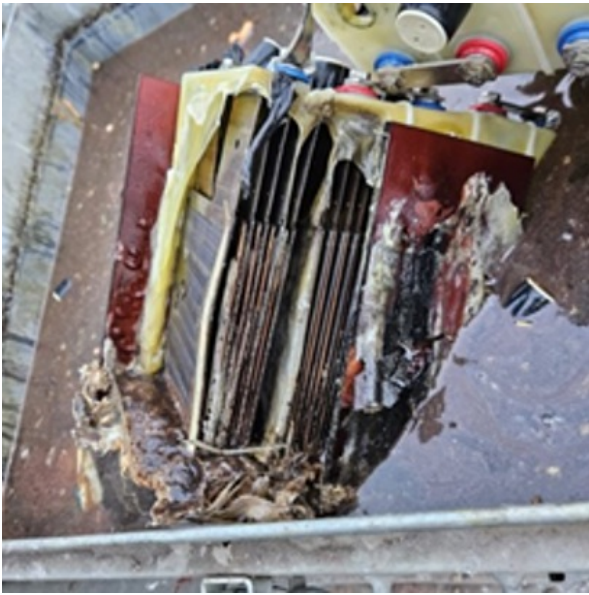
The batteries involved were manufactured in 2021. The batteries of this brand and type had been specifically selected for their robustness and resilience against higher ambient temperatures. The affected cabinet contained 32 Ni-Cd batteries configured across 4 shelves. Evidence of localized heating and off-gassing was observed without open flame. Closer investigation or investigation after the event showed chipping of plastic casings, likely from transport or installation.

*Damaged batteries*

- Battery overheating and gas accumulation: One Ni-Cd battery overheated, resulting in a chain reaction of gassing and smouldering across multiple units. The root cause could not be definitively identified but may relate to internal damage (chipped casings) during earlier transport or installation.

- Complete commissioning records should be retained for all critical power systems and any replacements or servicing done as part of the process should be documented. Any physical damage during battery transport or installation should be thoroughly assessed, even if minor.

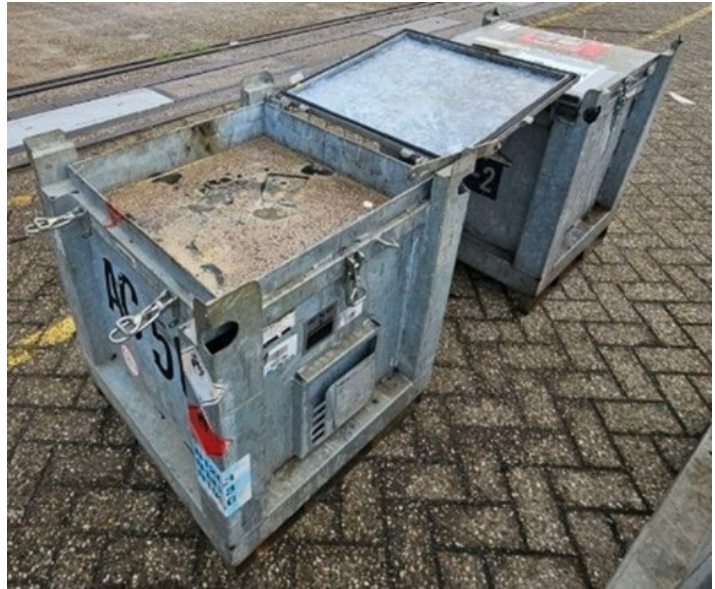
The event was brought under control by the onboard firefighting teams. Ventilation to the area was controlled and the relevant electrical circuits were isolated. The source of the smoke was identified as a set of overheated Nickel-Cadmium (Ni-Cd) batteries used for one of the UPS's (Uninterruptible Power Supplies) for the vessel's DP system. All damaged batteries were manually disconnected, removed and submerged in galvanized containers filled with water for cooling and containment.

*Faulty batteries safely removed from the vessel and submerged in water containers on the quay*
