MSF: Fast Rescue craft (FRC) washed overboard and lost at sea

Safety Flash Published on 14 May 2026 Generated on 14 May 2026 IMCA SF 09/26

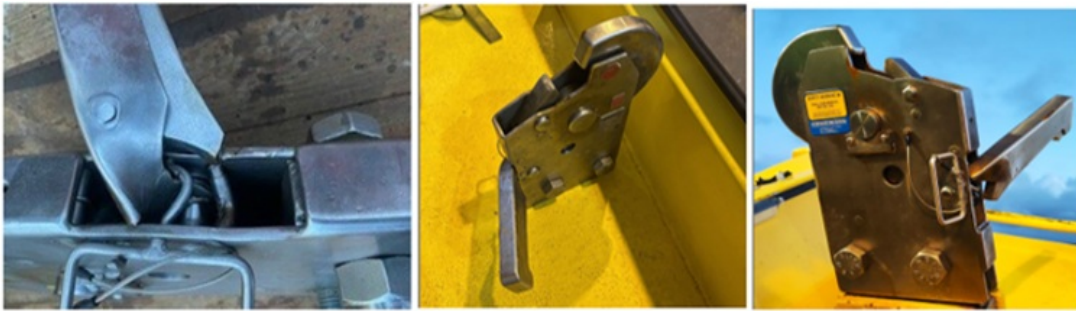
A vessel was proceeding from port to an offshore location when the port side Fast Rescue Craft (FRC) was washed overboard. An unexpected (rogue) wave impacted the port side FRC stowage compartment, which was swamped from abeam. The boat was immediately seen by the bridge watch to be in the water floating in a capsized condition. Video footage shows that the rogue wave reached up to and beneath the port side bridge wing. The boat could not be recovered at that time.

A large, unexpected wave hit the vessel from abeam. The wave forced the FRC upwards, impacting the davit with such a force that it severely damaged the hook release mechanism. The lashing straps for the FRC (2.5t) were under-dimensioned and worn out (5 years old).

During the onboard investigation it was confirmed that the davit hook and wire were still intact/undamaged, but the fibre lashing straps had been torn apart, and several davit components were damaged. The FRC was subsequently recovered and an equipment manufacturer report on the Henriksen type hook show that the arrangement had suffered plastic deformation of the hook body, hook element, and release mechanism consistent with an abnormal high energy impact, resulting in structural deformation. No evidence has been identified to suggest malfunction, wear-related failure, or spontaneous release under normal operating conditions

- The authorities and local Coast Guard were immediately informed.
- A temporary FRC was made available as soon as possible.
- Enhanced inspection of the FRC stowage and securing arrangements during weekly inspections, and when adverse weather is expected.
- Additional lashings may be applied in advance of forecast heavy weather.
- Periodic planned maintenance check of FRC lashing/ratchet straps (using 5t lashings), and planned maintenance routine to replace FRC lashings at 2-year intervals.
