1 Three crane incidents

2 Finger trapped and injured while working on heavy equipment

3 Machinery damaged through improper maintenance technique

4 Gangway damaged after unauthorised re-installation

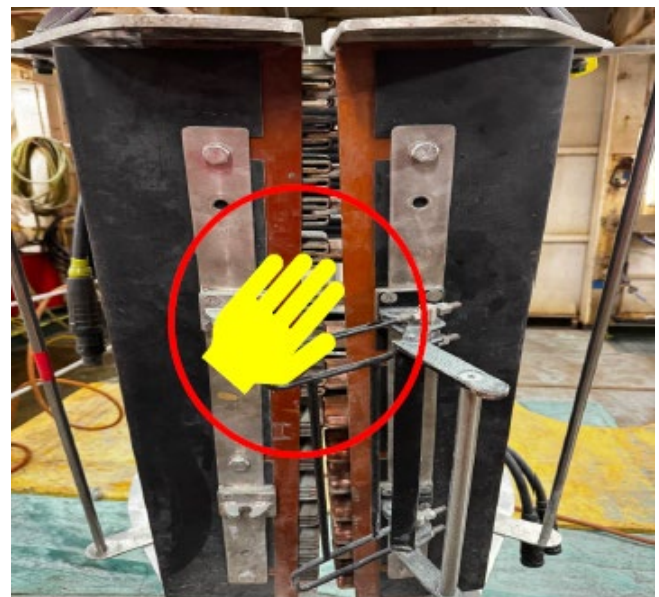
A third-party technician suffered a pinch injury to the right index finger. The incident – a Restricted Work Case (RWC) injury - occurred onboard a vessel while third-party technicians were conducting trials on pipelaying equipment. An Induction Heating Coil (IHC), suspended from a davit crane, did not open as intended. The technician, who was not part of the coating team, intervened to assist. During the intervention when the coil was subsequently prised open, the technician’s hand was placed near the closing joint. The coil then closed suddenly, pinching the individual’s right index finger.

- Change could have been managed better: The task was moved to a different work environment without a complete risk review, preparatory checks, or a formal Management of Change (MoC) process;
- Equipment could have been better designed: The lifting configuration did not fully align with the operational environment, and restricted space limited safer alternatives. Visibility of safety signage and labelling required improvement;

Showing the pinch point on the Induction Heating Coil

- Use of generic rather than specific documentation: generic documentation was used instead of task-specific controls. The lift was incorrectly classified, and the designated rigging was not used;
- Supervision: Roles and expectations across involved teams were not clearly aligned, which resulted in gaps in supervisory oversight;
- There were gaps in the contractor’s equipment assurance: Required compliance checks and supporting maintenance records for the contractor-supplied equipment were not available.

- Ensuring task-specific risk reviews, and use of the Management of Change process when the work environment, set-up or method of work is changed;
- Improved equipment design visibility and usability, ensuring controls and labelling are clear and safe to operate;
- Ensured appropriate levels of supervision to cover multiple, complex or simultaneous tasks;
- Ensured that Short Service Employees are given adequate support and supervision.

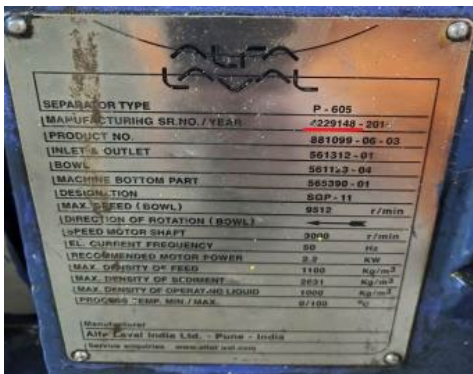
During an audit on an offshore vessel it was observed that the fuel oil purifier failed to self-discharge. Further investigation revealed that purifier bowl components had been swapped with parts from the lube oil purifier, with different serial numbers. After reinstalling genuine parts, the purifier showed excessive current flow and high vibration. Inspection confirmed mechanical damage to the bowl caused by improper dismantling.

Purifier nameplate, serial number ending ----148

- The procedures provided by the Original Equipment Manufacturer (OEM) were not followed.
 - Special tools specified by the OEM were not used, causing mechanical damage to critical parts. The purifier bowl and related components were dismantled without using special tools specified in the OEM manual;
- Compatibility of parts was not verified before installation. Parts were interchanged that should not have been interchanged. Parts with serial number linkage (bowl, sliding piston, cover etc.) were not freely interchangeable;
- Existing planned maintenance intervals were not followed;
- Maintenance documentation and traceability was found to be inadequate.

- Always follow the OEM manual and use specified tools for disassembly, assembly and maintenance;

- Carefully and thoroughly verify that you have the correct, compatible and genuine parts – in this case, using parts from another purifier may have led to excessive vibration/high current which may have damaged the whole machine;
- Communication and documentation: Keep detailed records with supporting documents of repairs and overhauls, with, where applicable, specific running hours and the condition of the unit;
- Use Stop Work Authority!

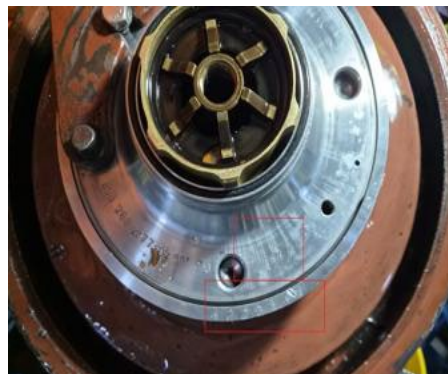
Bowl component parts, s/n ending ---147

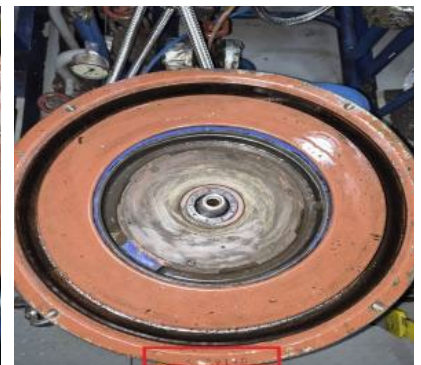
Purifier body, s/n ending ---148

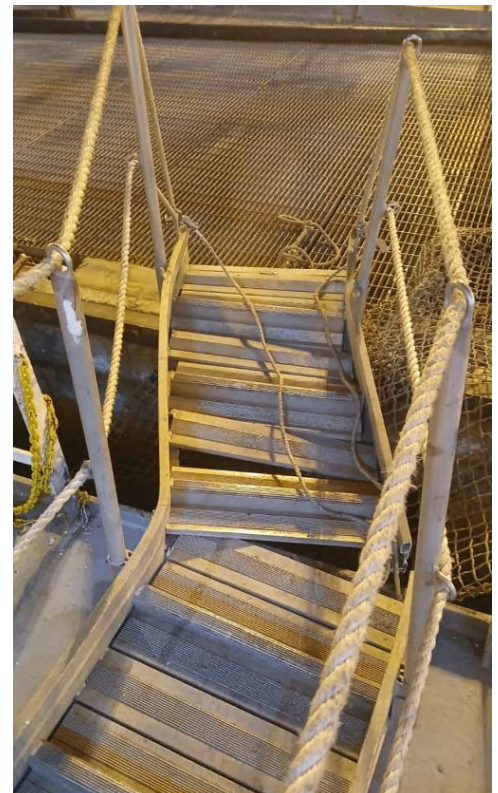
During cargo operations in port, a vessel’s aft mooring lines were found tightened. The port coordinator and third-party riggers were informed about temporarily suspending the operation. After the engines were ready, control was taken from the bridge, and the gangway was recovered onboard. While the deck crew was loosening the mooring lines, the port riggers that stayed onboard reinstalled the gangway without informing the vessel’s crew and then left the vessel. During subsequent vessel position adjustments, the unattended gangway was caught between berth and vessel, and damaged. No-one was injured.

- There was a failure in communication between the port coordinator, third-party riggers, and the vessel bridge. The bridge crew and deck crew were not informed of the gangway re-installation, and there was subsequent uncoordinated vessel movement;
- Unauthorized Gangway Handling – the third-party riggers re-installed the gangway without permission or proper communication;
- There was no control or supervision of the third-party riggers onboard the vessel;

- Vessel gangways are critical safety equipment and should only be handled by authorized vessel crew under an order given from the bridge;
- During re-berthing or gangway removal, it may be appropriate to have third-party contractors and visitors disembark unless full control over those remaining onboard can be guaranteed;
- Gangway access during vessel movement or when mooring lines are slackened, regardless of operational pressure, should not be permitted;

- Gangway barrier chains/access gates should be closed after gangway removal on deck;
- All shore/third-party personnel should complete vessel sign in & sign-off procedures while accessing & leaving vessel.
