Arm injury – need for focus on safe isolation and task control

Safety Flash Published on 11 June 2026 Generated on 11 June 2026 IMCA SF 11/26

A worker sustained an arm injury while troubleshooting a malfunctioning garbage compactor.

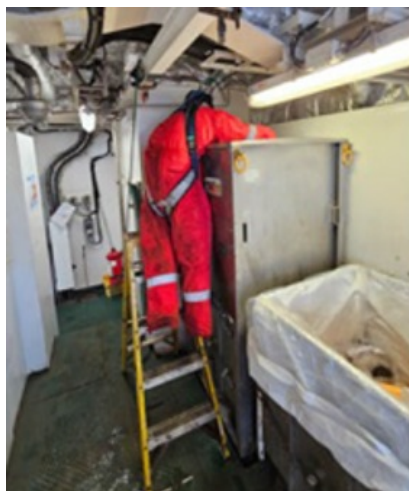
The individual accessed the top opening of the compactor, which was later determined to be part of the ram's movement path. During manual sensor testing using pliers, the compactor activated unexpectedly and the ram began to move, resulting in the individual's arm becoming caught between the ram and the top cover. The situation required immediate response, and nearby personnel provided timely assistance.

Position of person while reaching into compactor (re-enactment)

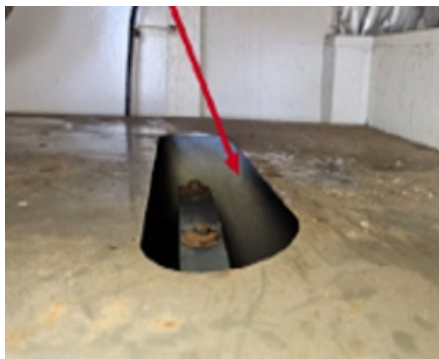
Top view of compactor with ram in low position, showing hole where arm was inserted

- **Equipment Safety Features – Protective Cover:** The compactor's design includes a protective cover over the top opening, as specified in the Original Equipment Manufacturer (OEM) manual. Screw holes were present, suggesting the cover may have been removed or not installed. The absence of this feature was not identified prior to this incident and highlights the importance of maintaining OEM safety components.

- **Where can we safely put ourselves? What might move suddenly?** The top opening was used as an access point without clear awareness of its function within the equipment's movement path. This underscores the need for improved equipment marking and user awareness regarding operational zones.

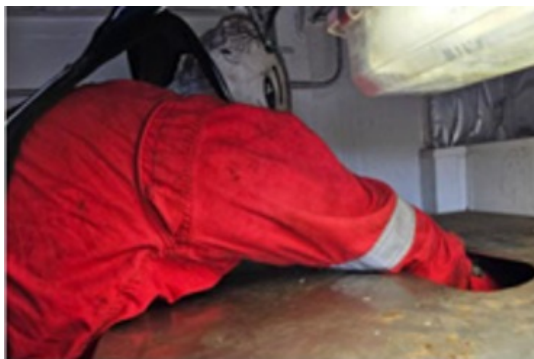
Position of person while reaching into compactor (re-enactment)
