## High potential near miss: Diving bell main lift wire connection failure

Safety Flash Published on 12 August 2026 Generated on 12 August 2026 IMCA SF 14/26

There was a high potential near miss failure of the main lift wire connection (Swivel unit) on a saturation diving bell permanently installed on a DSV.

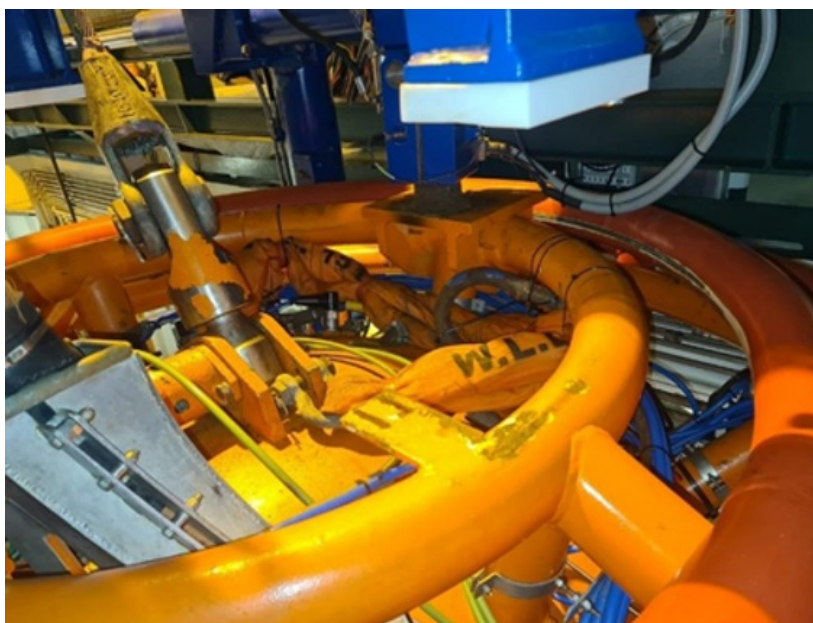
During routine annual maintenance activities, the top half of the Swivel unit was visually examined, and inspected using a Dye Pen. No issues were noted on the top eye bolt section whilst fitted to the Bell top. However, it became necessary to move the main swivel to the workshop, where it became clear there was a through-wall crack through one side of the Swivel unit.

*Main Bell Wire with spelter socket, Connection Swivel and Bell Flanges, Overview*

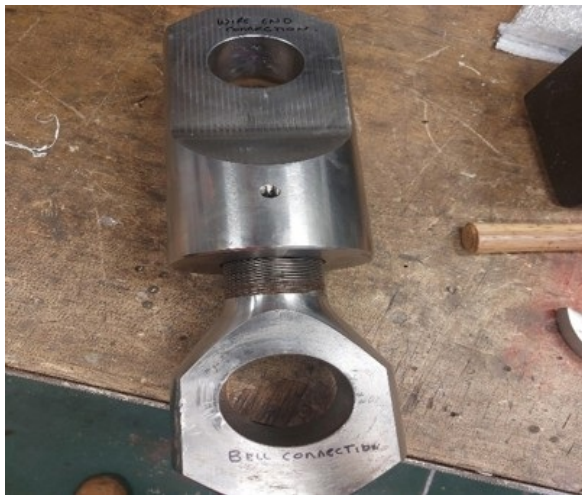
On further investigation another through-wall crack was noted on the opposite side of the unit. Crack propagation down sides 1 and 2 measured 22mm and 38mm respectively. Furthermore, the grub screw was removed and exposed what could be a possible full-length crack throughout the threaded area.

*Overall picture of the swivel unit*

- The swivel unit was taken out of the load path. The faulty component was sent to the manufacturer for investigation.
- A Management of Change process was used to facilitate change to an industry standard spelter socket in consultation with Class via the Manufacturer.
- Given this company has seen a failure of an in-service unit and a new unit under tests other options were sought using a standard spelter socket and shims. The inspection requirements may not have been exhaustive enough to have found the defect. This is under review.
- All in-service units of this type should be checked for defects as described here.
- Inspection regimes should be reviewed and enhanced if necessary. It may be worthwhile considering shortening periods between inspections until Manufacturer can establish a root case and any changes or modifications required.

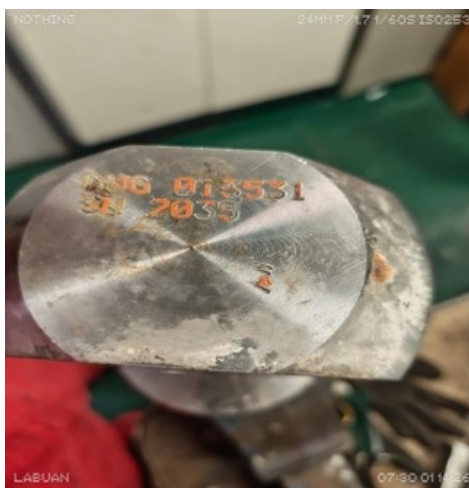
*Stamping on the swivel unit*

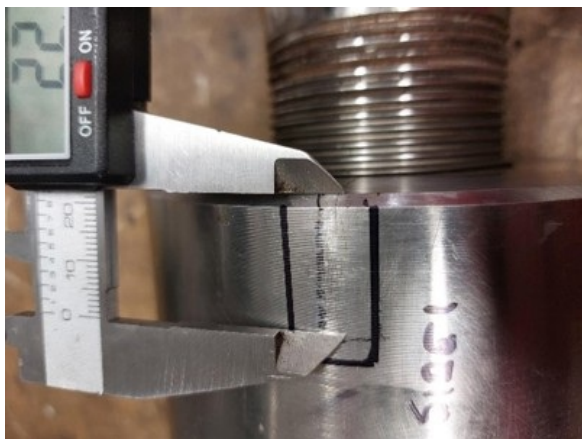
*Side 1 Measured*

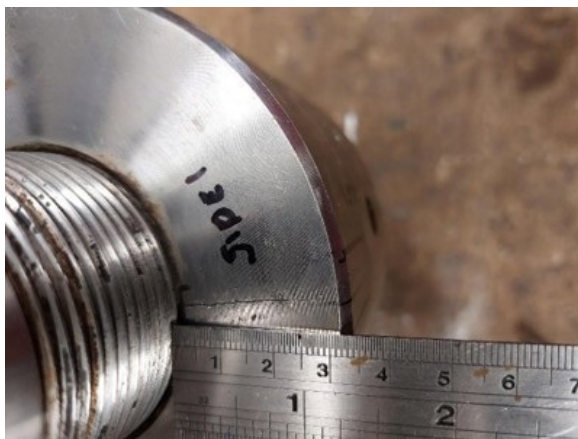
*Side 1 Thro' wall defect*

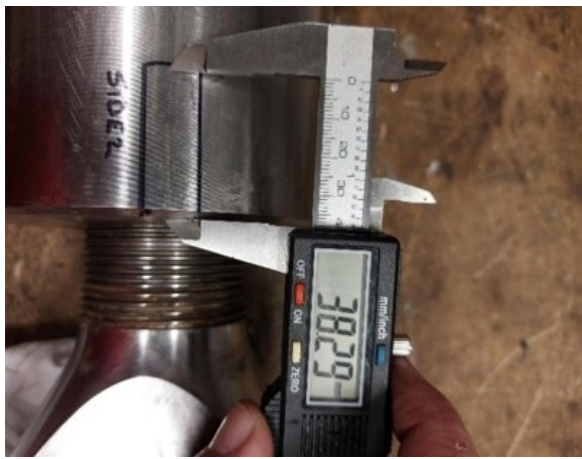
Side 4 Measured

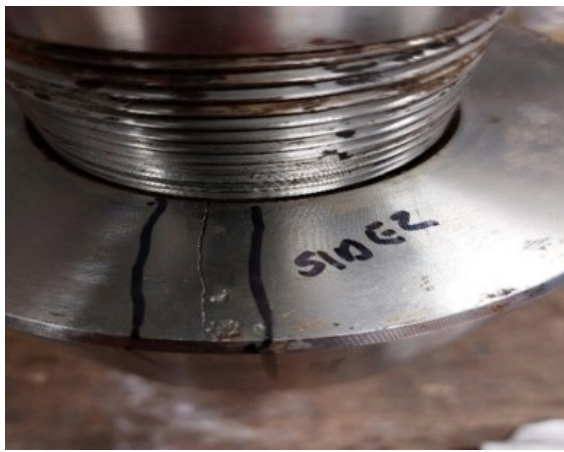
Side 2 Thro' wall defect

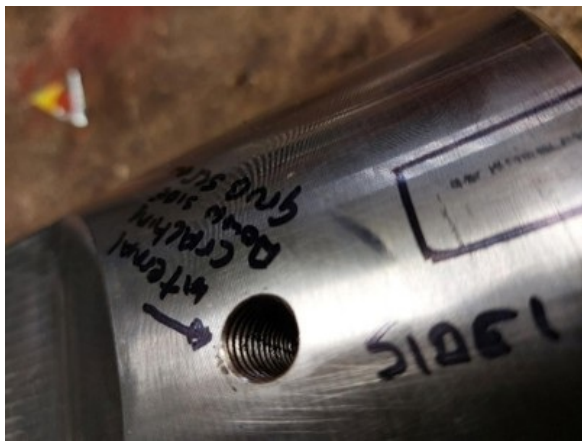
Side 1 Defect grub screw hole

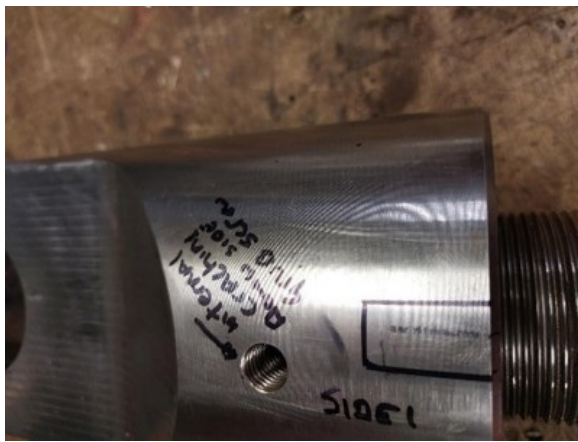
Side 1 Defect grub screw hole
