## MSF: hose got tangled in an azimuth thruster

Safety Flash Published on 10 September 2026 Generated on 11 September 2026 IMCA SF 16/26

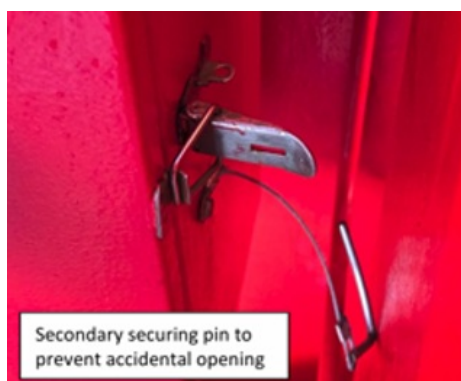
On a vessel transiting to port during rough weather a fire cabinet on the main deck opened, resulting in the fire hose being washed overboard. The fire hose subsequently became entangled in the vessel's starboard azimuth propeller. The fire cabinet door was fitted with industry-standard latches. The latches were not found to be broken or damaged. Following a remote inspection of the propeller, the vessel crew were able to release the fire hose by repeatedly adjusting the position of the starboard azimuth unit from forward to aft.

- The rough weather caused the fire cabinet door to open. It is possible that the fire cabinet door was not fully secured before the vessel encountered rough weather; however, this has not been confirmed.
- There was no secondary securing mechanism fitted to the fire cabinet door latches.
- There was no internal securing arrangement inside the fire cabinet to prevent the fire hose from being washed out if the cabinet door opened.
- A vessel walk-around to verify sea securing was not completed before the vessel encountered rough weather.

- Investigation into a suitable strap that can be installed inside the fire cabinet which can act as a securing mechanism for the fire hose to keep

the hose inside the box should the hatch open. The securing mechanism must not impede the crew's ability to access the fire hose in an emergency.

- Install a secondary securing pin on the fire cabinet door to prevent the main latch from opening accidentally.
- Assess which forecasted weather and sea conditions should trigger completion of the adverse weather checklist.
