## Mooring rope caught in stern thruster

Safety Flash Published on 10 September 2026 Generated on 11 September 2026 IMCA SF 16/26

**Confusion whilst unmooring as it was being prepared for departure from port, led to mooring ropes being caught in the stern thruster.**

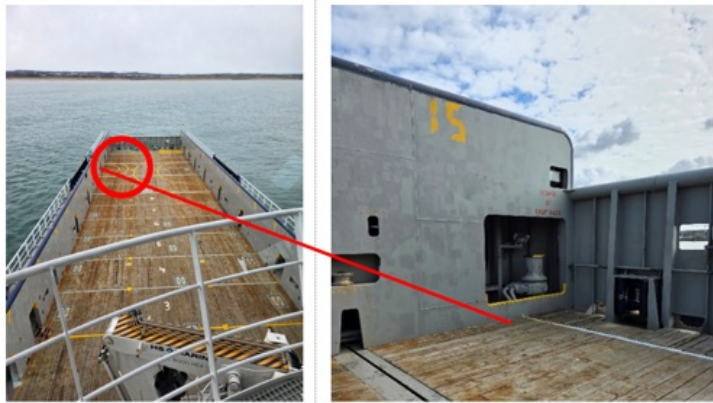
*Bridge view - Capstan winch located inside crash rail*
