## BSEE: poorly maintained crane components cause multiple injuries during personnel transfers

Safety Flash Published on 22 October 2026 Generated on 22 October 2026 IMCA SF 18/26

The United States Bureau of Safety and Environmental Enforcement (BSEE) has published [Safety Alert 517](#) relating to poorly maintained crane components.

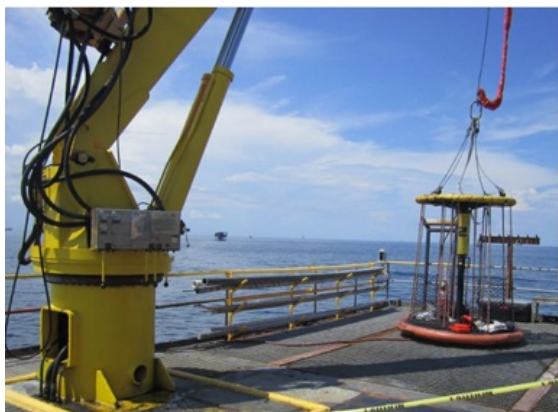
*Crane and personnel basket type involved in incident 1*

During a personnel transfer, a crane operator was lowering a worker in a rigid-type personnel basket to the deck of a motor vessel when the crane's auxiliary line suddenly and uncontrollably dropped 2-3m before coming to an abrupt stop approximately 8m above the water. The worker remained in the basket but suffered injuries to the back and leg. The injured worker needed medical evacuation.

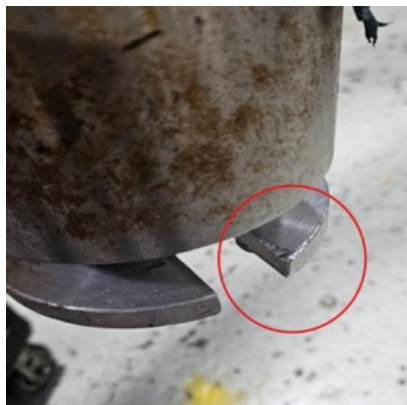
*Incident 1: Scarring observed on the anti-two block*

- Conduct thorough pre-use inspections before personnel transfers, including verification that brakes respond properly under load.
- Verify during pre-use inspections that the auxiliary wire rope's dead-end loop is not fouling on the anti-two-block device. Consider installing a striker plate on the auxiliary line above the dead-end loop to help prevent fouling and damage to the anti-two-block device or wedge socket. Reinforce stop-work authority. Stop operations immediately after any uncontrolled or abnormal crane movement, and resume lifts only after qualified personnel inspect the crane and correct any deficiencies.
