## Dropped scaffold board (kickplate) – SIF near miss

Safety Flash Published on 1 October 2026 Generated on 1 October 2026 IMCA SF 17/26

A scaffolding kickboard was accidentally dropped falling from a height of 6.5 metres to the main deck.

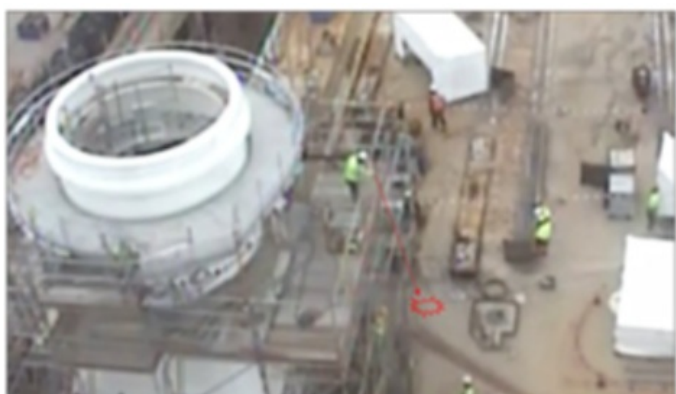
On a vessel in dry dock undergoing installation activities, a scaffolding team was in the process of completing the final adjustments to scaffolding erected around a new crane pedestal. During these final adjustments, a scaffolding kickboard weighing 2.4kg was accidentally dropped from the upper platform, falling from a height of 6.5 metres to the main deck.

- The scaffolders were using unsafe methods during the lay down process of materials.
- Simultaneous Operations (SIMOPS) were taking place, but had not been fully taken into account.
- There were no barriers erected.

- Follow the procedures! Don't take shortcuts. Safe work methods exist for a reason, in this case, to prevent dropped-object hazards.
- Ensure planning is properly coordinated and communicated in an effective way. Missing or not identifying SIMOPS shows how critical it is for all work parties to review planned activities together to understand interactions and potential conflicts.
  - Do we clearly understand what other work parties are doing around us?

- Have we let everyone who needs to know, before starting work?
- Keep people out of the way! Physical barriers are primary controls to separate people from hazards (e.g., lifting zones, moving vehicles, open excavations). When they're missing, the likelihood of a line-of-fire injury increases.
  - Have we verified that all necessary barriers, signage, and exclusion zones were in place?
- Don't forget the STOP WORK AUTHORITY – does everyone feel empowered to stop work when the process is not being followed?
