## H<sub>2</sub>S detected on deck

Safety Flash    Published on 1 October 2026    Generated on 1 October 2026    IMCA SF 17/26

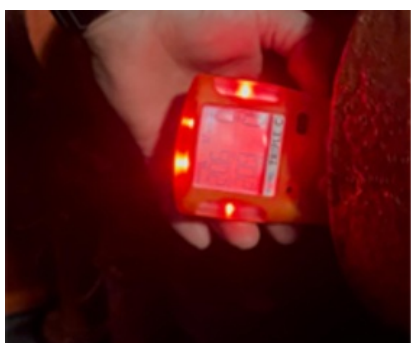
During vessel transit back to port, Hydrogen Sulphide (H<sub>2</sub>S) was detected by means of portable gas detectors, in the open space on the main deck, specifically from certain bilge vents. Sludge and bilge disposal services were arranged on arrival in port. There was no injury and/or ill-health consequence to personnel. The suspected conclusion for the source of the H<sub>2</sub>S was related to the mud loaded for the rig. The following immediate precautions were taken:

- The bilge system had not been flushed after the previous chemical handling, nor before mud loading, leaving reactive residues.
- There was a “procedural gap” in the cleaning protocol and risk assessment for the bilge system after multi-chemical operations - there was no mandatory bilge flushing step in the procedures following tank cleaning or chemical transfers.
- There were multiple chemical residues present in the system (brine, polymer, black water).
- Anaerobic conditions in the bilge tanks favour H<sub>2</sub>S generation.
- A lack of integrated chemical compatibility assessment during risk evaluation.
- Fixed gas detection system did not alarm because contamination developed later during transit.

- Why the Risk Exists: - KCl polymer mud and CaCl<sub>2</sub> brine themselves do not produce H<sub>2</sub>S.
- Bilge water often contains organic matter and anaerobic bacteria which can generate sulphides.
- Drilling mud residues may contain sulphide minerals (iron sulphide, sodium sulphide) from formations. When these sulphides are present and pH falls (acidic conditions), H<sub>2</sub>S gas can be produced.
- Risk Factors
  - Presence of sulphides in mud or bilge water.
  - Anaerobic bacterial activity in stagnant bilge water producing sulphides.
  - Acidic contamination (e.g., CO<sub>2</sub> ingress, acid cleaning fluids).
  - Temperature increase accelerating reactions.

- All personnel working on the main deck and in the engine room were equipped with portable gas detectors.
- The affected area was isolated and monitored continuously.

- Ensured vessel standard operating procedures include mandatory bilge flushing after chemical handling and before mud loading.
- Chemical compatibility review: Implemented a checklist for reactive residue risks, to be done during the toolbox talk.
- Extended cleaning scope to bilge system when tanks are pressure washed.
- Added periodic H<sub>2</sub>S checks in bilge tanks during transit.
- Crew training: Emphasise chemical interaction risks and anaerobic conditions in bilge systems.
