# Hydraulic oil leak detected below moonpool

Safety Flash Published on 1 October 2026 Generated on 1 October 2026 IMCA SF 17/26

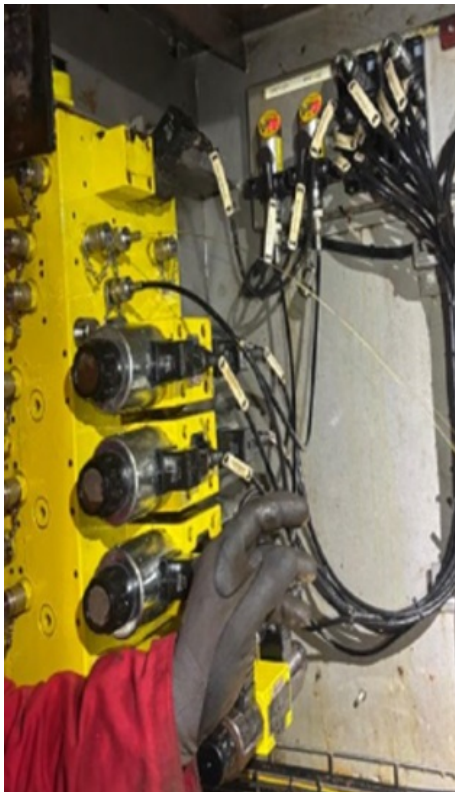
Operations were immediately stopped, and the main hydraulic power unit (HPU) was shut down and isolated. Investigation identified the source of the leak as a failed “minimess” monitoring hose at the termination/crimp fitting within the aft worktable door hydraulic control cabinet. Review of Supervisory Control and Data Acquisition (SCADA) data indicated a minor low-pressure alarm had activated earlier. However, visual inspection of the area below the moonpool doors had not been possible at that stage. It is estimated that approximately 185 litres of hydraulic oil were released during the event, of which approximately 35 litres were recovered, resulting in a confirmed loss of approximately 150 litres to sea.

- Asset lifecycle gaps: “Minimess” monitoring hoses of the kind that failed were not explicitly included within the flexible hose lifecycle management strategy and were treated as permanent fittings rather than consumable pressure retaining components.

- Inspection limitations: Routine planned maintenance consisted of visual inspection and torque checks only and could not verify hose crimp or termination integrity, the critical failure point.
- System configuration constraints: The hydraulic cabinet is inaccessible when the moonpool doors are closed, limiting early verification of alarm conditions during critical operations.
- Detection challenges: CCTV image quality, lighting conditions, and workload in the control room made gradual changes below the moonpool difficult to identify until the doors were opened.

- “Minimess” monitoring hoses were formally classified in the planned maintenance schedule as pressure retaining components with defined replacement intervals, and appropriate amendments were made to vessel procedures.
- An assessment was made of design options to see if it was possible to eliminate these hoses where feasible by direct sensor installation.
- Increased frequency of oil skimmer drills to improve readiness and familiarity with deployment.
