## Restoration and verification after maintenance

Safety Flash Published on 1 October 2026 Generated on 1 October 2026 IMCA SF 17/26

A missing flooring panel was identified beneath a 415V bow thruster electrical motor cabinet.

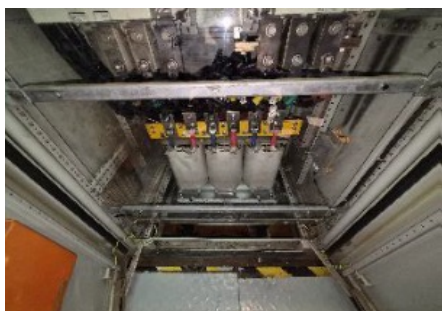
During a vessel inspection, a missing flooring panel was identified beneath a 415V bow thruster electrical motor cabinet. The panel had been removed to facilitate maintenance work, and had not been put back afterwards. It was also observed that water piping located directly beneath the cabinet lacked adequate splash protection. This created a potential risk of water ingress into electrical equipment and increased the likelihood of electrical failure, short circuit, or personnel injury.

*Bow thruster control cabinet*

- Check carefully and thoroughly after finishing maintenance and modification activities, that structural and safety protections are fully restored before equipment is returned to service.
- Have a formal sign-off or completion procedure: Final inspections, housekeeping checks, and permit close-out verifications are useful for confirming that work areas have been restored to a safe condition.
- Electrical equipment located above or below fluid or cooling pipework should be adequately protected against leakage and splash hazards.

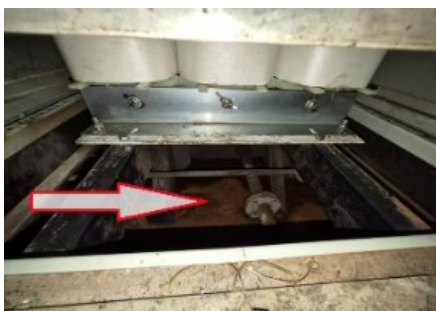
*Cooling pipeline located directly below the cabinet*
