1 Explosion - hot work in a flammable atmosphere (Transport Malta)

2 Process Safety Fundamentals – IOGP / Step Change

3 IOGP: Dropped object with potential for injury - riser release

4 Safe Use of Ladders and Stepladders

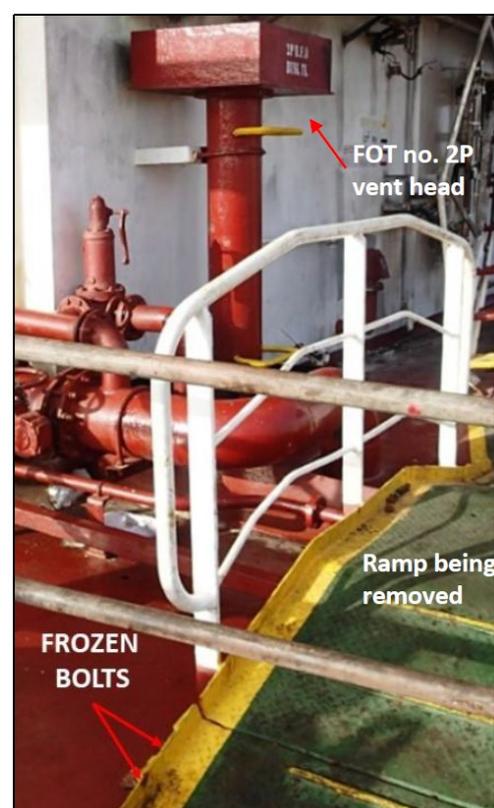
A large tanker was in transit to her scheduled dry-docking. Additional technicians were on board to assist with preparations for the dry dock. As part of this process, walkway ramps on the main deck were being dismantled to check on their condition and that of the piping passing underneath. Two of the bolts on the last ramp were particularly hard to undo and the assigned technician opted to use an angle grinder to facilitate the work. Sparks emitted from the grinding disk flew towards the vent head of a fuel oil tank (see photograph). Subsequently, an explosion rocked the vessel, causing damage to her steel structure, and port side lifeboat and life-rafts. There were no injuries.

- The safety investigation believes that, although the technician was aware that sparks would be generated by cutting the bolts with the angle grinder, he was unaware of the flammable gases accumulating around the vent head of the bunker tank in the vicinity.

- Refresher webinars were organised to emphasise the ‘stop work authority’;
- Better safety management and planning of work when additional crew are on board.

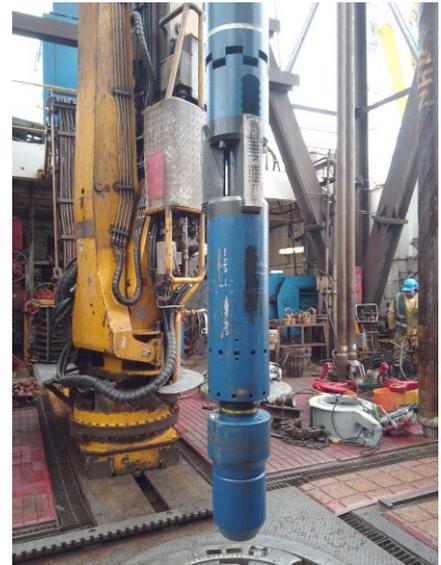
While recovering the 16" riser to surface, a drill-pipe deployed anchor tool, which was set inside the riser, prematurely released dropping the Riser approx. 14m and causing damage to the Subsea Wellhead Housing (WHH) sealing face. There were no injuries.

The load rating of the drill-pipe deployed anchor tool in operation was not as per advised value and it subsequently failed when a relatively modest load was inadvertently applied. (The tool prematurely released at around 35K lbs overpull, rather than the 114K lbs rated overpull).

A drill-pipe deployed anchor

IOGP recommends that during recovery of casing or riser, that the slip mechanism of the anchor tool is energised constantly by applying pressure and that the shear pins and ratchet mechanism are not solely relied upon as a means to ensure tool engagement.

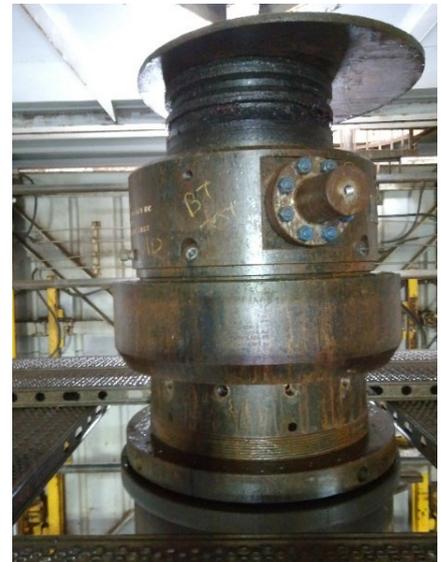
Riser

The damage to the wellhead sealing face was subsequently addressed and confirmed satisfactory.
