## MSF: Grease gun hand injury

Safety Flash Published on 4 September 2025 Generated on 5 September 2025 IMCA SF 16/25

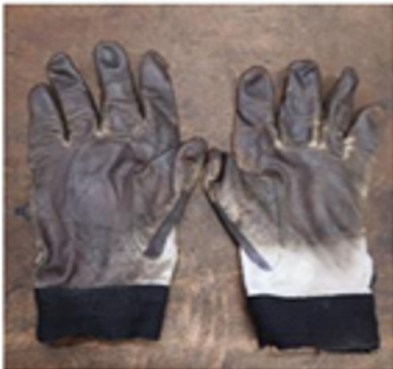
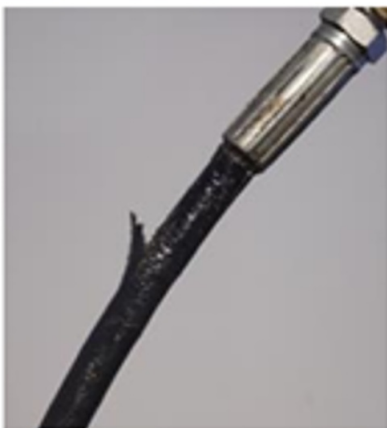
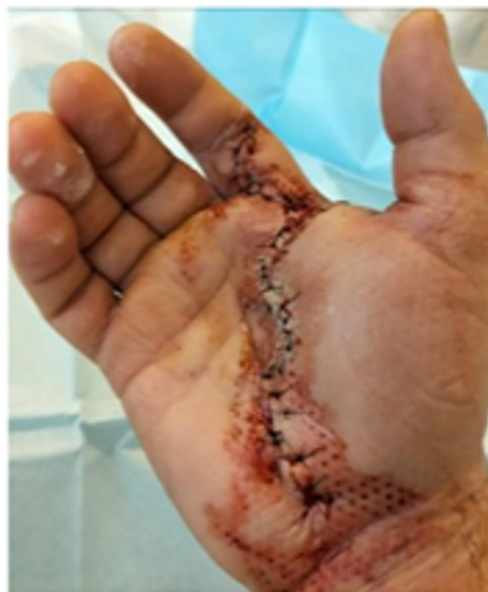
The Marine Safety Forum have published [Safety Alert 25-08](#) relating to a hand injury suffered when a grease gun burst. The incident occurred during routine greasing of a tensioner unit using an electrically powered battery grease gun, when the hose burst and grease punctured the operator's hand. The crew member was wearing full PPE and performing the task in accordance with safety procedures that were in place at the time. As the crew member attempted to remove the greasing hose from the greasing point, the hose burst on his right hand. The high-pressured grease passed through the damaged hose causing a penetration through his glove, leading to a small open wound on his skin. The crew person immediately attempted to remove as much grease as possible from the wound and proceeded directly to the onboard medic for evaluation and treatment. Following consultation it was decided to sail back to port for medical attention at local hospital

- Immediate Cause
  - The pressure release valve in the grease gun did not function as expected, causing grease to be injected at high pressure.
- Underlying Cause
  - It was possible that the grease gun was not properly or safely handled due to lack of experience, insufficient training and lack of awareness of the hazards involved.
  - The injured person was unaware of the high pressure in the grease gun system at the time, therefore he began to exert effort on the grease hose to remove it from the grease nipple. The grease hose was (most likely) unable to handle the pressure and collapsed. This resulted in a grease injection through his glove and skin into his right hand.

- High-pressure grease guns have the potential to cause serious injury or even death if not properly used and properly maintained. Grease in this type of equipment is under pressure up to an operating pressure 69 MPa (10,000 psi).

- The velocity of grease forced through a pinhole break in a hydraulic hose can be in excess of 250 metres per second (600ft/s). This is close to the muzzle velocity of a rifle, and is sufficient to drive fluids through protective clothing, including protective gloves.

- Penetration of the skin can occur at pressures as low as 100psi - BE AWARE of the dangers of high pressure injected injuries.
- Ensure grease guns are used in compliance with equipment manufacturers instructions.

- Inspect the integrity and security of grease nipples and hoses prior to starting the task.
- Ensure correct gloves are used with grease guns.
- Can greasing be done with a different kind of tool that is safer?
